## M2 Roof Repair

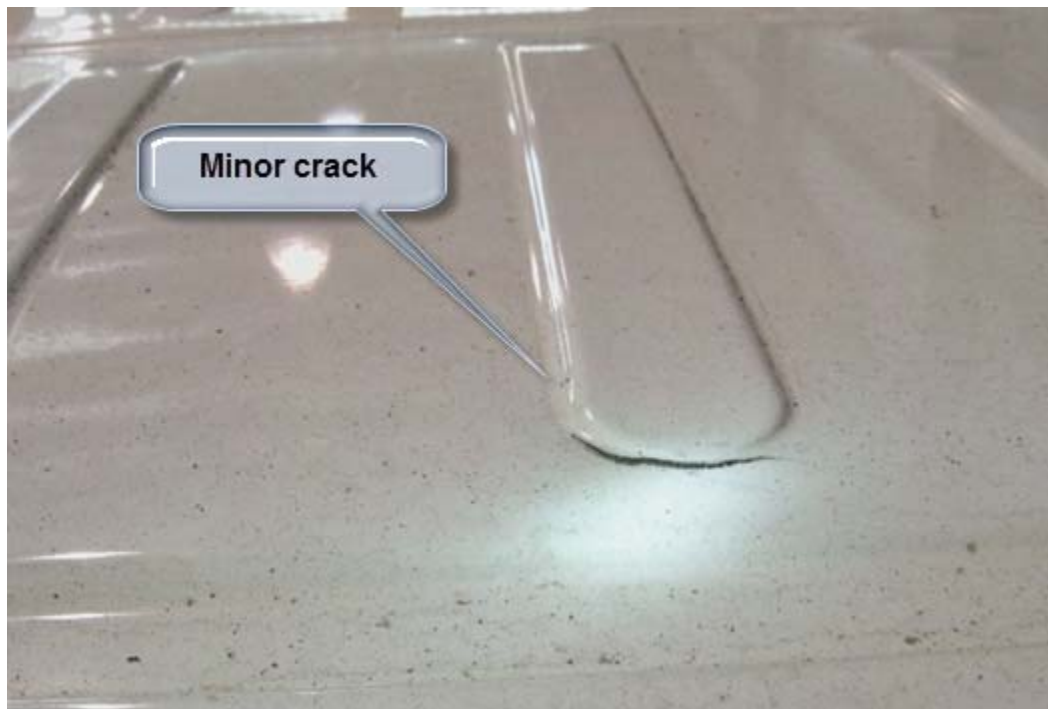
The roof cracks from the roof bows not being bonded to the skin properly. This issue is found mainly on STD cab M2 with a dry van body causing the cab roof to pop from the air buffeting the front of the body.

Recommended repair for this condition suggests removing loose OEM sealer and installing Fusor 121 Flexible Foam between roof ribs and metal roof panel.

Repair the crack drilling the ends of the cracks and refilling or a severely cracked or warranty repair it is a recommended repair for roof suggests cutting out distressed area and installing a patch panel using Fusor 110B and following recommended patch panel installation and preparation techniques which include proper bevel on overlapping edges. Exterior of patch panel finished with fiber rich polyester filler followed by a suitable polyester skim coat. Prime and paint according to paint manufacturer's recommendations.

Adding an extra roof bow to the center of the interior riveting to the front overhead console and to the rear header and gluing the rib to the skin will stop any noise and re-cracking of the skin.
