## Customer / Dealer Advisory

### Subject: Steering Pitman Arm Check

Models Affected: Specific Freightliner Cascadia Model Year 2018

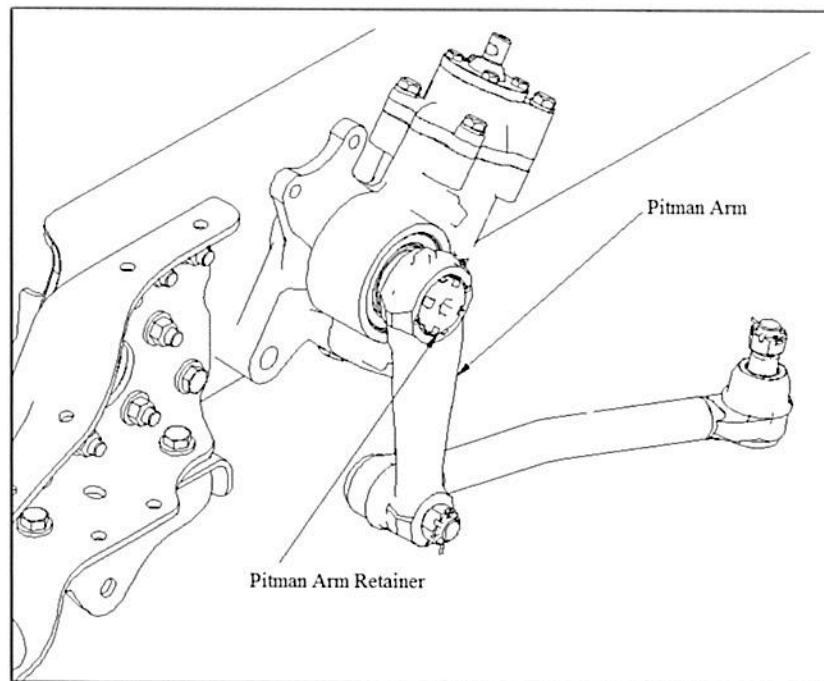
Fig. 1

1. Park the vehicle on a level surface, shut down the engine, and set the parking brake. Chock the rear tires.
2. Locate the pitman arm retainer as shown in Fig. 1.

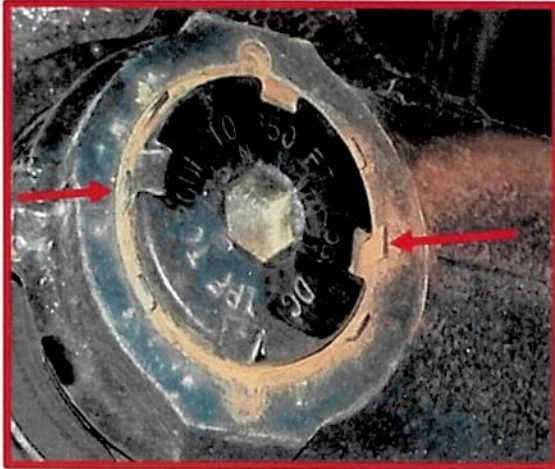
Fig. 2

3.2 Fig.2 Shows the incorrect installation where the tabs are NOT bent. Fig. 3 shows the two washer tabs correctly bent into the notches of the retainer.

**INCORRECT**

3.3 IMPORTANT: If inspection reveals the two washer tabs are not bent into the notches of the retainer, do not put the vehicle into service. Contact a certified Freightliner service provider for repair.  
**DO NOT DRIVE THE VEHICLE.**

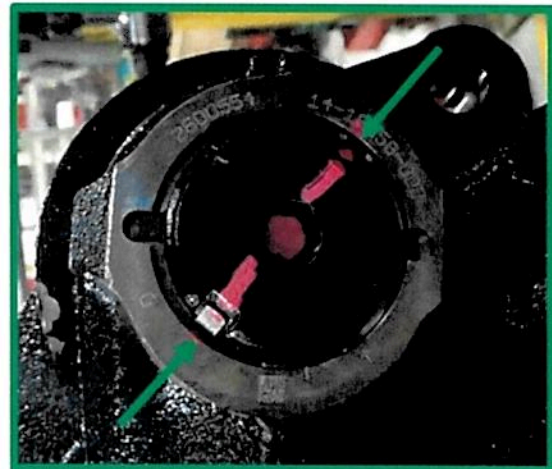
Fig. 3

**CORRECT**
