Freightliner  
Service Bulletin

## General Information

On M2 vehicles equipped with an Allison transmission, the Behr/Mahle cooling modules use quick-connect fittings to attach the transmission cooler lines to the radiator. Some of the fittings may leak, which can cause the transmission to lose fluid. Use the procedure in this bulletin to inspect and repair the connections.

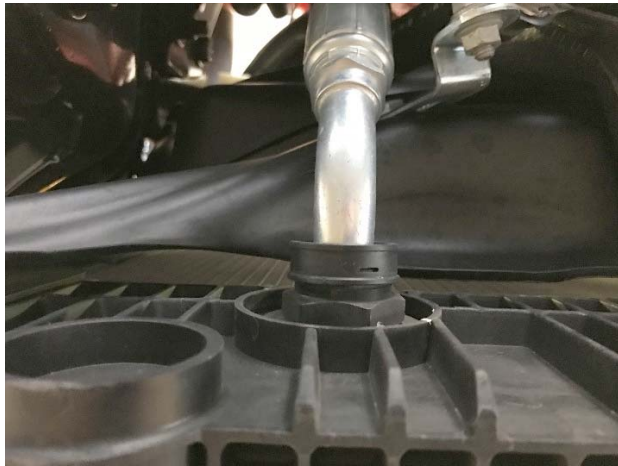
**Fig. 2, Cooler Line Connection with Original Plastic Cap and Spring Clip**

1. Park the vehicle on a level surface, shut down the engine, and set the parking brake. Chock the tires.
2. Inspect the transmission cooler lines where they connect to the radiator and determine if they have the original plastic cap and spring clip as installed from the factory (see [Fig. 2](#)) or if a hose clamp has been installed as a temporary containment (see [Fig. 3](#)).
