## **SS1033890 DD5 Coolant Sensor Fault 111/1**

M2

CPC fault code 111/1, Coolant Below Normal Range

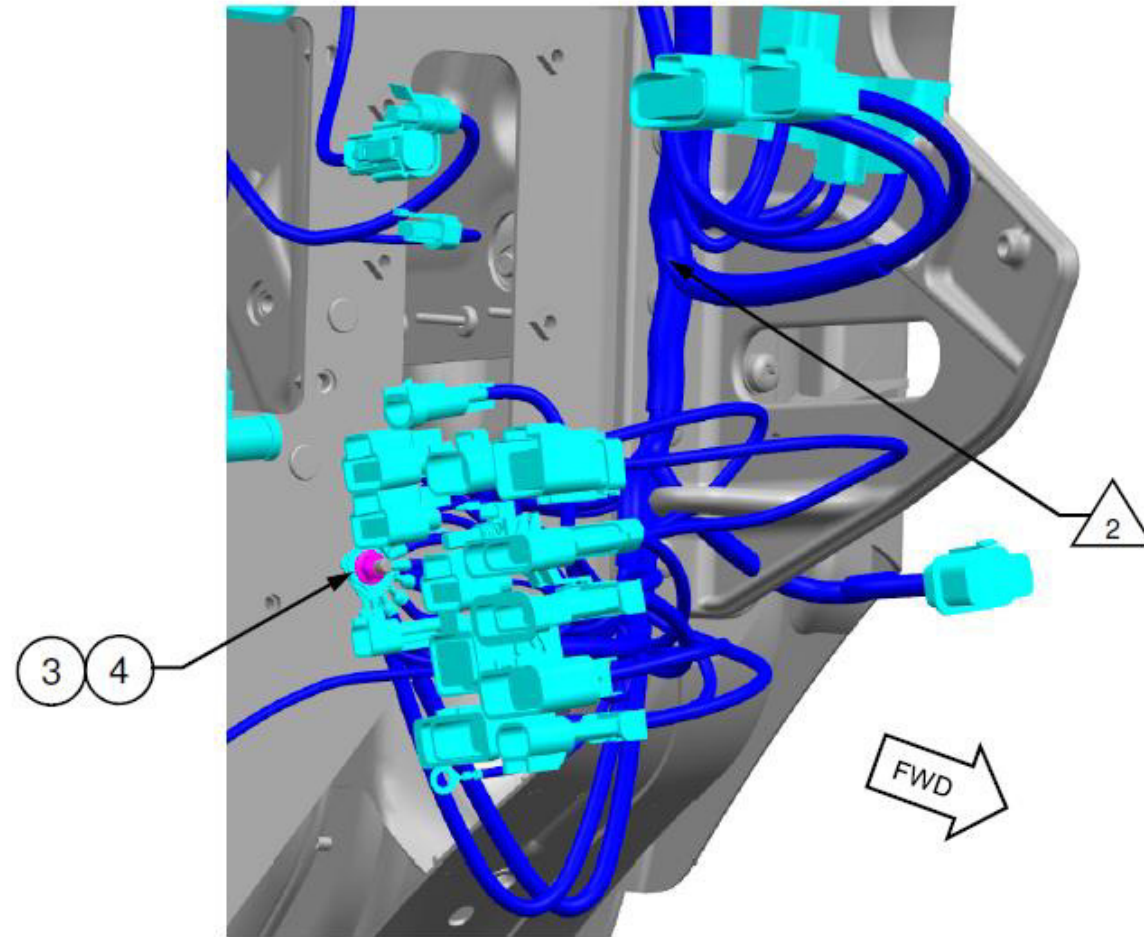
VIEW F

Affected vehicles involve inactive readings of the engine low coolant level sensor (LCL).

See attached document for relocating the ground for the LCL.
