SPN 191/13 and 84/19, VSS Codes on Cascadias with DT12 Transmission

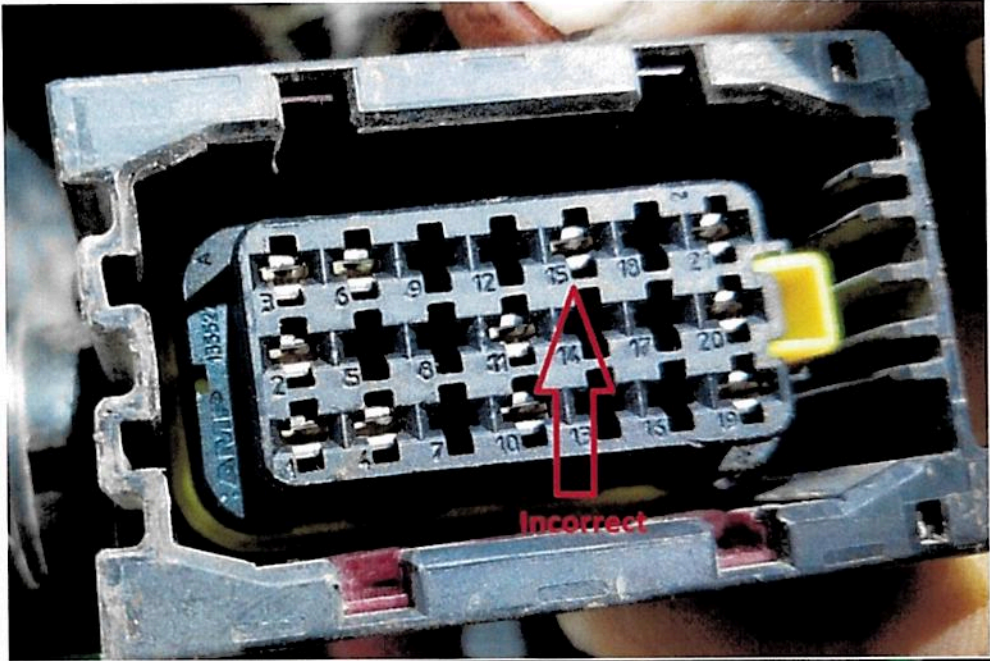
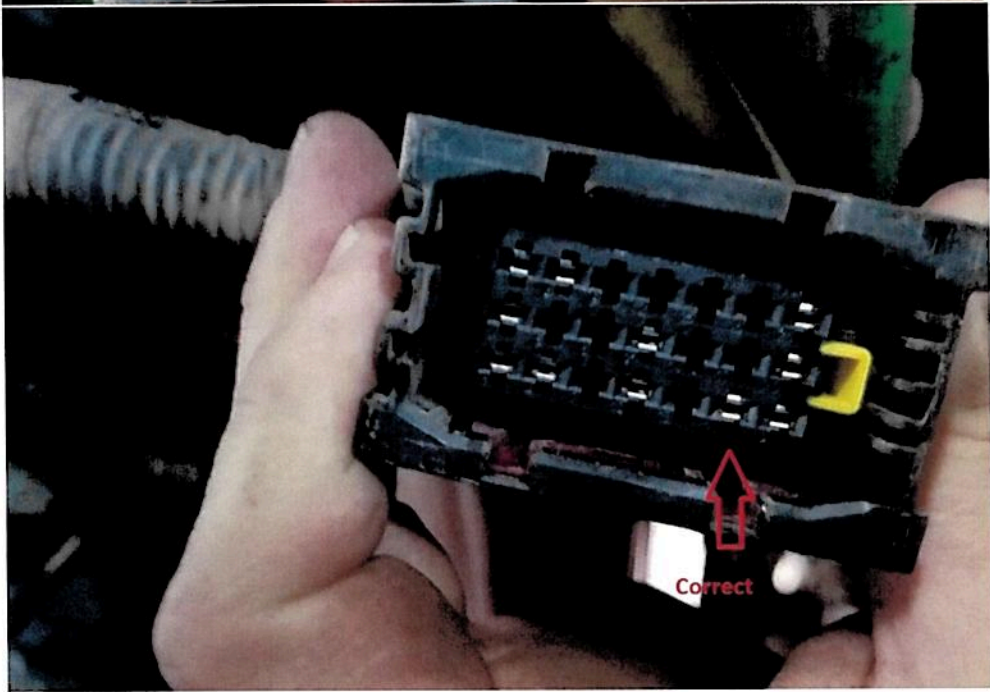
We have found two trucks recently with the following very intermittent fault codes on Cascadias with DT12 transmissions with low miles.

SPN 191/FMI 13, J1939 Transmission Output Shaft Speed Signal is missing.

SPN 84/FMI 19, J1939 Wheel-based Vehicle Speed Signal (VSS) from Source #1, #2, or #3 is Erratic.

See attached picture outlining correct and incorrect cavity location.

If you encounter these codes and troubleshooting does not lead to root cause, check for ground wire in cavity 15 of the 21-pin connector. If found, relocate to cavity 16.
