# SS 1033850 New Cascadia Multi-Purpose Camera (MPC01T) Will Not Calibrate During Road Test

This solution applies to all New Cascadia vehicles built with the MPC01T Multi-Purpose Camera.

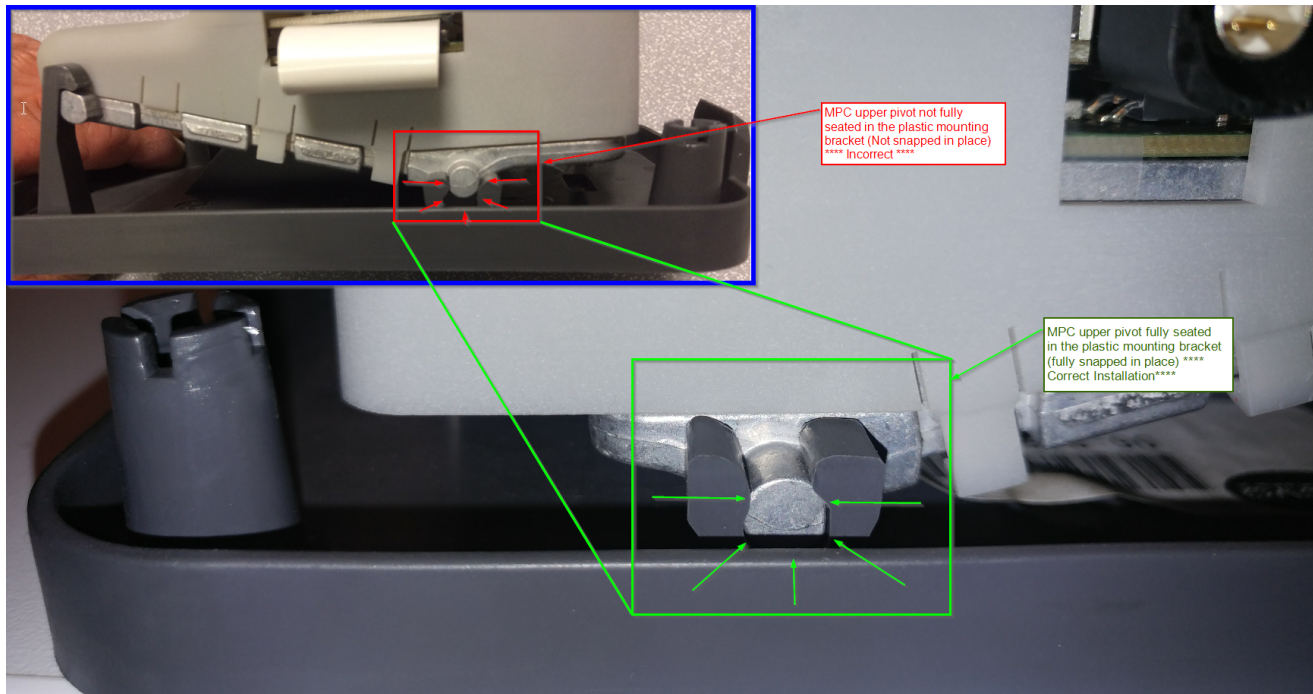
If the MPC camera is not fully snapped into its plastic mounting bracket, vibration and the incorrect camera angle can then cause the camera not to properly calibrate.

When running into issue where the MPC camera will not calibrate it is important to make sure the MPC is fully snapped into its mounting bracket that is attached to the front windshield. The below image show both the incorrect and correct mounting of the MPC upper pivot. The camera needs to be properly mounted, as well as the mounting of the bracket being properly installed to the windshield and the camera lens and windshield viewing area must be clean.
