September 2018
FL768AB
NHTSA #18V-250 School Buses
#18V-378 Non-School Buses
Transport Canada #18-197

Subject: FCCC Bus Chassis Battery Cable Interference

Models Affected: Freightliner Custom Chassis B2 school bus chassis (Thomas Built Buses Saf-T-Liner C2) and S2C shuttle bus chassis manufactured March 10, 2017, through March 6, 2018.

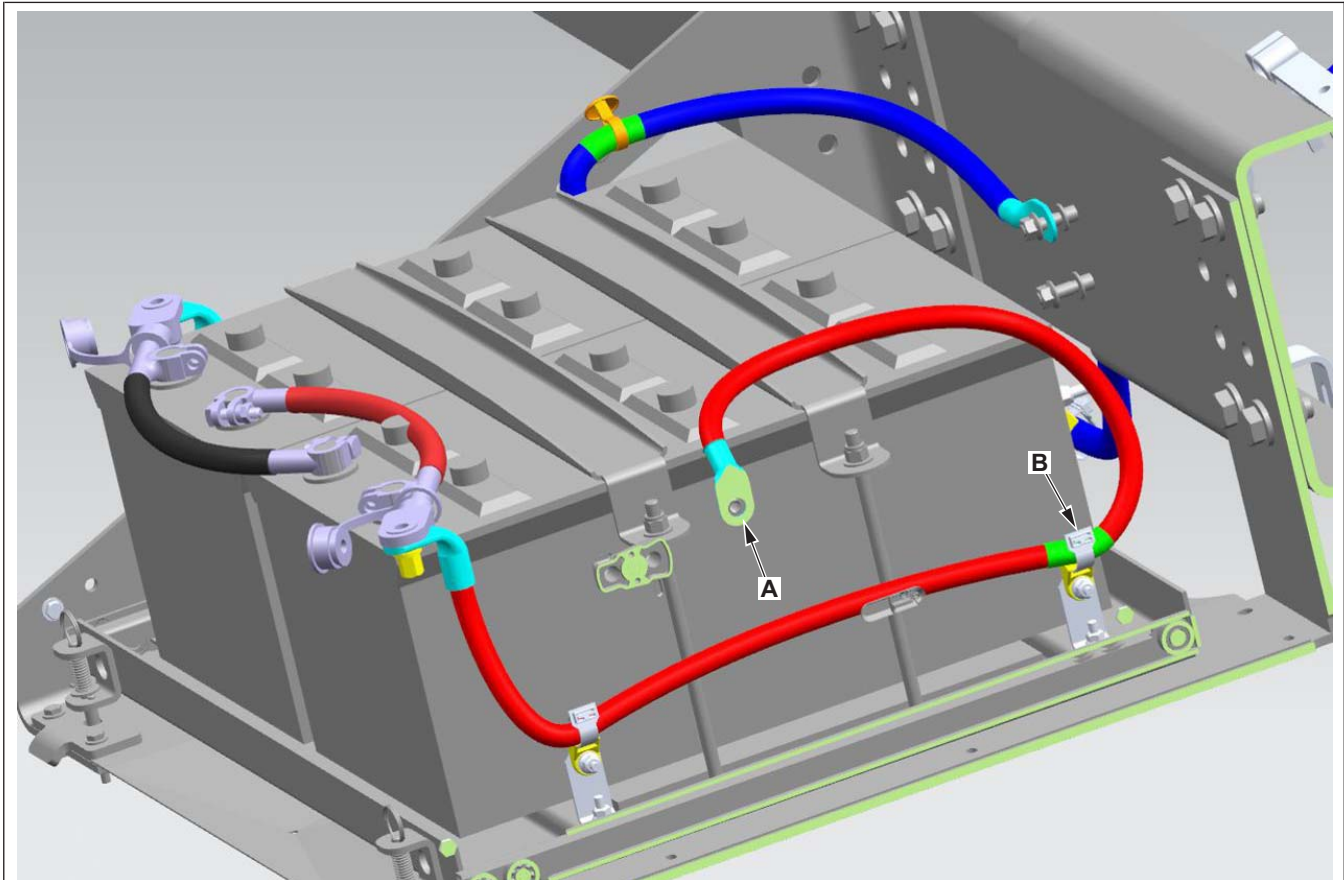
- A. Rotate the end of the battery cable to an approximate 11 o'clock position.
B. Align the tape on the battery cable with the saddle mount.

Fig. 2, Correct Battery Cable Installation

4. With the battery tray pushed in, use a wrench to loosen the nut on the battery cable at the power distribution module (PDM) stud.
5. Rotate the end of the battery cable as shown in **Fig. 2**, then tighten the nut 26 lbf-ft (35 N-m).

6. Slide the battery tray in and out to verify the battery cable does not rub the battery hold-down bracket or stud.
7. Clean a spot on the base label (Form WAR259). Write the recall number, FL768, on a blank red completion sticker (Form WAR260), and attach it to the base label to indicate this recall has been completed.

4. With the battery tray pushed in, loosely install the new battery cable on the PDM stud with the nut removed earlier. Route the cable back toward the frame rail, then loop it forward, aligning the tape on the cable with the saddle mount as shown in **Fig. 2, ref. B**. Rotate the end of the cable to the 11 o'clock position (approximately), ensuring there is ½ inch (13 mm) clearance between the battery cable and the battery hold-down bracket and stud. Tighten the nut 26 lbf·ft (35 N·m).
