October 2018  
FL766A  
NHTSA #18V-191  
Transport Canada #18-190

## Subject: Western Star Power Cable Studs

**Models Affected:** Specific Western Star 4700, 4900, 5700, and 6900 model vehicles manufactured September 12, 2016, through February 6, 2018.

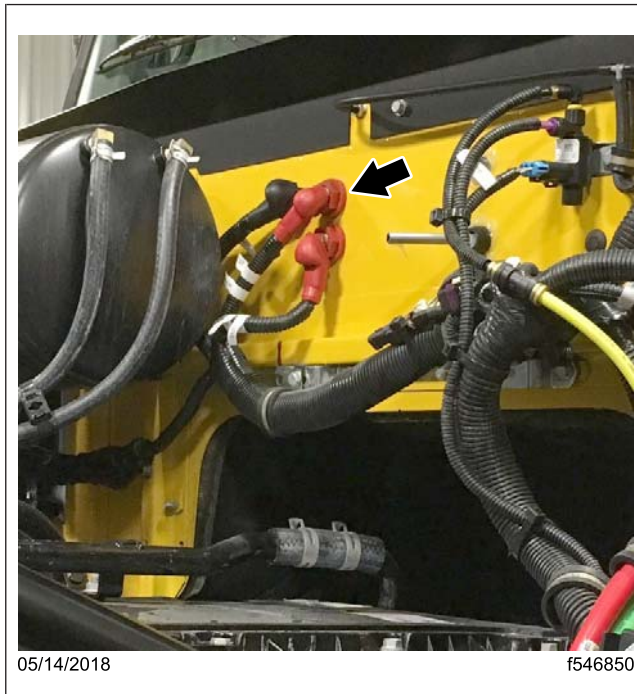
Fig. 1, Power Cable Stud Connector Location

1. Check the base label (Form WAR259) for a completion sticker for FL766 (Form WAR260) indicating this work has been completed. The base label is usually located on the passenger-side door, about 12 inches (30 cm) below the door latch. If a completion sticker is present, no work is needed. If a completion sticker is not present, proceed to the next step.
2. Park the vehicle on a level surface, shut down the engine, and set the parking brake. Chock the tires.
3. Open the hood and locate the three power cable stud connectors on the front wall. See [Fig. 1](#).

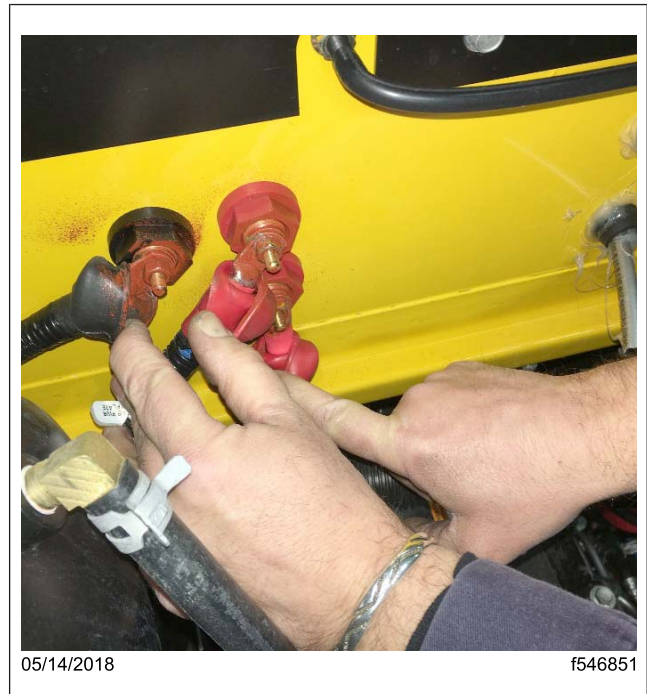
Fig. 2, Removing Connector Protective Cover

4. Pull back the covers on the power cable stud connectors. See [Fig. 2](#). Inspect each cable stud to make sure at least one thread protrudes past the plastic nut. See [Fig. 3](#) and [Fig. 4](#).

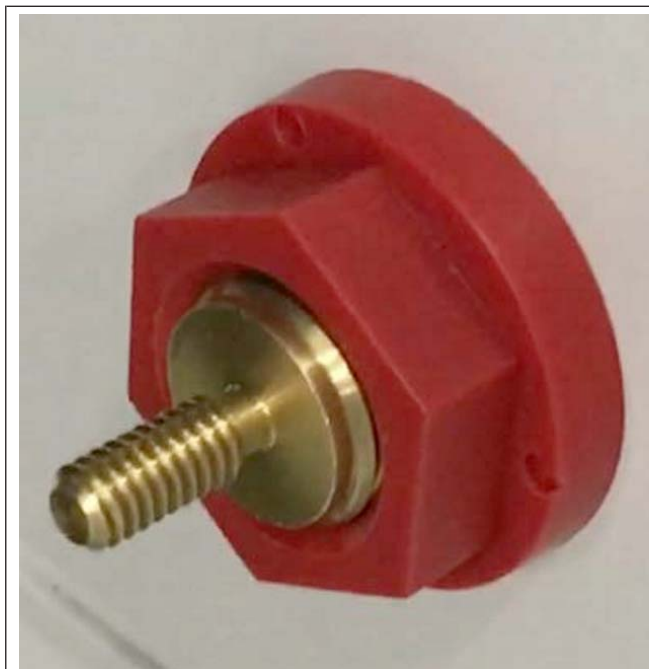
Fig. 3, Installation Inspection

If at least one thread does **NOT** protrude past the plastic nut, the installation is **INCORRECT**. Proceed to "Power Cable Stud Replacement."

If at least one thread protrudes past the plastic nut, the installation is **CORRECT** and the recall is complete. Continue with the next step.

A. Correct Installation

B. Incorrect Installation

5. Disconnect the cables from the terminals on the outside of the front wall.
6. Remove the plastic nuts and the studs.
7. Remove the old power cable studs and replace them with the new power cable studs.
8. Fully seat each stud in the square hole.
9. Tighten the plastic nuts 60 to 84 lbf·in (680 to 950 N·cm). Make sure at least one thread is exposed past the plastic nut.
10. Connect the cables to the terminals on the outside of the front wall.
11. Connect the cables to the terminals inside the cab.
12. Install the dash. Refer to *Western Star Workshop Manual*, **Section 60.06, Subject 110**.
13. Clean a spot on the base label (Form WAR259). Write the campaign number, FL766, on a blank red completion sticker (Form WAR260) to indicate the work has been completed and attach it to the base label.

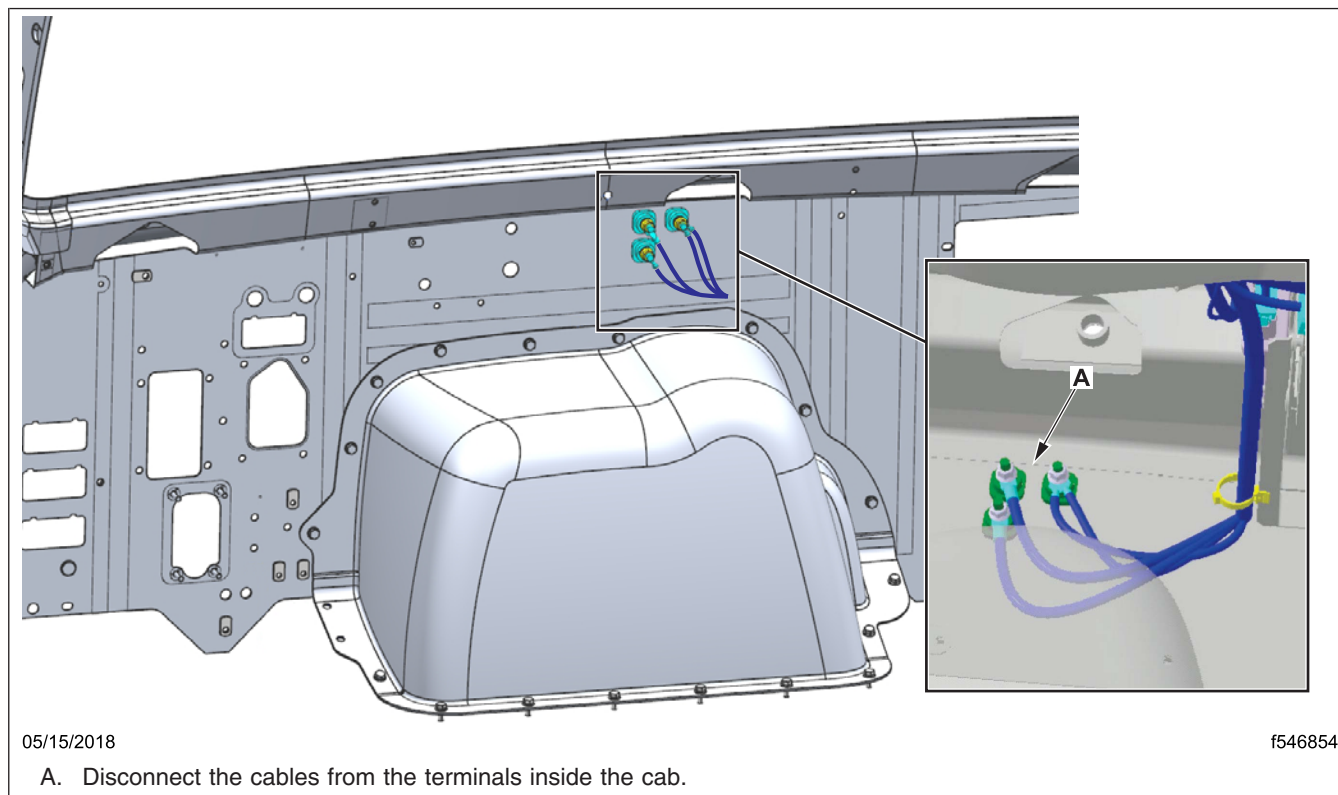
**Fig. 5, Location of Front-Wall Power Terminals (inside the cab)**

4. Disconnect the cables from the terminals inside the cab. See [Fig. 5](#)
