## **SS 1033950 New Cascadia trailer receptacle back wall grounding stud**

New Cascadia

Some New Cascadia vehicles built with the seven way primary cable receptacle mounted at the lower left hand back of cab may have the trailer grounding circuit incorrectly attached to the interior back wall.

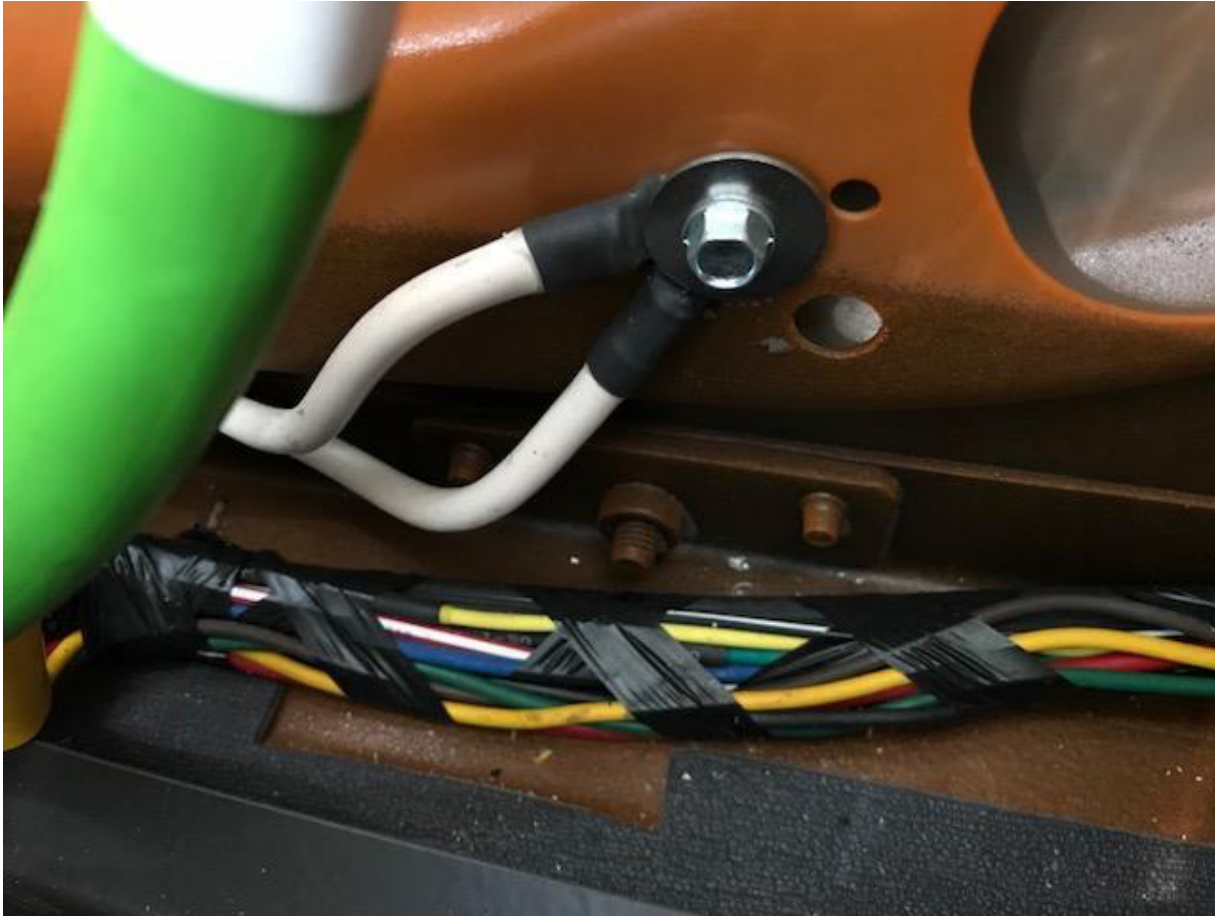
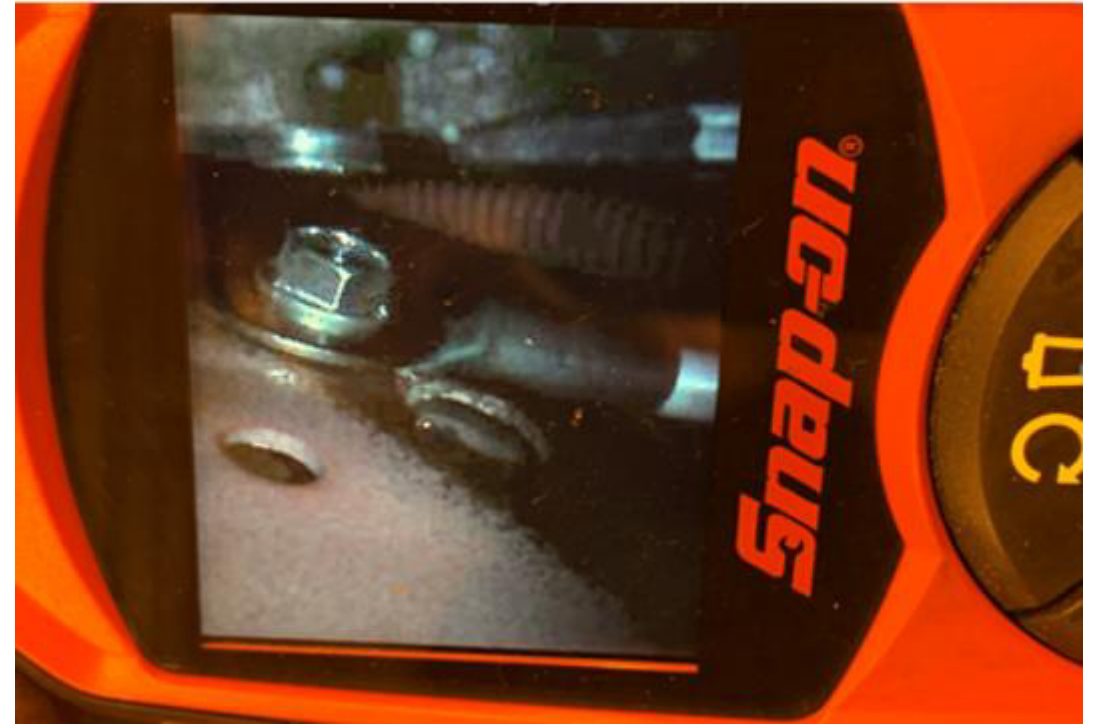
Note the visuals below for incorrectly installed trailer grounding circuit inside the back of cab regarding datacode 1AZ. Note that there can be more than (1) eyelet, if the vehicle has an optional connection for trailer ABS only.

Bore scope camera visual from driver's side utility light access

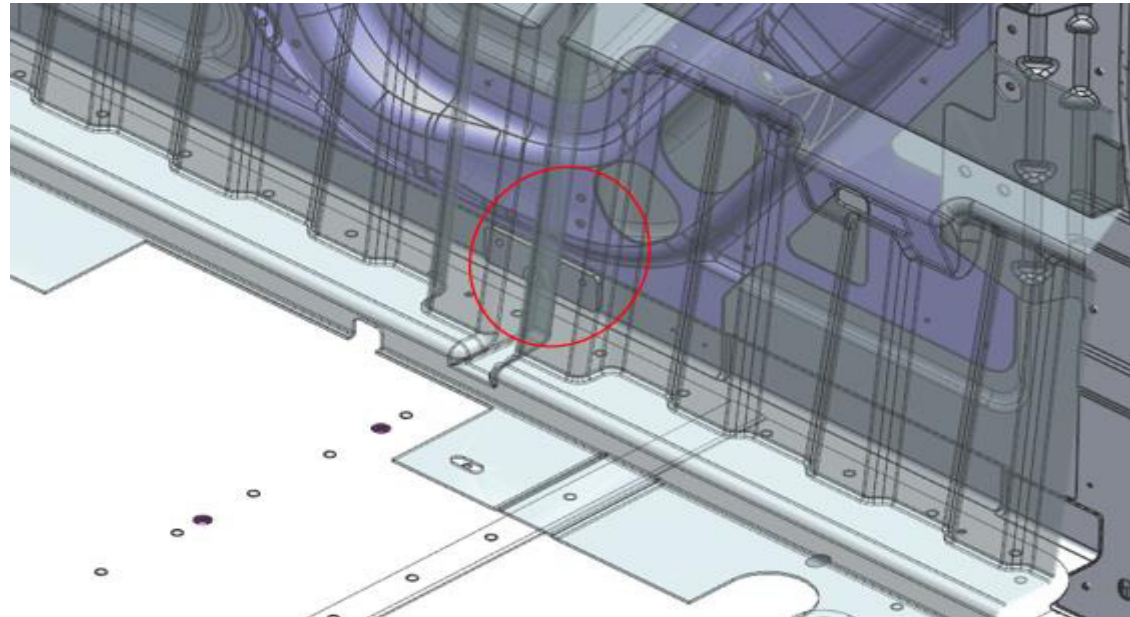
Note in the visual below, the parting of the corrugated panel, roughly 24" inboard from the drivers side when measured from the door latch as noted in previous slide.

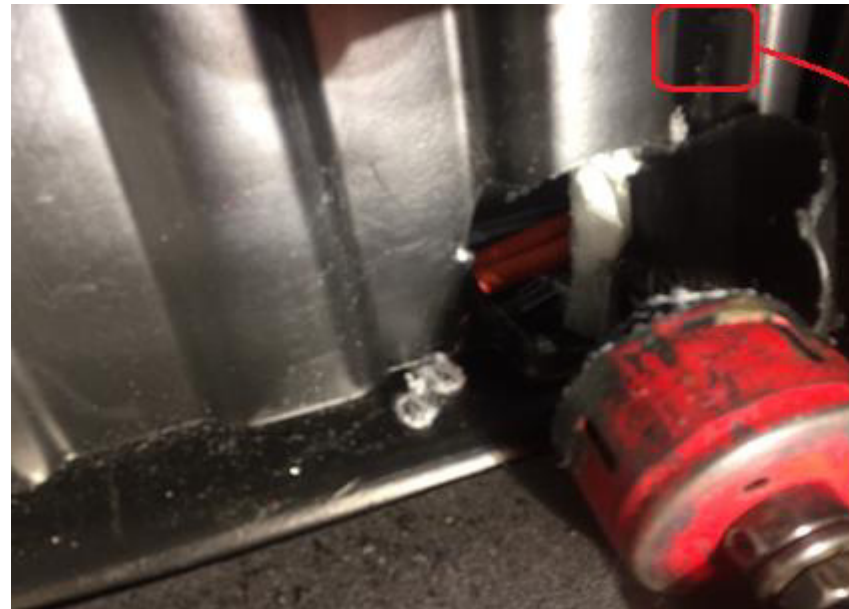
See here for the deep  
portion of the  
corrugated back panel

See below for the drilling function. Set the pilot on the hole saw to a shallow minimal depth. Carefully drill the hole, leave one side of the drilled portion attached to the panel to act as a hinge for later closure. We are purposely drilling off to the left of the stud location to allow access for the clinch nut retaining tool in the opening.

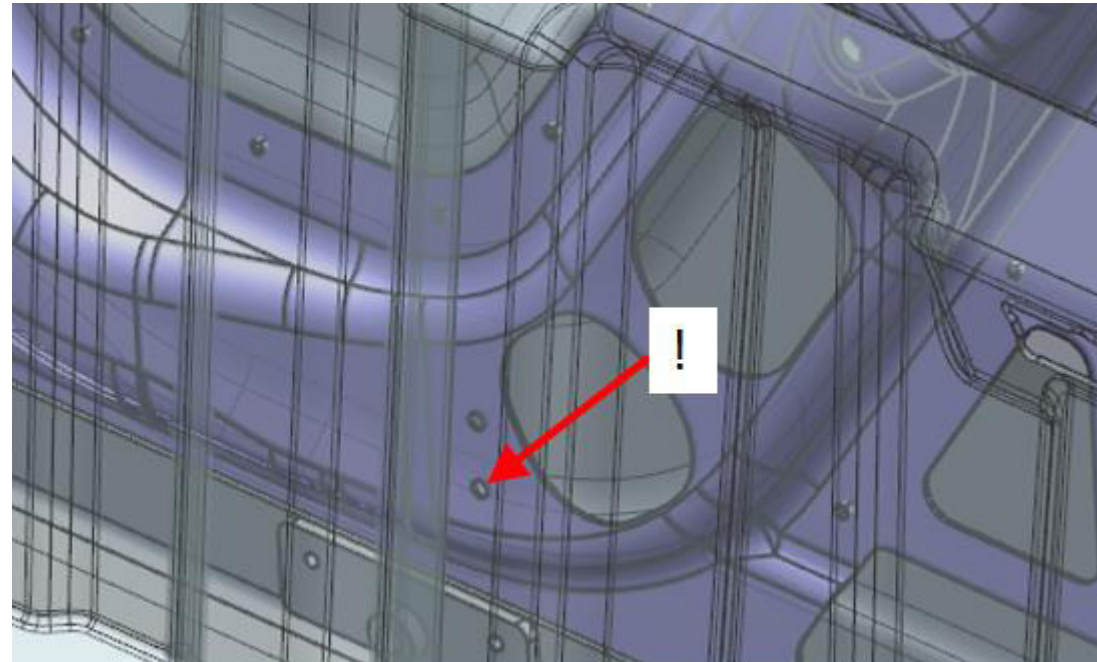
Remove and discard the improperly installed self tapping screw and washer.

Locate the 2<sup>nd</sup> hole in the back wall as noted below. Remove the paint directly around where the eyelet(s) will mate with the panel:

Note the second hole in the backwall as noted above. Drill this hole out slightly over 1/2".
