TECHNICAL BULLETIN 18-01

MMX Platform

SUBJECT: YFS Plated Bolts in Coupler Plates

DATE: March 2018 REV: E

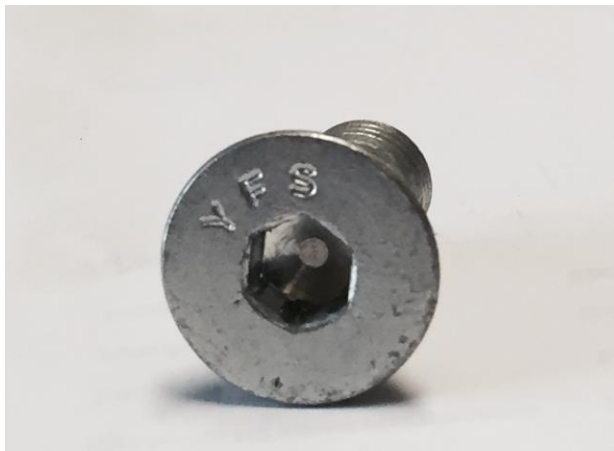
East Manufacturing Corporation has decided the bolts manufactured by YFS do not meet our performance standards and quality expectations in this location and application **when plated** instead of the black oxide.

It is possible for these bolts to crack and loosen over time.

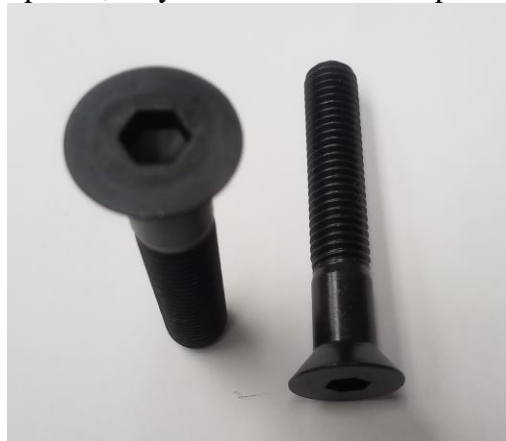
When an MMX Platform comes in for any service work, please check the bolt heads on the exterior of the coupler plate. If they are **plated and stamped with YFS**, all bolts in the coupler plate will need replaced.

East Manufacturing Corporation will voluntarily remedy this defect at no charge to the trailer owner via **replacing the plated YFS** coupler plate bolts with new bolts from a different supplier with a track record for consistent quality. If the bolts are not plated, they do not need to be replaced.

The coupler plate will not need to be removed from the trailer to make this repair. The repair can be completed in no more than 5-6 labor hours to replace all 38 bolts. Torque all bolts to 70 ft lbs.

- 1.) Remove all exterior bolts holding the coupler plate on unit (ones that can be viewed from outside the main beam). Replace with new ½-13 x 2.75” Flat socket cap bolts (PN 542-01027-08), flat washer (PN 540-02000-08) and top lock nut (PN 540-14000-08) typically 18 bolts per trailer.
- 2.) Then remove all remaining bolts and replace with ½-13 x 2.75” Flat Socket Cap bolts (PN 542-01027-08), flat washer (PN 540-02000-08) and top lock nut (PN 540-14000-08) typically 20 bolts per trailer.
