## TECHNICAL BULLETIN 18-03

Drop Deck Platforms

SUBJECT: Cracking in Bottom Deck Transition Weld

DATE: November 2018 REV: A

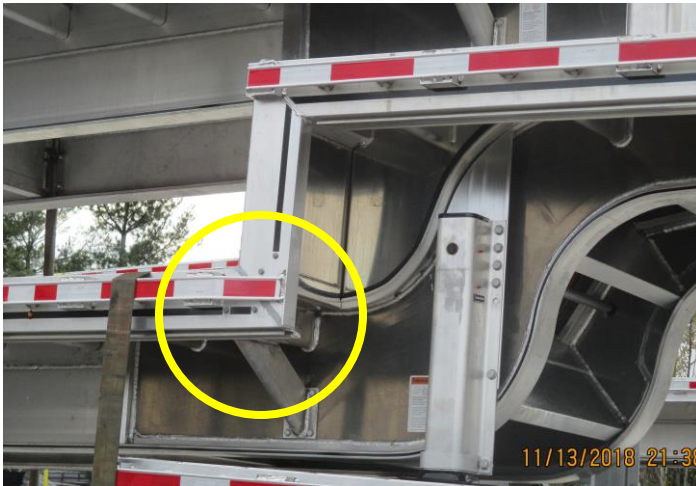
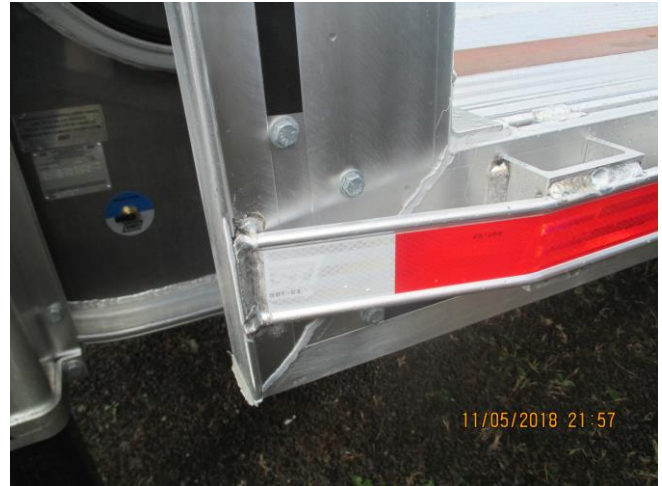
It is possible for the inside weld to crack on the bottom deck transition as the trailer deck flexes under a load. This is a cosmetic issue, and not a structural issue, as this bolted joint is designed to flex as needed.

- 1.) Carefully, using a grinding wheel, remove welds on the inside joint of the outer rail transition. Pay special attention to avoid the wiring harness routed through this area.
- 2.) Using gray caulking, place a bead of caulking on the 45 degree joint.
- 3.) Smooth out and wipe off any extra caulk.
