December 1, 2018

Clicking or Grinding is Heard When Accelerating While Turning

AFFECTED VEHICLES

Year	Model	Trim	VIN Range
2014-15	Civic	EX and LX CVT models only.	ALL

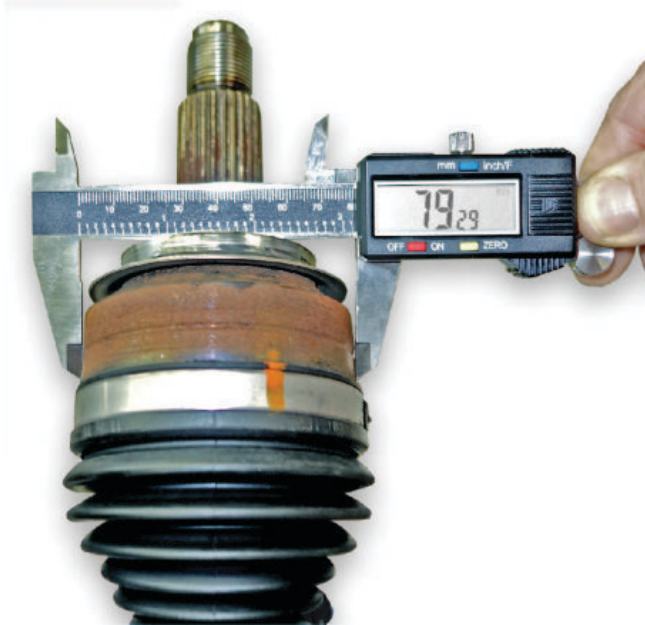
ORIGINAL CV JOINT (79 mm)

There is excessive internal clearance or wear in the outer CV joint.

- Axles must be replaced as a set.
- The improved CV joint design is larger than the original CV joint.

Replace both left and right axle assemblies.
