Preliminary Information

PIP5191C Engine Ticking Noise or oil pressure fluctuation On Cold Start

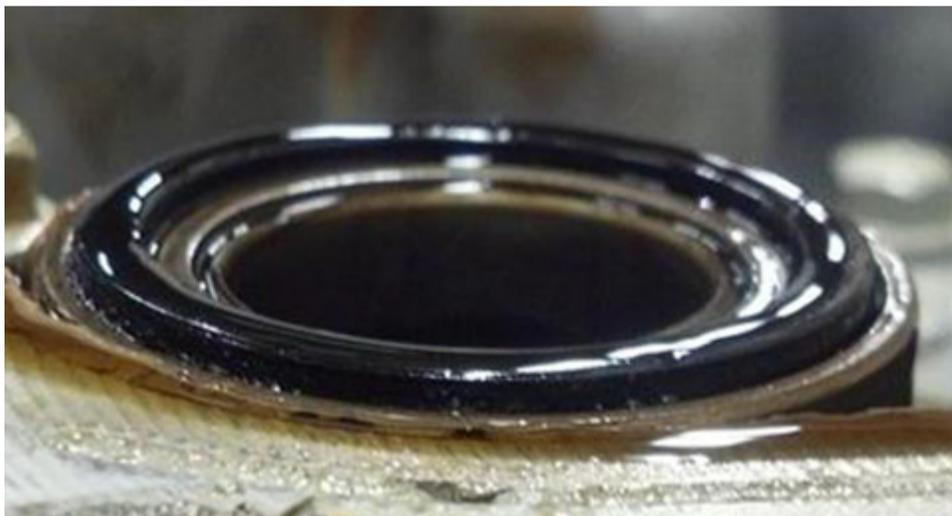
This is an example of a new seal

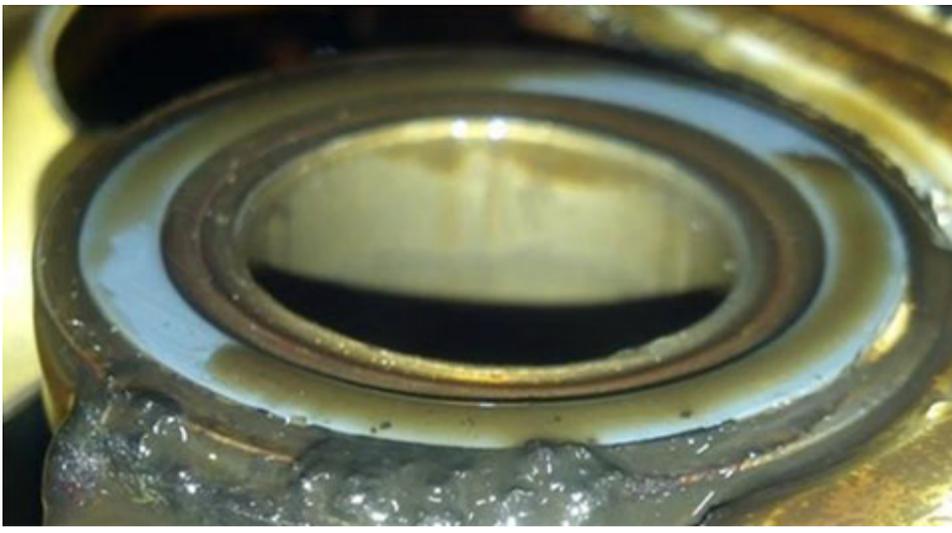
We have identified a possible concern with the oil pump pick-up tube to block seal being compressed.

When this occurs there is the potential to draw in air when first started before the pump picks up oil to seal the gap,

Or to continue to pull some air causing oil pressure fluctuation.

This is an example of a compressed (worn out) seal

If this seal is compressed within the cutout of the pick-up tube, then replace the seal and reevaluate the concern.
