Preliminary Information

PIT5272B Diagnostic Tip: Whistle Noise from Inside Vehicle

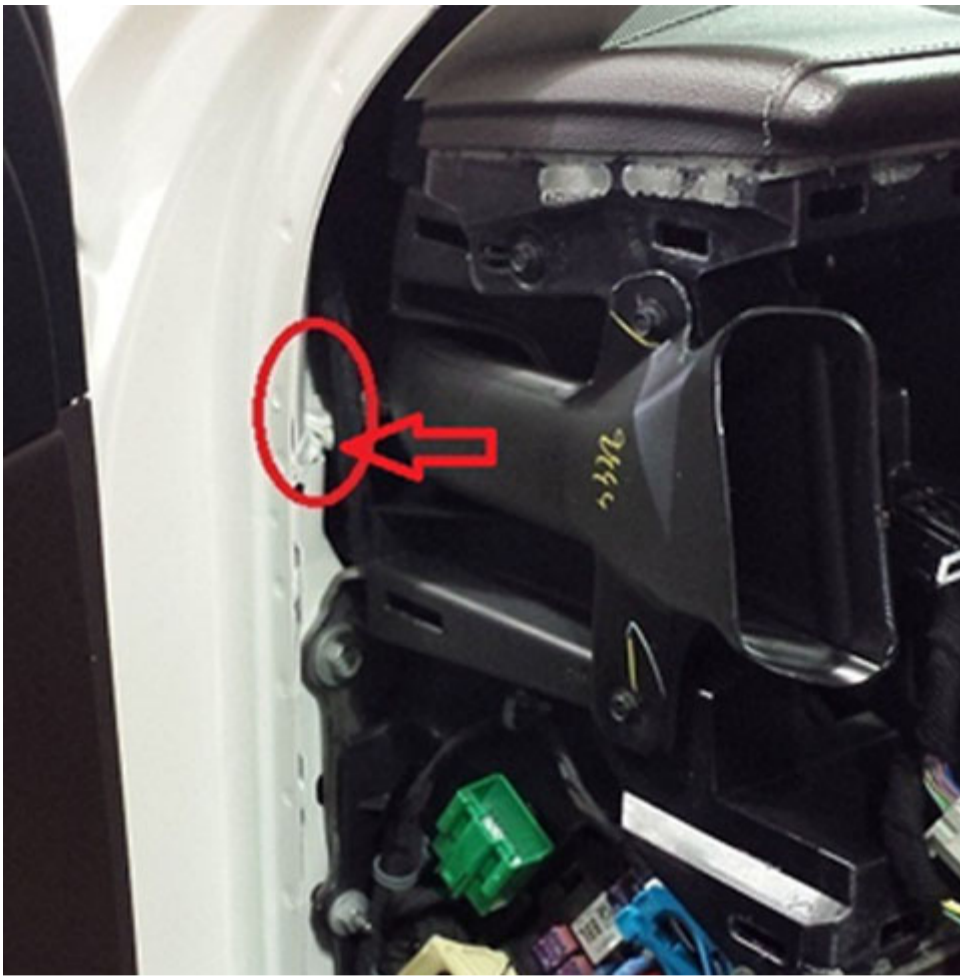
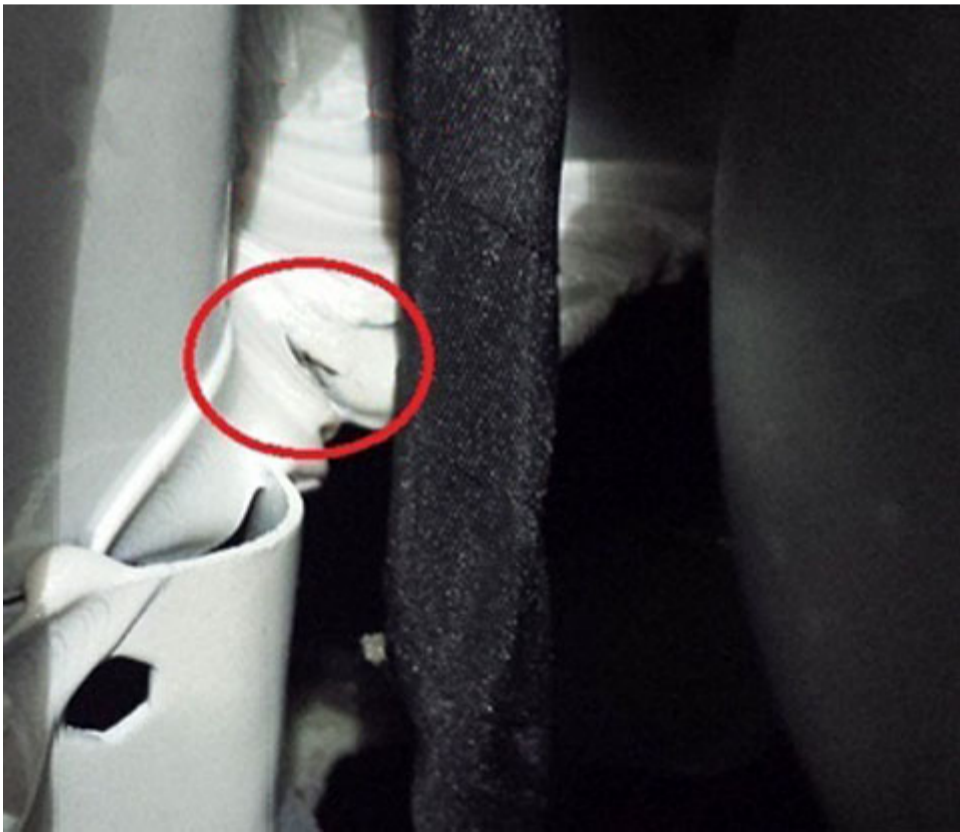
Some customers may comment there is a whistle noise in the vehicle from the driver or passenger side. Some may also state this is present while driving or with the HVAC on and in recirculation mode or the noise will go away or change if HVAC is switched out of recirc, or if a window is cracked open. This could be caused by voids in the body sealer in one or more places.

- 1.) It may be helpful to use a hose as a listening aid to be able to tuck it down along the corners of the IP behind trim to get closer to the source of the noise to help pinpoint areas for focused inspection.**
- 2.) Inspect for voids in the body sealer on the left or right side A-pillar as shown in the pictures below.**
 - A.) It may be necessary to remove the Front Door Body Side Weatherstrip to gain access to the lower A-Pillar to cowl seams.**

3.) If voids are found in the A-pillar sealer, repair the voids and retest.

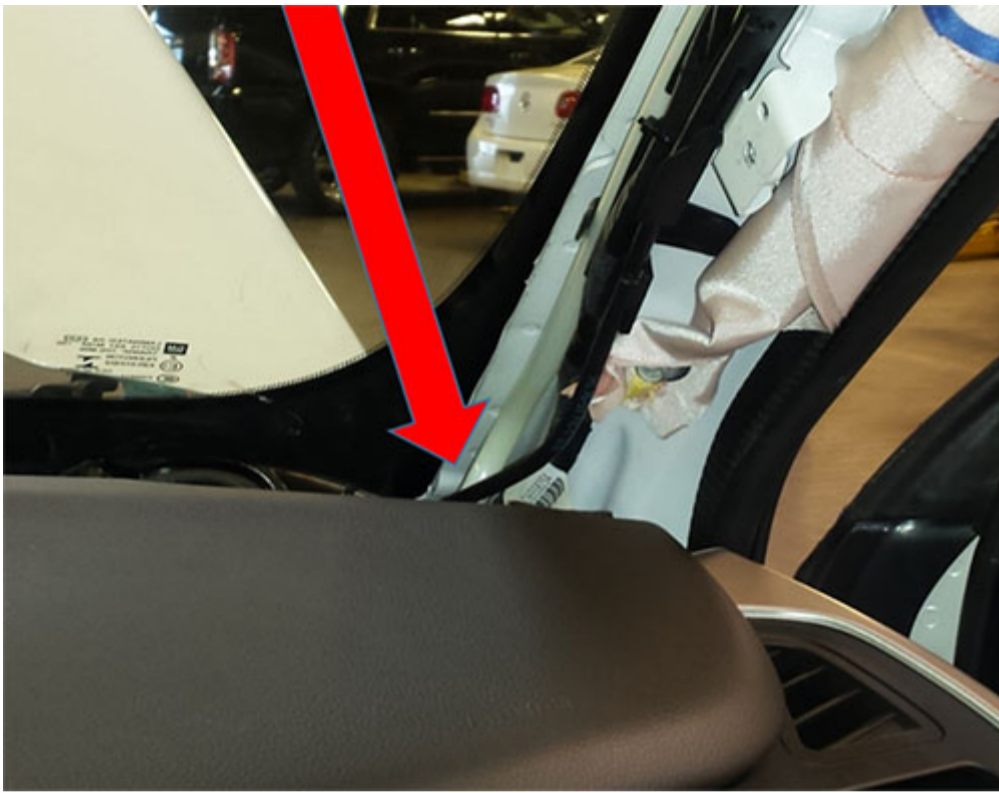
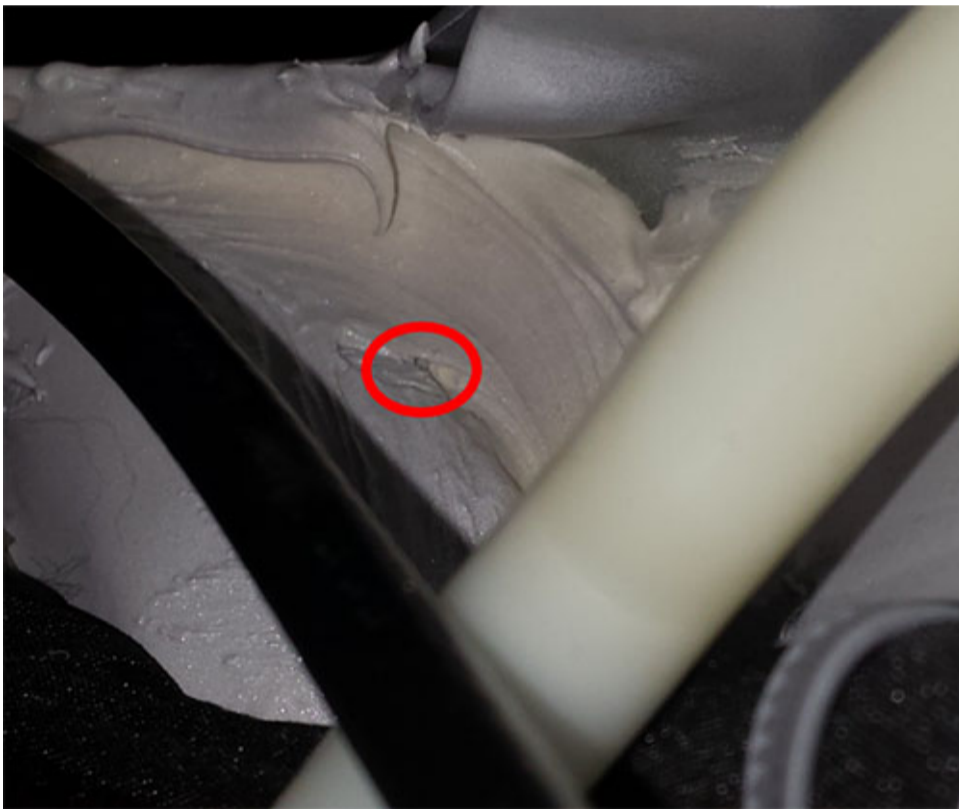
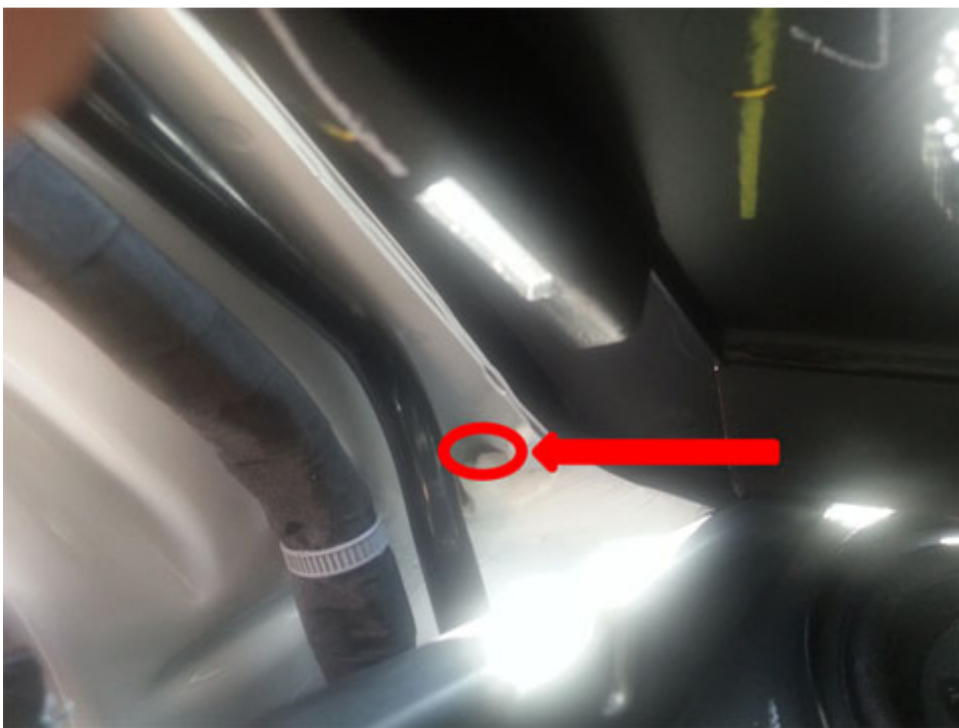
B.) When looking at the base of the left or right A-Pillar to cowl, it may be necessary to look in through the windshield to locate the missing sealer.

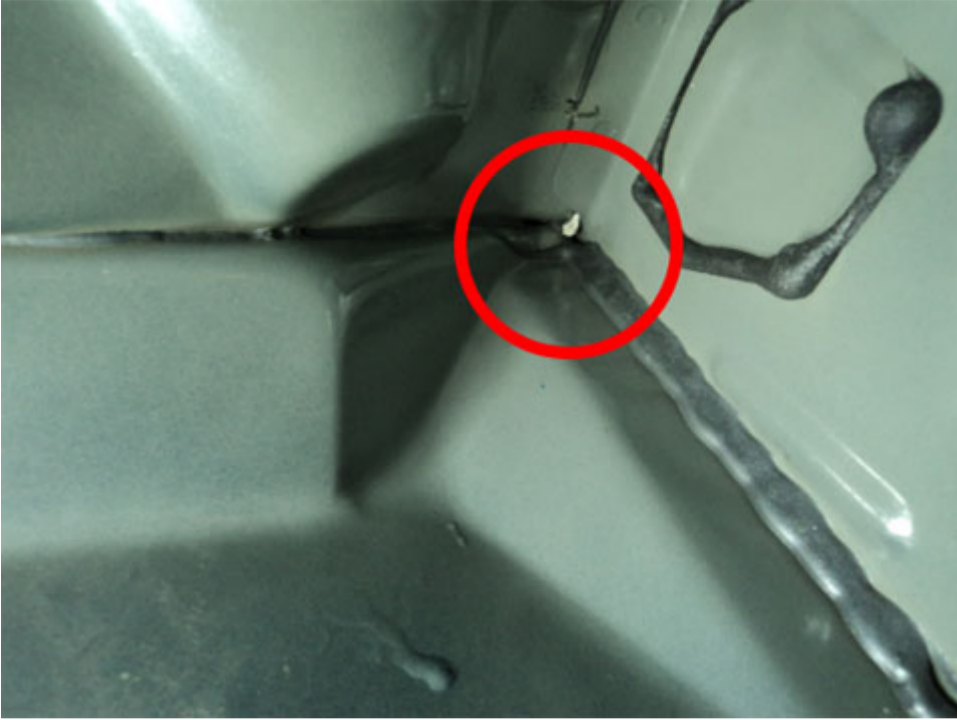
4.) If no voids at the A-pillar were identified or if repair of voids did not completely eliminate issue, inspect for voids in the body sealer at the cowl seam under Air Inlet Grille (wiper

plenum) Panel on the left side as in the picture below.

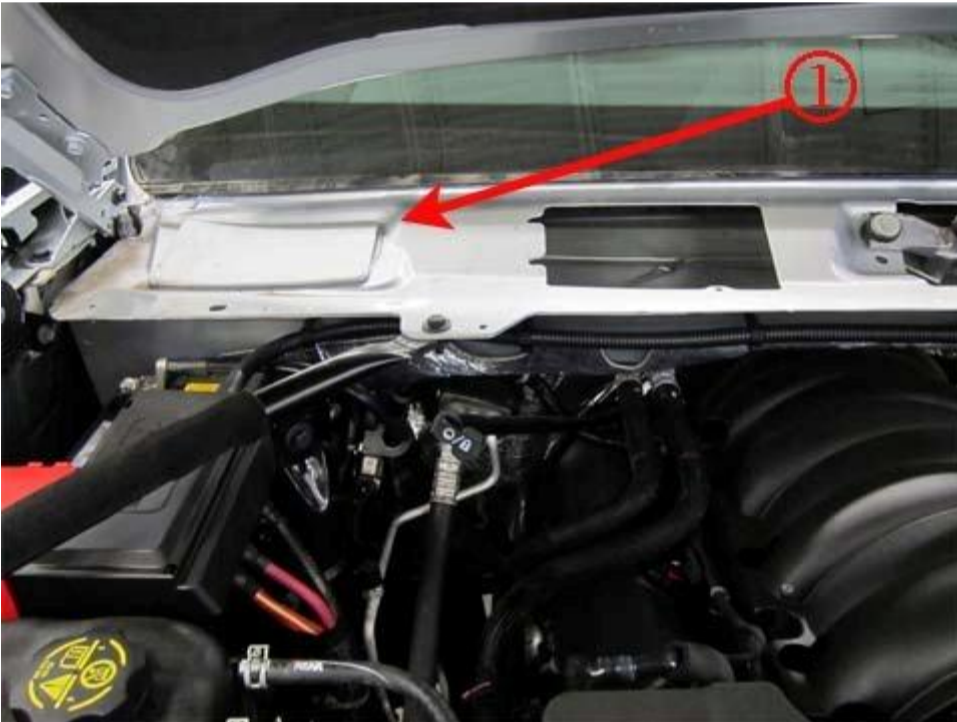
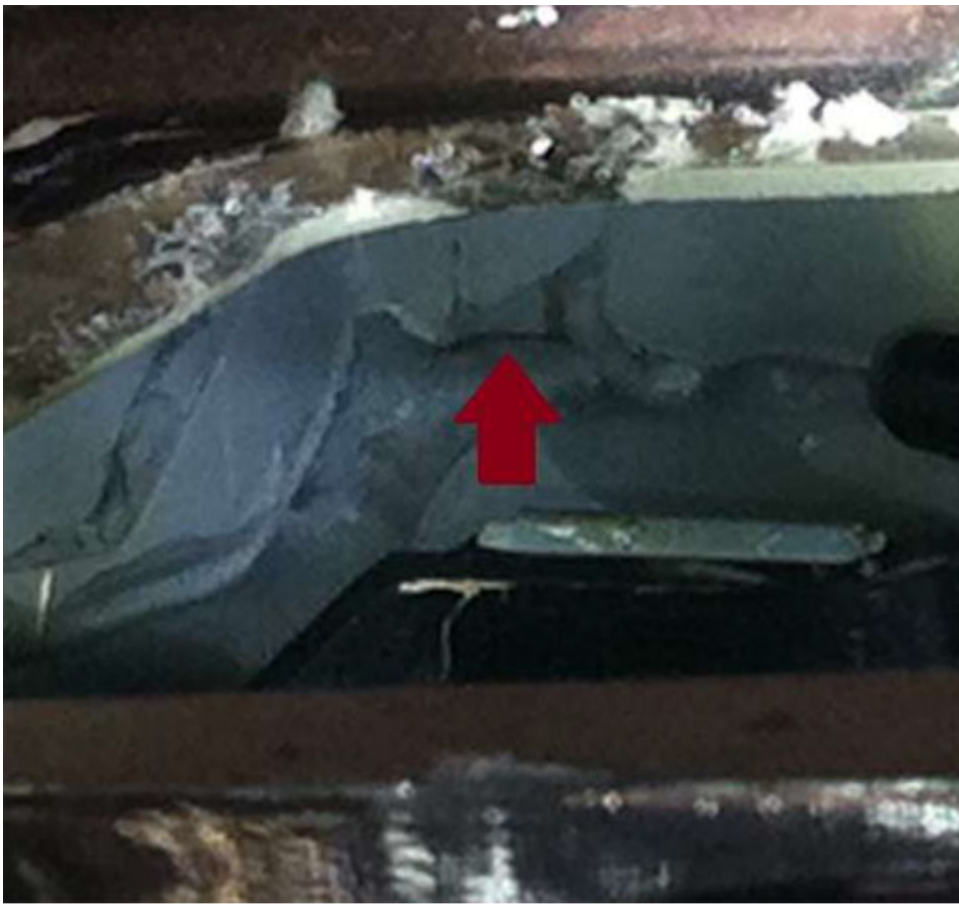
5.) Inspect for voids in the body sealer at the cowl seam on the right side under the plenum cover cap as shown in the picture below.

NOTE: The plenum cover cap (1) must be removed and resealed to perform this inspection.
