Preliminary Information

PIC6288A Unable to charge the High voltage battery, DTC P1FFE  
Models

Brand:	Model:	Model Years:	VIN:		Engine:	Transmissions:
			from	to		
Cadillac	CT6 Plug-in	2017 - 2019	ALL	ALL	LGT	MRD

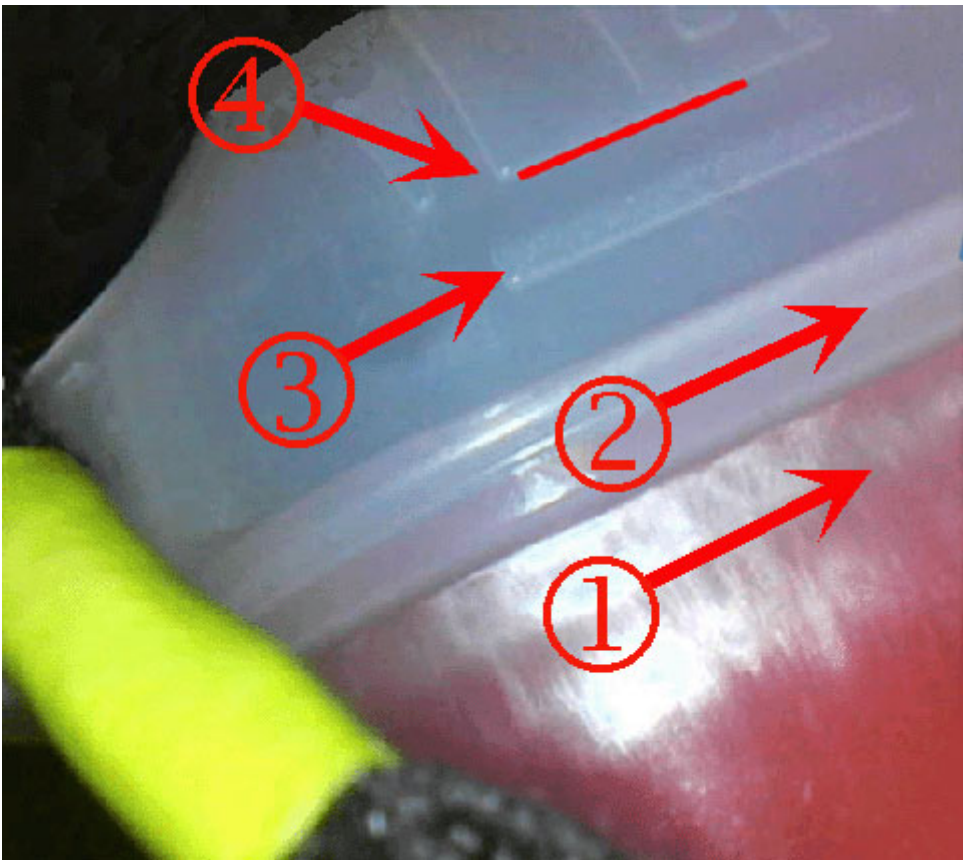
Involved Region or Country	North America
Additional Options (RPO)	HP6
Condition	Customer is unable to charge the HV battery. DTC P1FFE is set when coolant level is at the full indicator line after Hybrid battery pack service or hybrid battery pack cooling system service.
Cause	The coolant level sensor may be stuck, indicating low coolant after Hybrid battery pack service or Hybrid battery pack coolant system service.

- Verify coolant level in tank, Please follow SI for the right steps to check the Level.
  1. Is where it is possible to false low Coolant DTC (Seen in Development)
  2. Low Fill Level
  3. This is the Fill Level Line
  4. Fill to this Level.

- Run Pump using GDS2 and monitor coolant sensor signal
- Run a magnet across sensor on the outside of float to see if signal changes
- If signal changes no further action required, clear codes and test drive the vehicle
- If unable to get signal to change while using a magnet across sensor float replace sensor and do Evac n Fill.

- Although Evac n Fill is not required for level sensor replacement, potential air pockets from previous repairs could be root cause of stuck sensor float.
