Bulletin No.: PIC5667B
Published date: 11/15/2018

PIC5667B Service Power Steering Message DTC C0800

Brand:	Model:	Model Years:	VIN:		Engine:	Transmissions:
			from	to		
Chevrolet	Volt	2011 - 2015	ALL	ALL	LUU	MKA

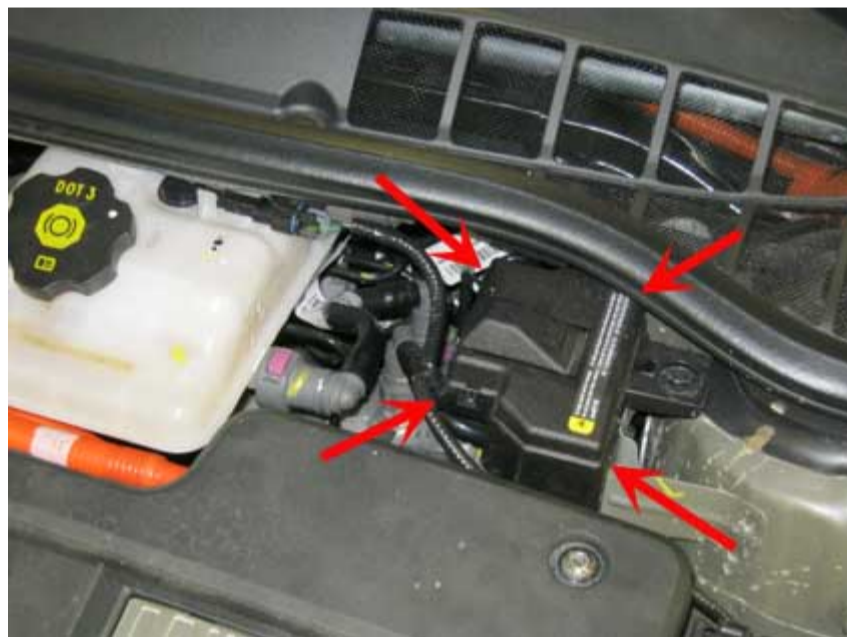
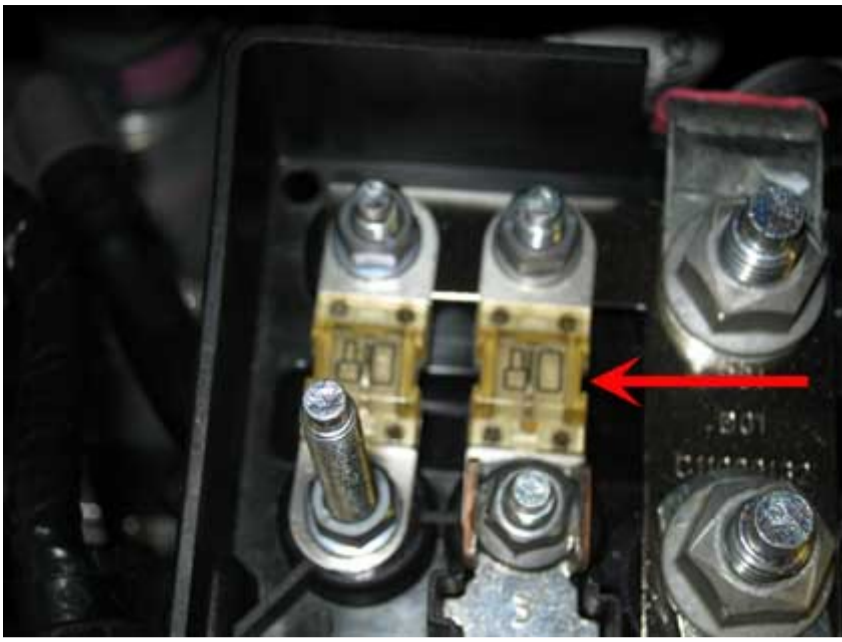
Some customers may experience a "Service Power Steering" message at times. The concern may also be followed by a current or history code C0800 set in the power steering control module.

1) Check the F2UB (80 amp) fuse connection in the X50 auxiliary under hood fuse box. Check for a loose connection by checking the torque on the nut. Also check for any signs of arcing. If there is signs of arcing, replace the fuse and torque to the proper spec's.

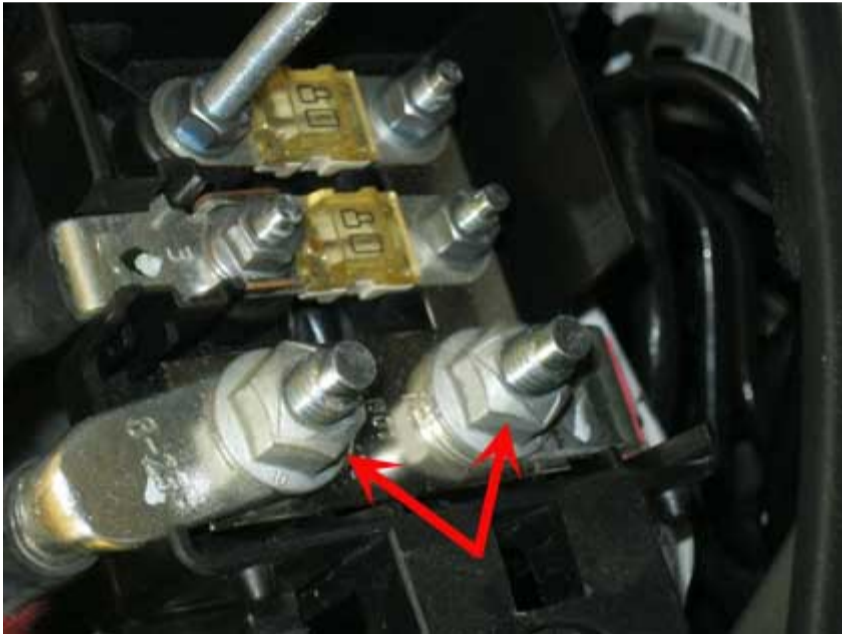
2) Check the torque on the main power feeds cable at the X50 auxiliary under hood fuse box. If loose, torque to factory spec's and retest system.

Note: You will have to remove the fuse box cover to gain access to the fuse and the main power feeds.
