Preliminary Information

PIT4573E No Crank With DTC P1AAB, P1AAC, P1AAD, and/or P1AAE

Models

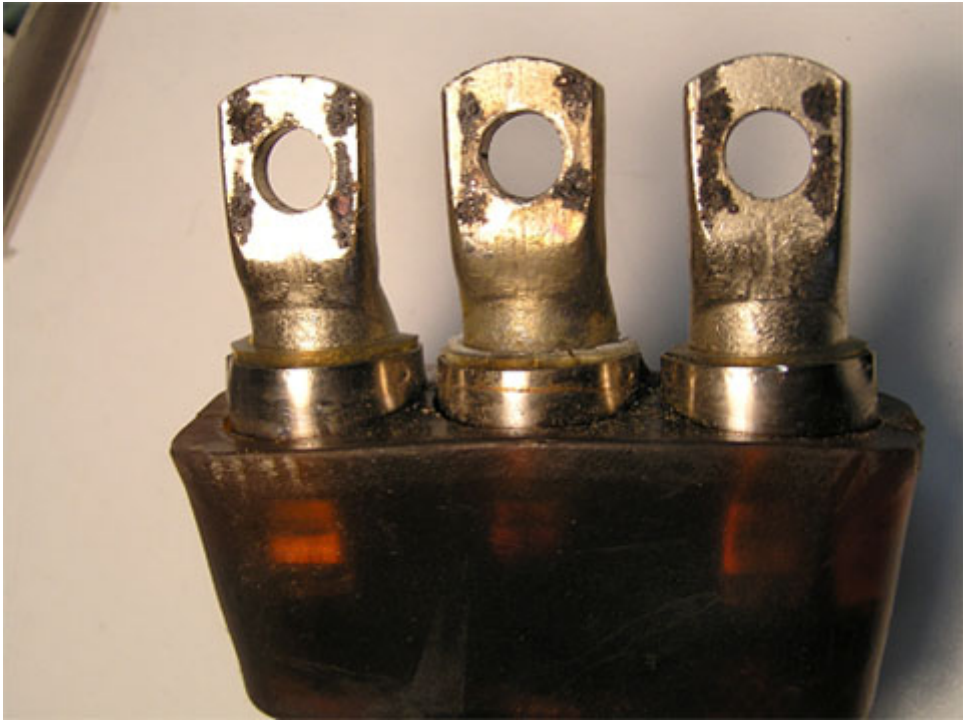
This is signs of pitting/arching. These should be replaced. Minor pitting can be cleaned up and the cables reused.

A visual inspection for arcing at the cable to stator connections must be performed first by removing the cables from the stator. If there are signs of arcing, replace both components. While replacing the stator and cables remove part of the under hood cowl wall insulation mat in the area that the 3 phase cables are routed.

Even if there is no arcing, the stator still should be replaced before the SGCM. If the concern is still present after the stator and/or cables have been replaced retest them for a short to ground, open between the phases and there should be less than 1 ohm of resistance between the phases. If all test good replace the SGCM.
