PIT5284D Rattle Noise from Second Row Seat and/or Seat Back Will Not Fold to Upright Position

Product Investigation Review Required

Brand:	Model:	Model Years:	VIN:		Engine:	Transmissions:
			from	to		
Cadillac	Escalade Models	2015 - 2019	All	All	All	All
Chevrolet	Suburban	2015 - 2019	All	All	All	All
Chevrolet	Tahoe	2015 - 2019	All	All	All	All
GMC	Yukon Models	2015 - 2019	All	All	All	All

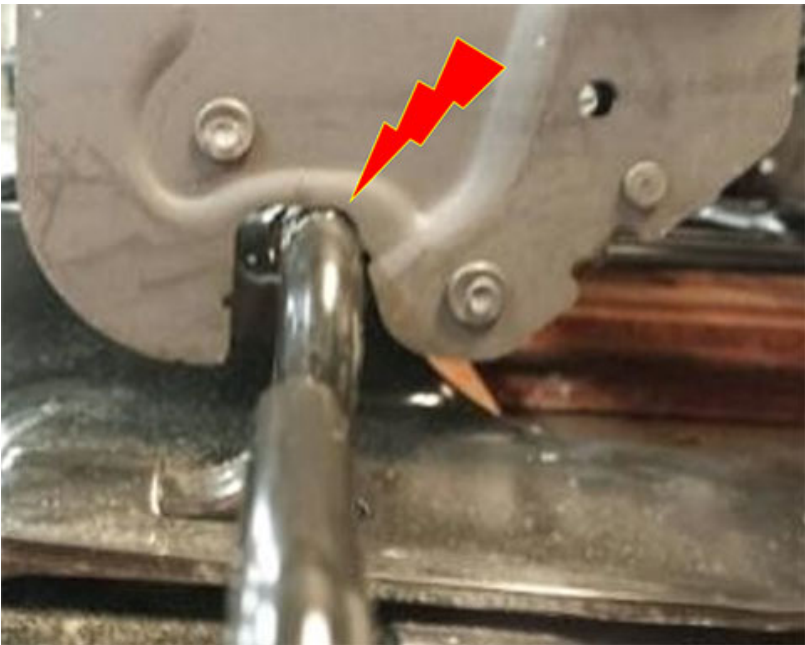
Condition 1: Striker not aligned properly fore/aft in latch opening, see picture below. This could cause a rattle or the striker to drag on the side of the latch opening not allowing the seat to flip forward or latch down easily.

Condition 1 Repair: Striker not aligned properly fore/aft in latch opening

To repair this condition, rework/adjust the striker in the direction to center it in the latch opening. An adjustable wide mouth metal working tool may be used to carefully rework/adjust the striker just enough to center in the latch opening, as shown below.

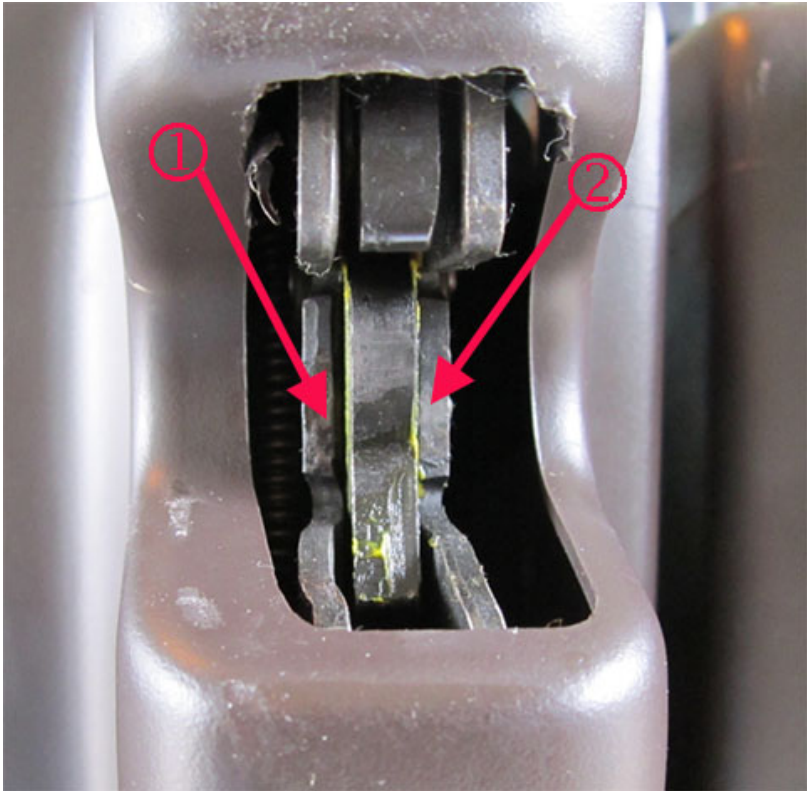
Condition 2: A seat bottom latch (inboard and/or outboard) may have an unequal latch opening side-to-side for the striker to seat into, see picture below.

Opening (1) may protrude down farther than opening (2), which can cause a rattle, and which may make it difficult to secure and/or release latches.

With the seat latched down, if the striker to latch interface is inspected on both sides of a latch, there will be a gap on one side of the latch and no gap on the other side of the same latch.

Condition 2 Repair: A seat bottom latch (inboard and/or outboard) may have an unequal latch opening side-to-side for the striker to seat into.

This procedure will form the protruding latch opening to the striker, which will allow the two openings (1, 2) to be equal/parallel to each other so the striker contacts both openings.

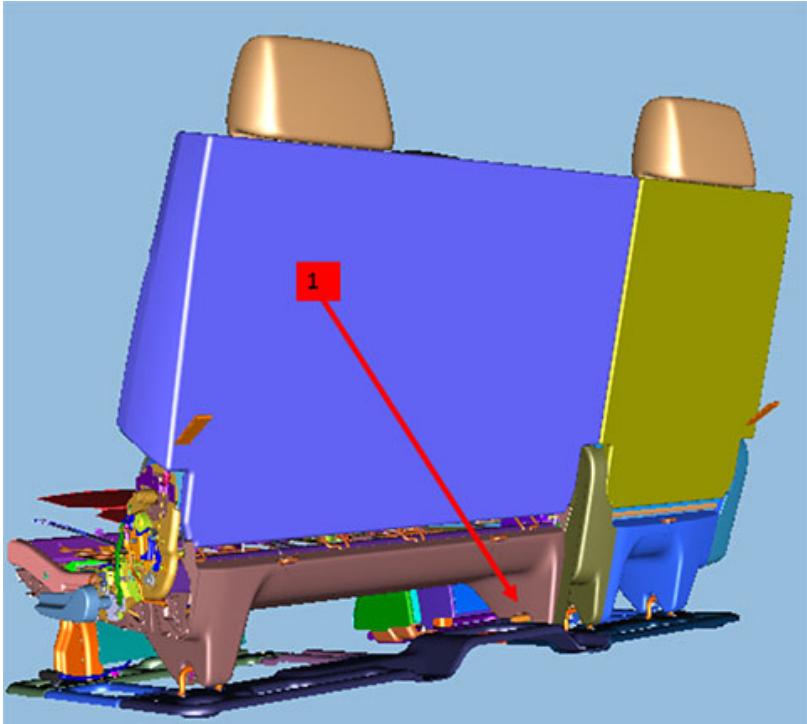
Condition 3: 60/40 Split Bench Seat: 60-percent long side bench, inboard latch (1) may not be properly aligned fore/aft in striker opening.

Could cause a rattle and/or the striker to drag on the side of the latch opening not allowing the seat to flip forward or latch down easily.

Condition 3 Repair: 60/40 Split Bench Seat: 60-percent seat, inboard latch (1) may not be properly aligned fore/aft in striker opening.

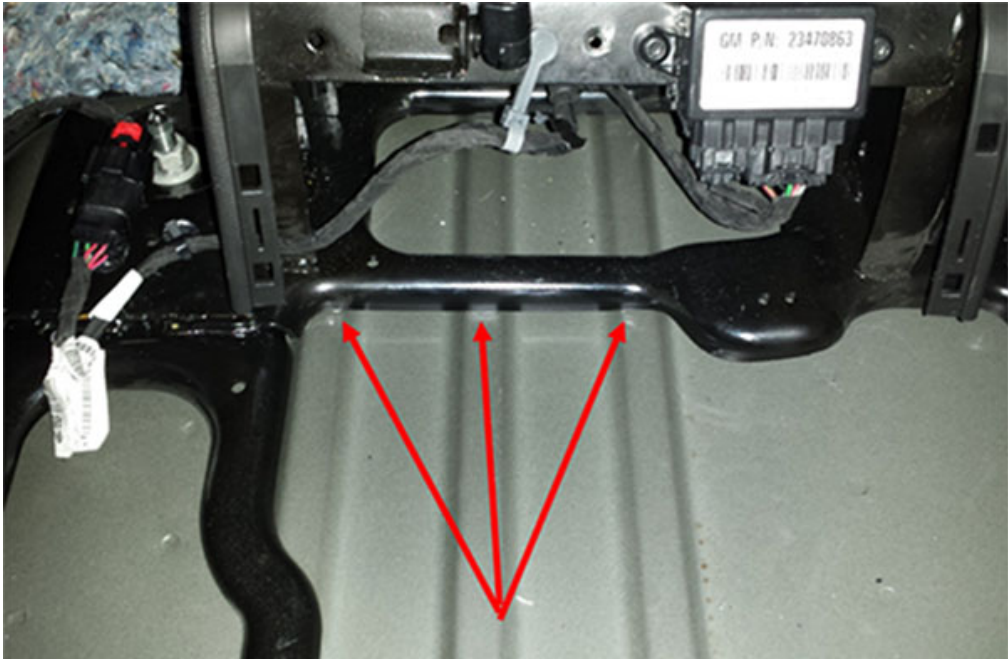
Condition 4: Seat base plate contacting/rattling against ribs of floor pan.

4.3 Apply Mylar tape to the floor pan to provide relief for the rattle condition, then reevaluate.

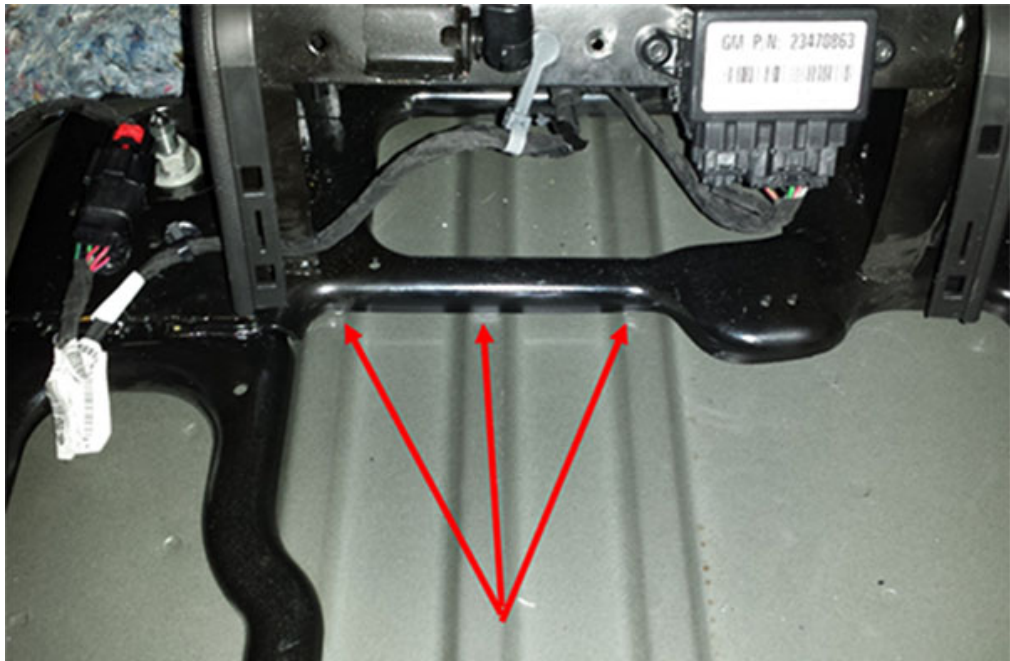
4.2 Inspect the seat base plate for contacting the ribs of the floor pan, as shown below. If contact is present paint damage may be visible at the area of contact.
