Preliminary Information

PIP5298A SES Traction Control lamp on and Engine Runs Rough with DTC P0300

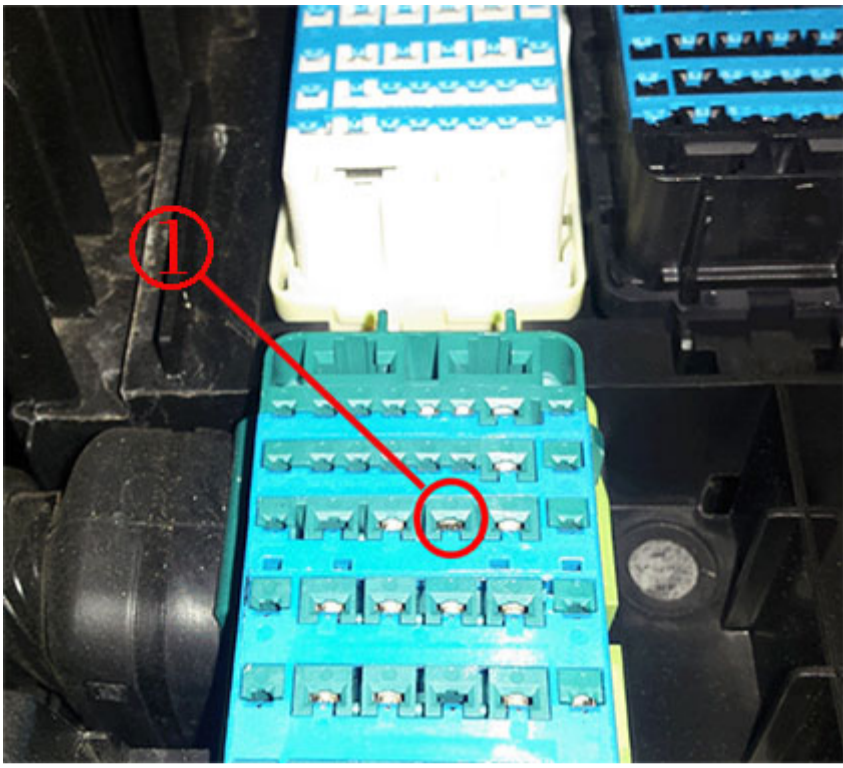
X2 Terminal

If SI diagnostics have been completed with no trouble found inspect for a possible terminal tension concern on both the ignition coil power feed for a possible cause of the DTC P0300 set and/or a rough running engine, and the X2 connector of the UBEC (Under hood Fuse Block) for an intermittent SES Traction control lamp concern and repair as necessary.

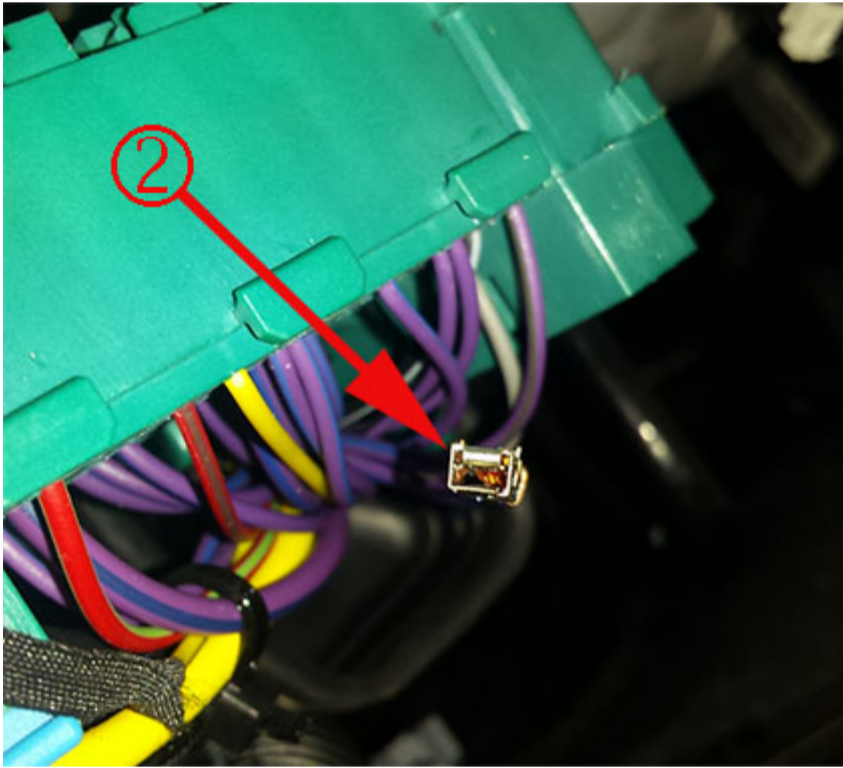
Notice terminal "spread" NO tension
