**Bulletin No.:** PIC6293A **Published date:** 11/26/2018

# PIC6293A Installation of the GM Accessory Interior Spectrum Lighting Kit

Prand:	Model:	Model Years:	VIN:		Engino	Transmissions:
Brand:			from	to	Engine:	Transmissions.
Chevrolet	Camaro	2016 - 2019	All	All	All	All

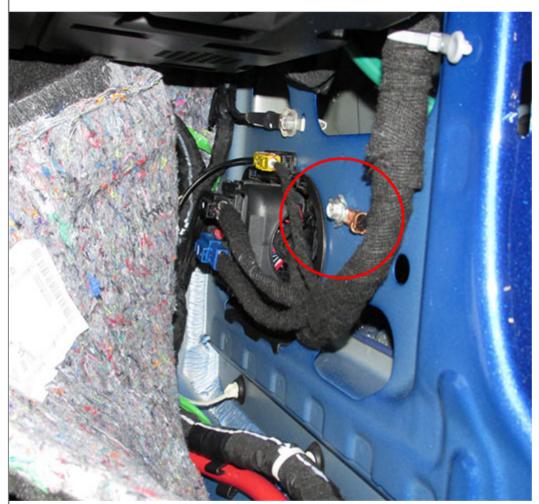
• If the entire kit has been installed and the lighting is entirely inoperative, there are a few things to go back and check. The most common area for concern is G202, which is located at the RH kick panel. Typically, this ground has paint on it when the kit's eyelet is installed. Just tightening the fastener does not provide a good ground path if there is still paint covering the sheet metal. The fastener will have to be removed, the paint needs to be cleaned or ground off, and the ground path verified.

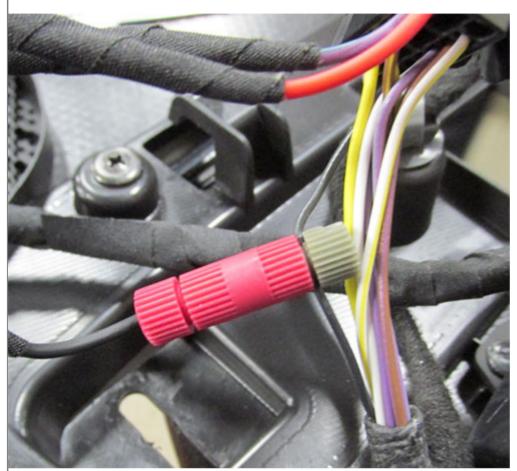
- There are 3 circuits that are spliced or plugged into the BCM related wiring. One of the circuits in the kit has a bunt cut end and must be tapped into the dash wiring going to the BCM. The two other wires have terminals crimped on the end and they are supposed to be inserted into empty BCM connector cavities. A common installation error is to install either of these circuits into the incorrect connector cavity. Either one of these terminals can easily be installed accidentally into an adjacent BCM connector cavity.
- Another common issue that is seen relates to the Posi-Tap connectors used in the kit. These connectors are used to splice the accessory harness to the vehicle's wiring harness.

Dealership technicians are to go back through the installation and verify that each connector is tight. If one or more of these connecters was loose, this will cause any number of performance issues with the kit. The connector shown in the photo below does not have tape or a zip tie covering it for clarity. Once the connector is properly installed, the instructions have the technician tape back the splice to the main harness using cloth tape. This will prevent the connector from loosening up over time.

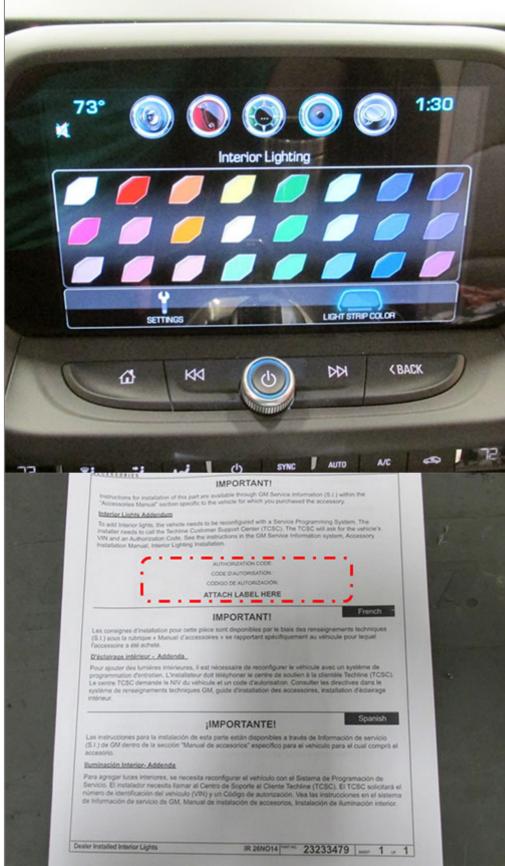
• If the vehicle is equipped with the uplevel radio (RPOs IO5, IO6, IOS, or IOT) the BCM and the HMI will require reprogramming through Techline. This programming allows the customer to select the various lighting colors on the radio's touchscreen, as seen in the color palette photo below. As seen in the second photo below, there will also be a sheet of paper included in the kit that has an authorization code printed on it. Once that code is provided to Techline, they will be able to assist in correctly programming the vehicle.
