Preliminary Information

PIT5643 Intermittent Reduced Engine Power or Stall with P0689 and/or P1682

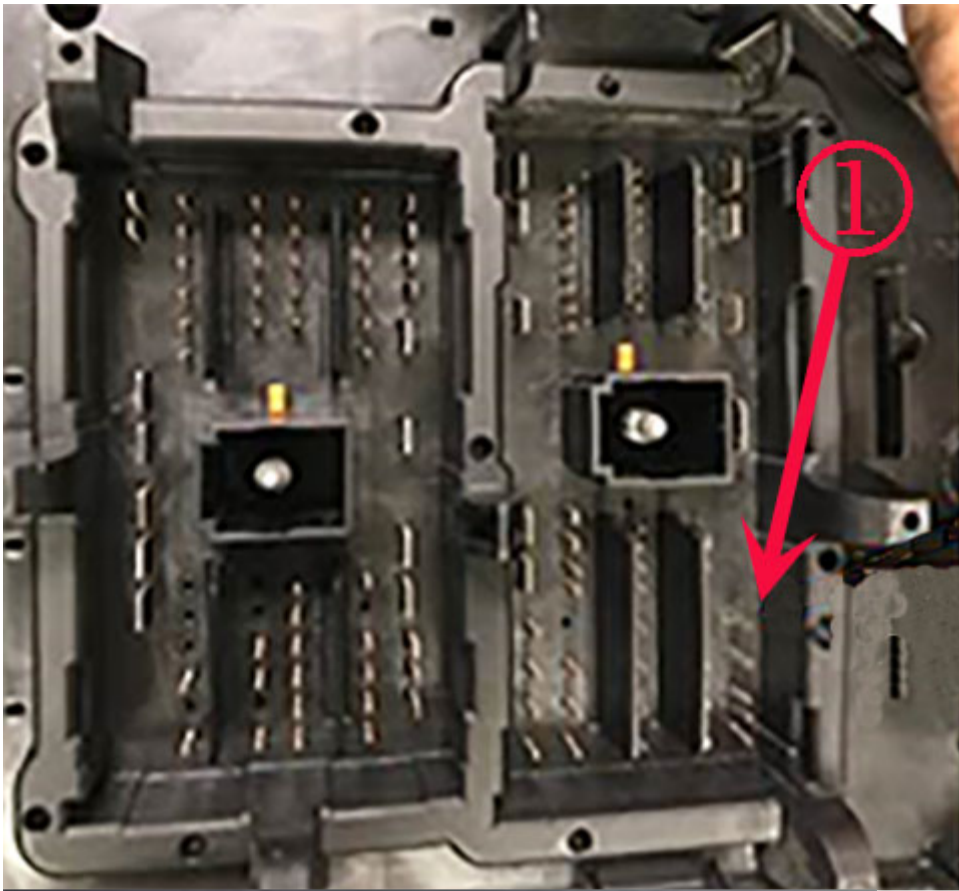
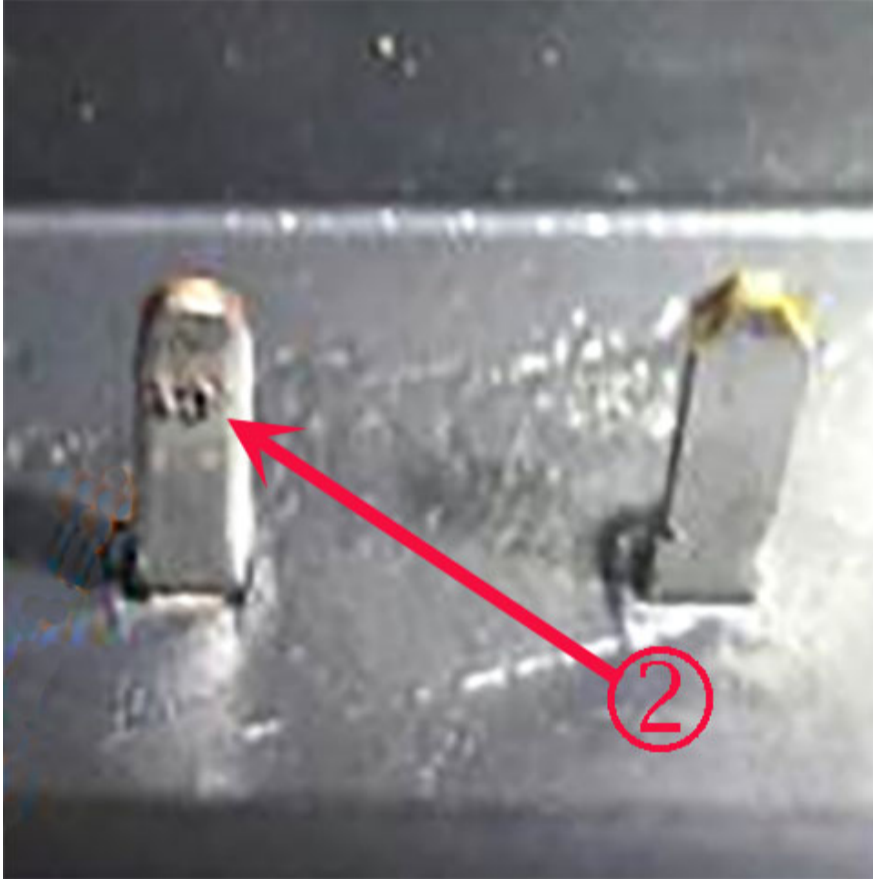
Involved Region or Country	North America
Condition	Customer may comment of intermittent Service Engine Soon light on with Reduced Engine Power and/or engine stall with P0689 and/or P1682 stored in history.
Cause	Terminal #51 at X3 Connector of Under Hood Fuse Block loose terminal tension with arcing corrosion on terminal #51 on fuse block. Note: Engineering is still investigating the root cause. The PI will be updated to a bulletin once the final root is understood.

1. Follow SI diagnostics for P0689/P1682. If no problem found proceed to 2.
2. Check for water intrusion on IP fuseblock. If water leak and corrosion is found, repair following normal SI procedures. If no indication of water or corrosion proceed to step 3.
3. Remove under hood fuse block and inspect for any arcing corrosion on terminal 51 of the X3 connector. It is helpful to use a cell phone camera to zoom in on the terminal to see the arc spot. If arc spot is found, replace under hood fuse panel and terminal 51 in the harness using a terminated lead.
