Bulletin No.: PIC6190A  
Published date: 11/28/2018

### PIC6190A Foam And Cardboard Insert Found In Trunk During PDI Models

Brand:	Model:	Model Years:	VIN:		Engine:	Transmissions:
			from	to		
Chevrolet	Volt	2016 - 2019	All	All	L3A	MKV

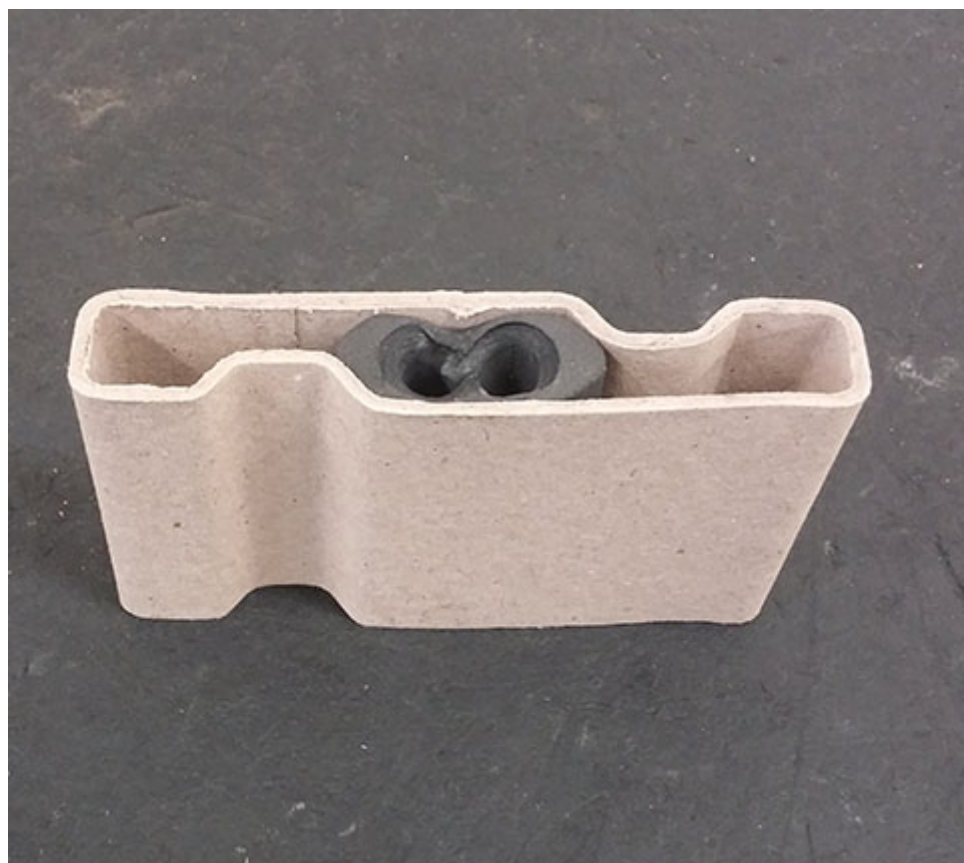
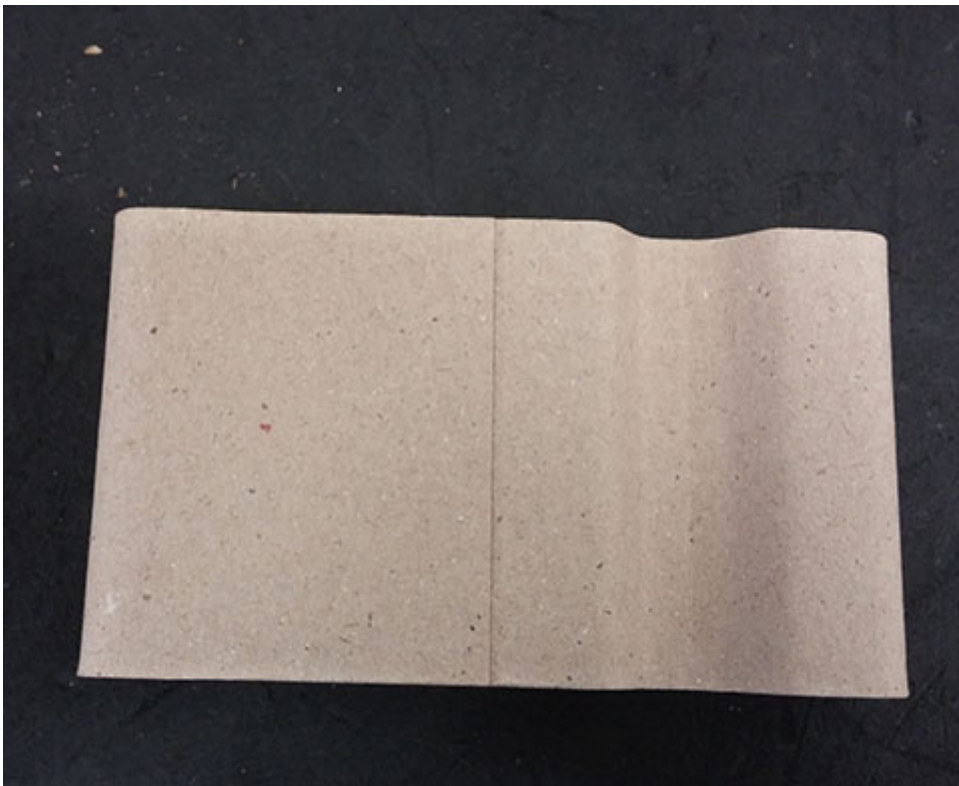
**When performing a pre-delivery inspection you may find a piece of foam that is surrounded by a cardboard shell that is found in the vehicle during PDI. ( See Photos below )**

**This Insert is a spacer that is part of the tire Inflator kit and should be placed between the compressor assembly and the tire sealant canister. This Insert needs to be installed to prevent the damage to the contents of the bag when tightening the hold down for the Inflator kit.**
