PIP5197K Possible Oil Consumption / Leaks – Blue Smoke Exhaust – Whistle Noise – DTC P0171 and/or P0300 and/or P0299

Brand:	Model:	Model Years:	VIN:		Engine:	Transmissions:
			from	to		
Buick	Encore	2013 - 2019	All	All	LUJ and LUV	All
Chevrolet	Cruze	2011 - 2016	All	All	LUJ and LUV	All
Chevrolet	Sonic	2012 - 2019	All	All	LUJ and LUV	All
Chevrolet	Trax	2013 - 2019	All	All	LUJ and LUV	All

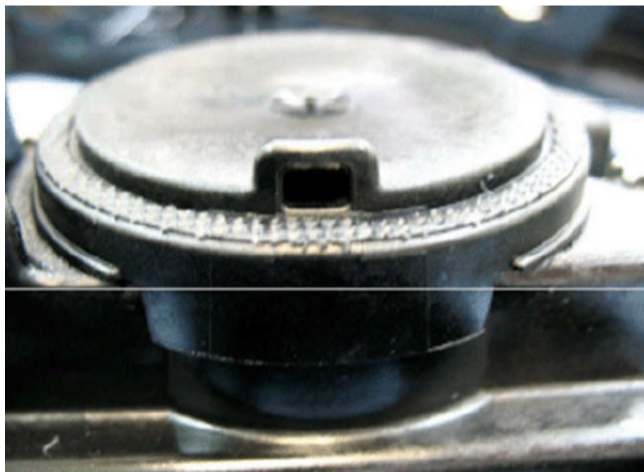
Check the PCV orifice for leaking oil or drawing vacuum at idle thru its external port. (The PCV orifice is an integral part of the camshaft cover). (See picture below).

If the PCV orifice external port is leaking oil or vacuum, replace the camshaft cover and perform the following testing.

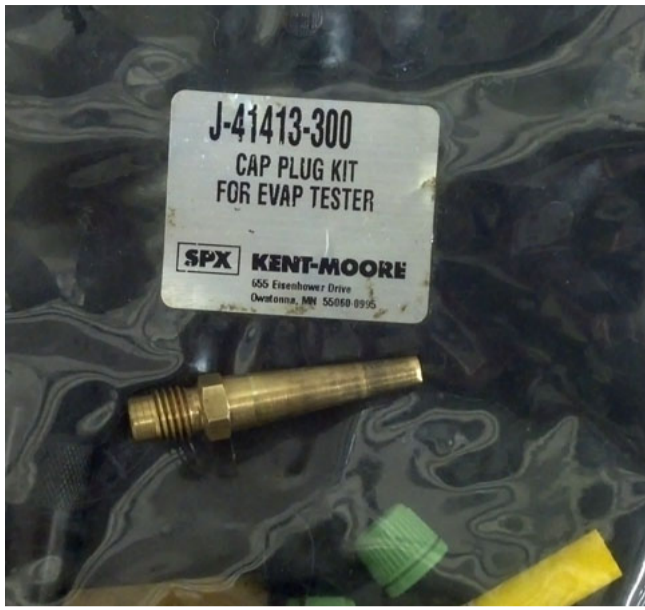
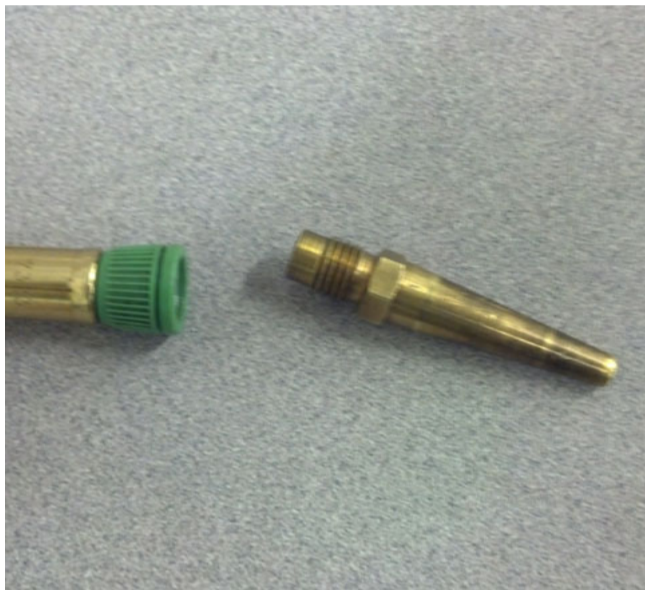
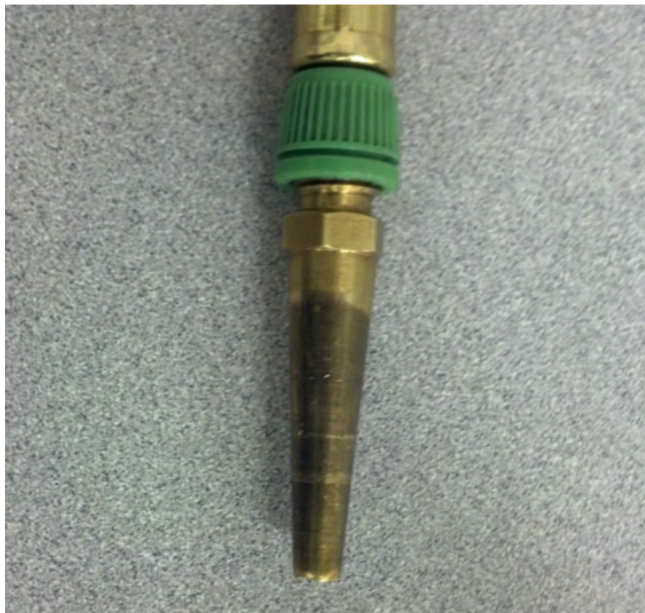
Next (refer to the pictures below) use the ESST gage and connect the ESST fitting at the engine oil dipstick hole of the camshaft cover.

Then start the engine, with the engine running at hot idle in park, snap the throttle and record the crankcase pressure.

If the crankcase pressure test reading is found to be a normal, between -11 and -18 inches of H₂O (during the hot idle in park and during snap throttle testing) Then, continue by cleaning any oil residue from all induction system components.

If the crankcase pressure test reading is found to be an abnormal reading between -10 and 0 inches of H₂O (during the hot idle in park and during snap throttle testing), this pressure reading is an indication of a cylinder leakage related concern, possibly caused by a weak or broken piston ring land.

Complete a cylinder leakage test to determine if the cause is a possible weak piston ring or broken piston ring land.

If a broken piston ring land is found, replace all four piston assemblies and retest for proper crankcase pressures.

Clean oil from all induction system components and retest for oil consumption, leaks or DTCs resetting.

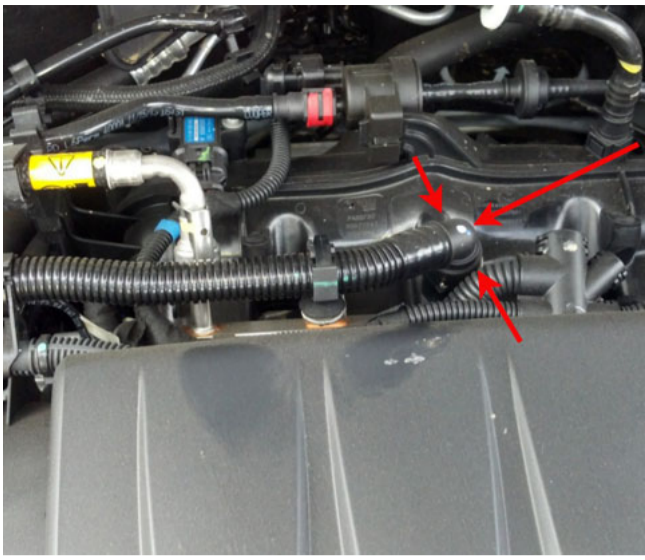
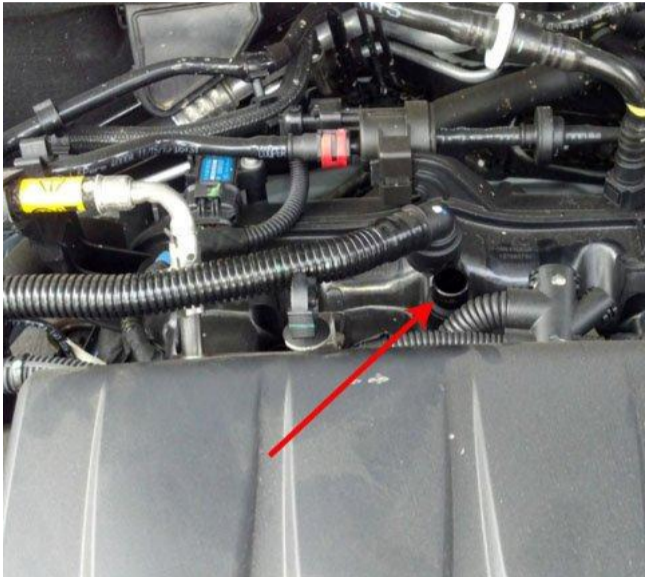
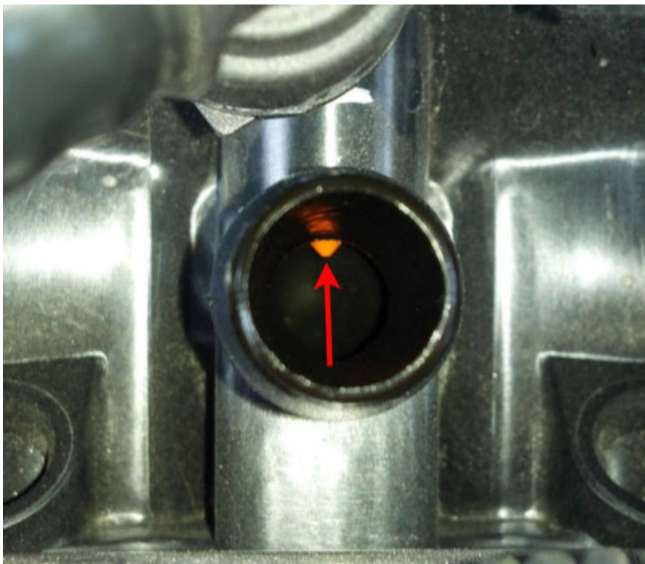
Check for a missing intake manifold Non Return Valve that may have damaged the PCV orifice diaphragm. (See pictures below for inspection procedure).

If the non return valve is not visible as shown in picture, then use a long cotton swab to wipe any excess oil from the valve to validate.

If the non return valve is still not visible, then intake manifold removal for inspection is required to validate.

If the valve is present reinstall the intake manifold. Do not replace.

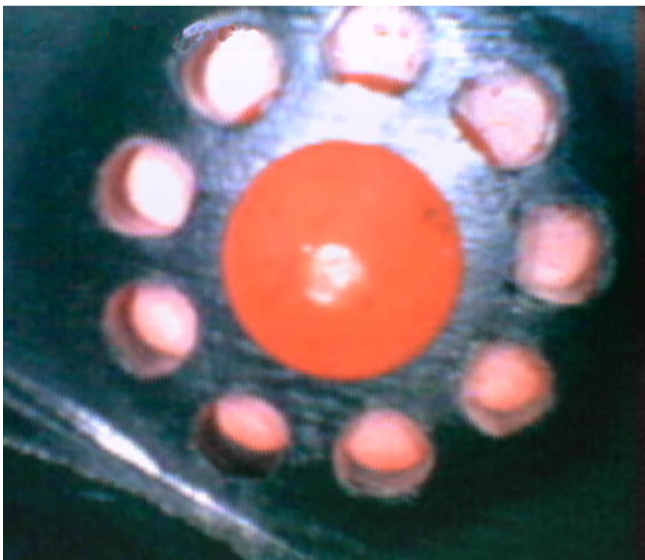
Properly seated Non Return Valve as viewed with the intake manifold removed.

If the intake manifold Non Return Valve is missing, then replace the intake manifold assembly,

Clean oil from all induction system components and retest for oil consumption, leaks or DTCs resetting.

If the intake manifold Non Return Valve is seated properly, clean oil from all induction system components and retest for oil consumption, leaks or DTCs resetting.
