Technical Service Bulletin

GROUP	NUMBER		
BODY ELECTRICAL	18-BE-018		
DATE	MODEL(S)		
NOVEMBER, 2018	IONIQ ELECTRIC (AE EV) IONIQ PLUG-IN HYBRID (AE PHEV)

SUBJECT: CHARGING INLET LOCKING ACTUATOR PART INFORMATION AND REPLACEMENT PROCEDURE

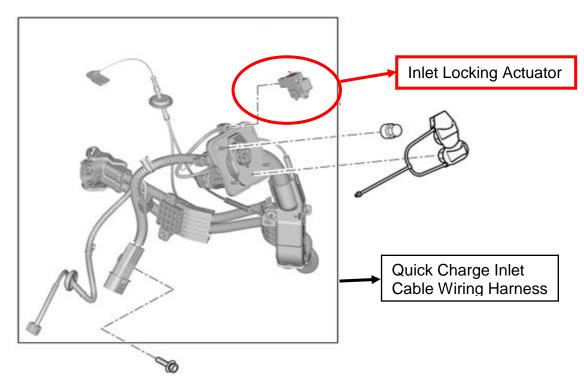
Description: Some Ioniq EV (AE EV) and Ioniq Plug-in Hybrid (AE PHEV) vehicles may experience a charging connector lock/unlock actuator malfunction, which may cause:

- The charging connector to not remain locked when the charger is inserted into the charging port.
- The charging connector to be unable removed from the vehicle charging port.

This bulletin provides part replacement instruction and information on the availability of the inlet locking actuator as a separate part. If the vehicle exhibits one of the condition described above, it is recommended to replace the inlet locking actuator only, not the entire quick charge inlet cable wiring assembly.
