**HYUNDAI**  
**Technical Service Bulletin**

GROUP <b>BODY ELECTRICAL</b>	NUMBER <b>18-BE-015-1</b>
DATE <b>NOVEMBER, 2018</b>	MODEL(S) <b>Tucson (TL) Elantra GT (PD)</b>

**SUBJECT:** SOUND FADER SETTINGS CHANGE

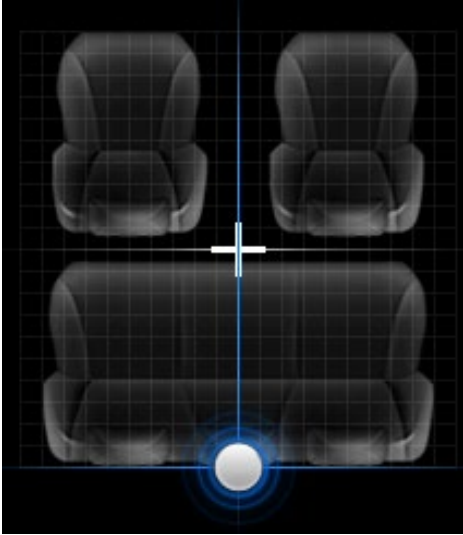
**Description:** This bulletin describes the procedure to determine if the vehicle's Radio Assembly /Navigation unit needs to be replaced as a result of the sound fader settings changing without any user input intermittently.

SYMPTOM(S)	
<b>Sound Fader Setting Change Without Any User Input</b>

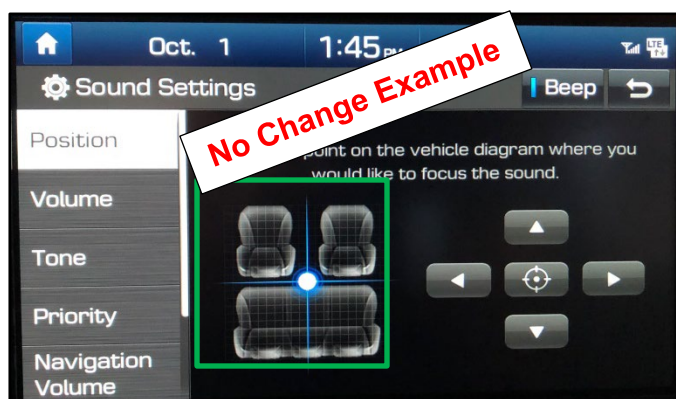
5. Confirm fader settings have changed without any user input.

**If yes, replace the Radio Assembly/Navigation Unit.**

For vehicles with mileage **below 500 miles, order a new radio.**  
*Part number examples are listed in the table on page 1.*

For vehicles with mileage **above 500 miles, order a remanufactured radio.**  
*Remanufactured radio Part numbers have FLT or FL at the end.*
