GROUP BOD	MODEL 2017-2018MY Niro (DE P/HEV)
	NUMBER 186	DATE November 2018
TECHNICAL SERVICE BULLETIN		
SUBJECT: SERVICE ACTION: OUTSIDE DOOR HANDLE COVER REPLACEMENT (SA361)

This issue number is SA361.

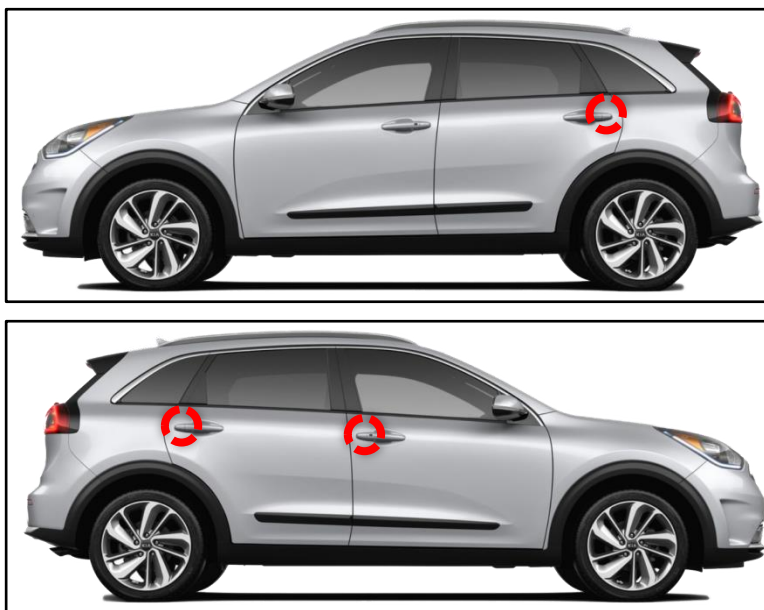
This bulletin provides the procedure to replace three (3) outside door handle covers (right front, left rear, and right rear) on some 2017MY-2018MY Niro (DE P/HEV) vehicles, produced from December 14, 2016 through March 31, 2018, which may exhibit separation of the outside door handle cover. Follow the procedure outlined in this bulletin to replace the outside door handle covers with an improved part on all affected vehicles, including dealer stock. Before conducting the procedure, verify that the vehicle is included in the list of affected VINs.
