MODEL
2019MY
Optima (JFa)

NUMBER
153

TECHNICAL SERVICE BULLETIN

SUBJECT: SERVICE ACTION: POWER WINDOW SWITCH
ASSEMBLY REPLACEMENT (SA354)

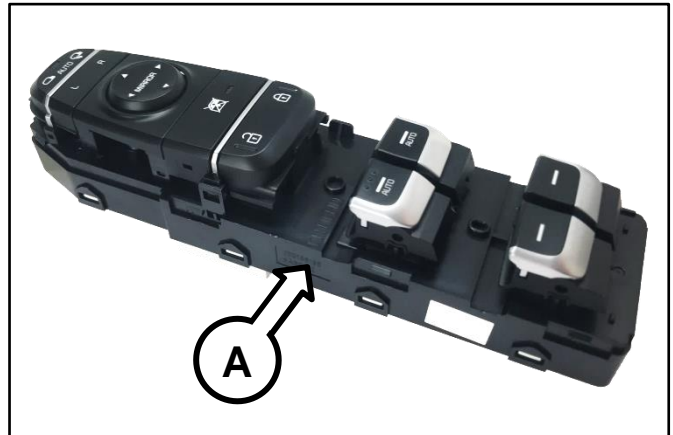
This bulletin provides the procedure to replace the main power window switch assembly on some 2019MY Optima (JFa) vehicles, produced from May 22, 2018 through August 30, 2018, which may experience a non-functioning “auto-up” window switch. Follow the procedure outlined in this bulletin to replace the main power window switch assembly.

1. Remove the main power window switch assembly (A) by referring to the “Body Electrical System → Power Windows → Power Window Switch → Repair procedures” chapter in the applicable Shop Manual on KGIS.
