| | GROUP<br>ENG | MODEL<br>2018MY<br>Stinger (CK) 2.0T |
| | NUMBER<br>191 (Rev 1, 11/12/2018) | DATE<br>November 2018 |
| SUBJECT: SERVICE ACTION: 2.0T ECU REPLACEMENT FOR<br>DTC P053F AND/OR P0087 (SA352) | | |

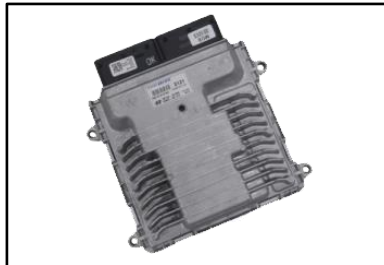
This bulletin provides the procedure to replace the Electronic Control Unit (ECU) on ALL 2018MY Stinger (CK) 2.0T vehicles, produced from September 29, 2017 through March 27, 2018, which may exhibit engine hesitation and/or a Malfunction Indicator Light (MIL) ON with DTCs P053F and/or P0087 as the engine is warming up to operating temperature. Follow the procedure below to replace the ECU. Before conducting the procedure, verify that the vehicle is included in the list of affected VINs.

**P053F: Cold Start Fuel Pressure Performance**  
**P0087: Fuel Rail/System Pressure – Too Low**
