## SUBJECT: SERVICE ACTION: INTELLIGENT VARIABLE TRANSMISSION (IVT) ASSEMBLY REPLACEMENT (SA364)

This issue number is <u>SA364</u>.

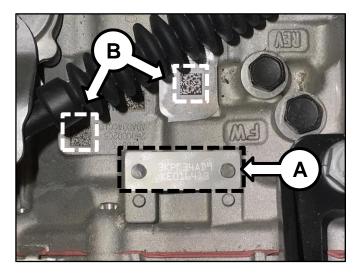
Position the provided VIN plate (A) over the pair of studs nearest to the QR codes (B) with the top of the VIN plate placed towards the QR codes (B), as shown. The VIN must be legible when standing over the driver front wheel.

With the VIN plate in place, use a large mallet and carefully secure the plate by firmly striking on the two (2) studs.
