**Mack Models**

**Volvo Models**

| Title | Tech Tool Returns Error Code 140 Failed To Run On-Vehicle Test; Programming, Calibration, Or Test Operations Fail In Premium Tech Tool (PTT), PTT Displays Control Unit Information Correctly - <b>US10+OBD13 And Newer Emissions, Common Model Year 2014 And Newer</b> |

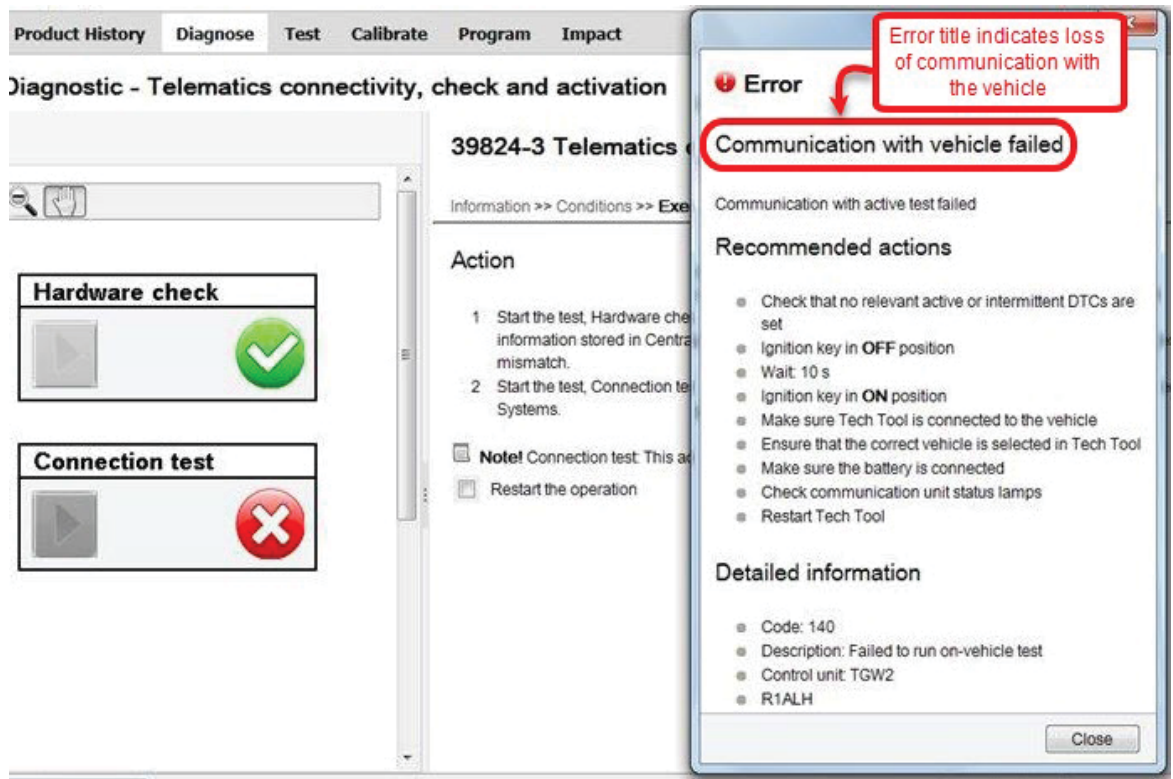
- In the example shown below, the flash screen in PTT looks like the ECU software is sending the error code because it is processing a Routine—R1ALH—that is being run when the failure is detected.

**Note:** This error may appear in a separate window or in the right pane of the PTT screen itself. The location of the error message will depend on the operation being performed.

- The actual message is indicating loss of communication with the vehicle.
- The recommended actions give a high level list of general items that could be tried to correct the issue.
- **If the recommended actions do not correct the problem** then the individual circuits to the specific ECU that is being tested should be investigated as outlined below.

Checking and cleaning the battery connections and the main ground stud on the frame can help correct general voltage and performance issues with the chassis.

1. Using the correct breakout box for the ECU being tested, check for drops in voltage while performing tests that could take the module offline.

**2. The ECU that causes test failures can be supplied with a straight power and ground source routed through a breakout box connected directly to the ECU connector.**
