**Title** Mack Chassis - Diagnostic Trouble Codes (DTC) P2604 , P2606 - Intake Heater / Preheater / Preheat "A" Circuit Range / Performance - **US10+OBD13, US14+OBD13 To US14+OBD16, Model Years 2014 To 2017**

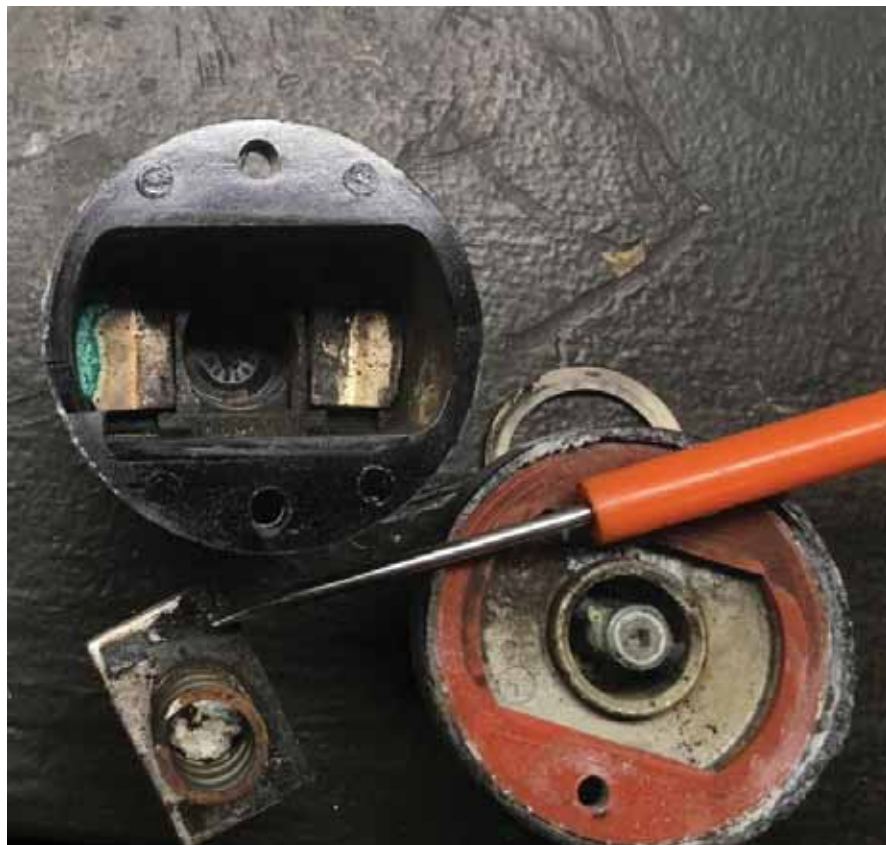
**Cause** DTCs P2604, P2606 Intake Heater / Preheater / Preheat " A " Circuit Range / Performance may be generated on a US14 OBD2016 Mack Chassis due to excessive circuit resistance related to corrosion seen within the Master Disconnect Switch.

An example of a switch with internal corrosion can be seen below:

**Solution** A check should be performed that there is no corrosion to the internal contacts of the Master Disconnect Switch present.
