## ATA operates without obvious cause

Topic number	LI80.50-P-061700
Version	6
Function group	80.50 Anti-theft alarm system (ATA), Interior motion sensor/Tow sensor
Date	06-29-2018
Validity	BR453 with SA code V19
Reason for change	Part number changed
Reason for block

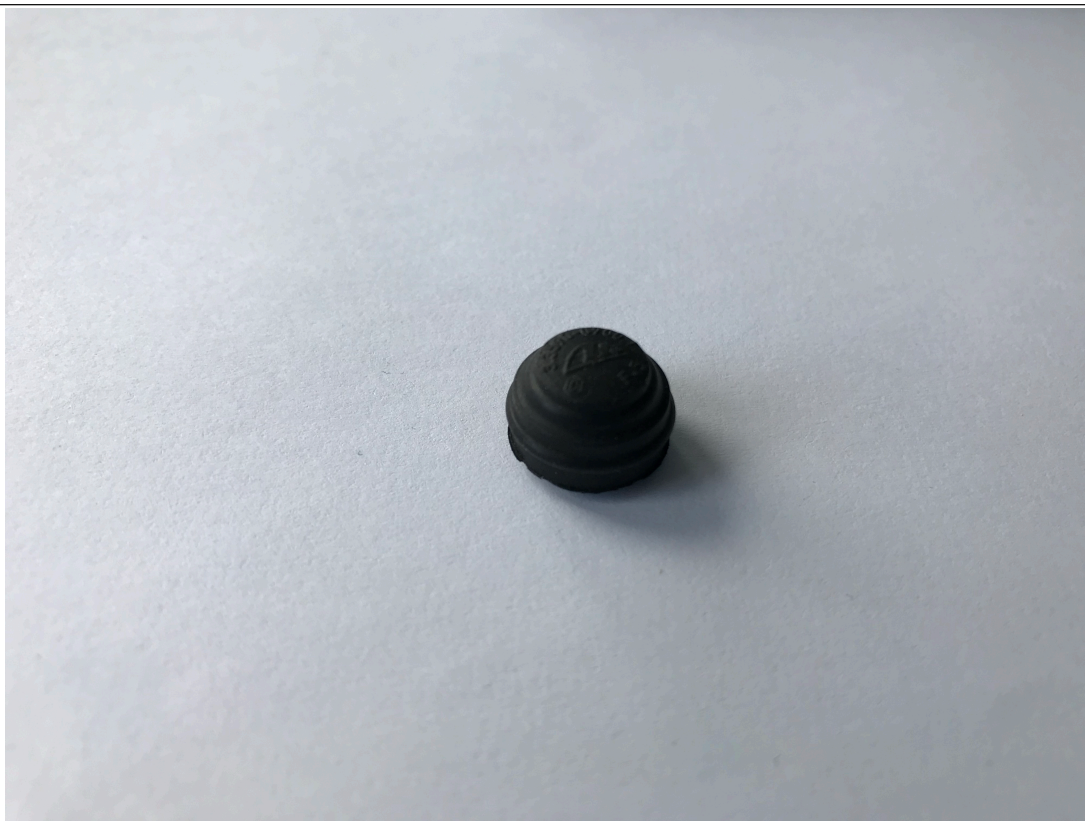
Rubber cap.jpg:

The engine hood contact switch is not depressed sufficiently by the contact plate. Small deviations in the tolerance result in inadvertent actuation of the ATA.

- Open service flap
- Press rubber cap (picture 1) all the way onto sensor (picture 2)
- Sensor with rubber cap (picture 3 and picture 4)
