## Blue smoke after engine start or slight oil leakage at turbocharger

| Topic number | LI09.40-P-055396 |
| Validity | Vehicles with engine 271.8 EVO |

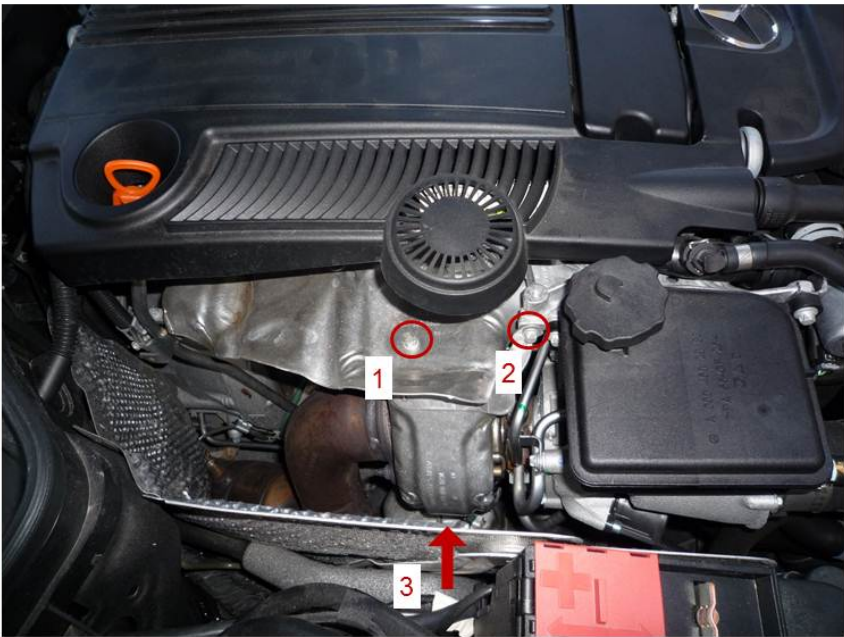
Screwings\_turbocharger\_  
screening\_plate.jpg:

| Attachments | |
|---|---|
| Screwings_turbocharger_screening_plate.jpg | Shield - Installation location of bolts |

- 1.) Detach small shield of turbocharger (see attachment for installation location of bolts).
- 2.) Remove oil feed line in accordance with WIS document AR09.40-P-6020-13EVO steps 1, 2 and 3
- 3.) Replace previous banjo bolt with banjo bolt with integral valve A0019972401. Observe tightening torque as per WIS document AR09.40-P-6020-13EVO! (6 Nm + 90°)
- 4.) Install in the reverse order
