## Vehicle does not start

| Topic number | LI54.00-P-067822 |
| Validity | 453 (smart electric drive) |

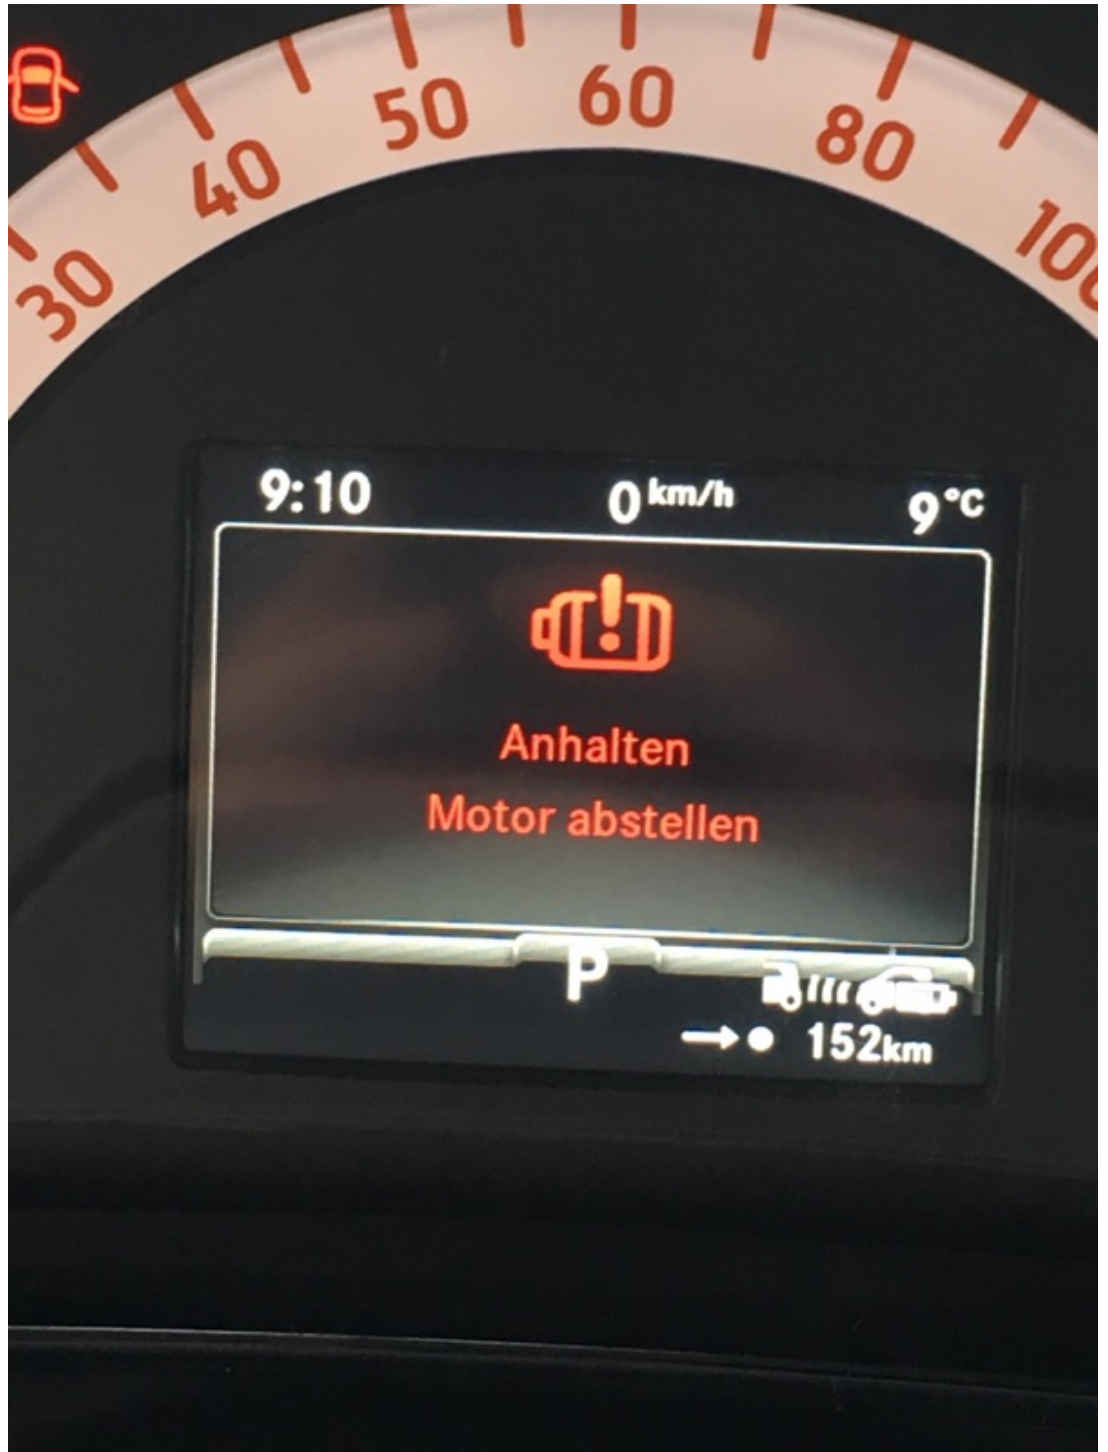
Bild vom Ki e smart.jpg:

HV fault message (see attachment) in instrument cluster.

| Attachments | |
|---|---|
| Bild vom Ki e smart.jpg | IC warning message 1 |

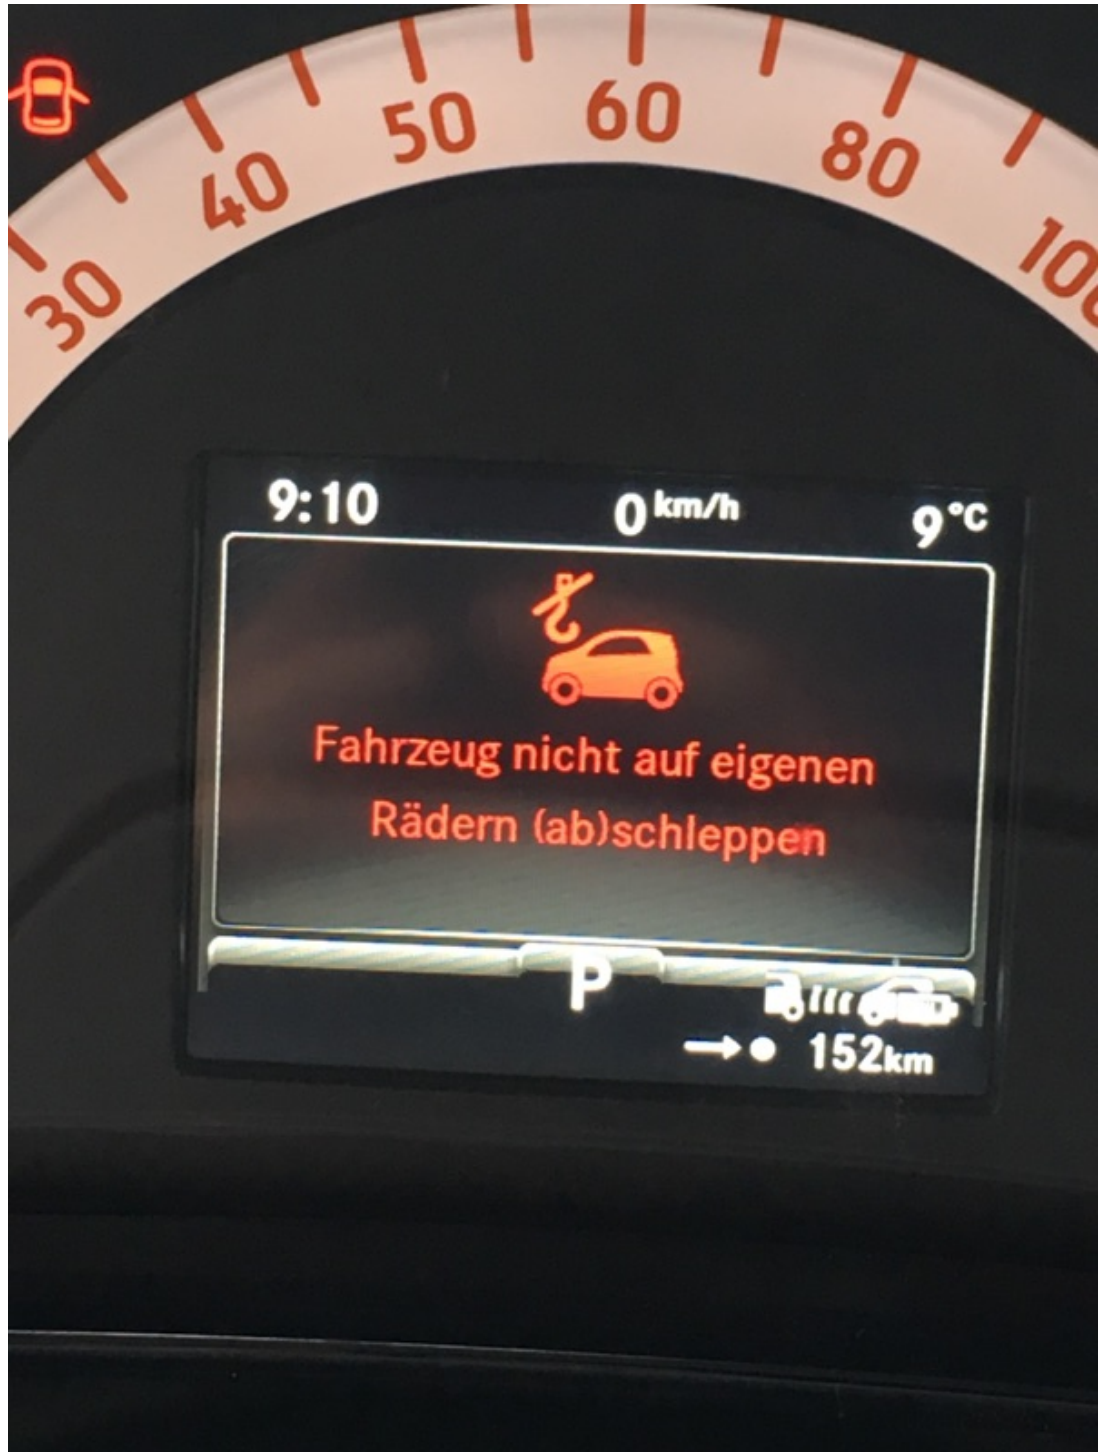
Bild vom Ki e.jpg:

| Attachments | |
|---|---|
| Bild vom Ki e.jpg | IC warning message 2 |

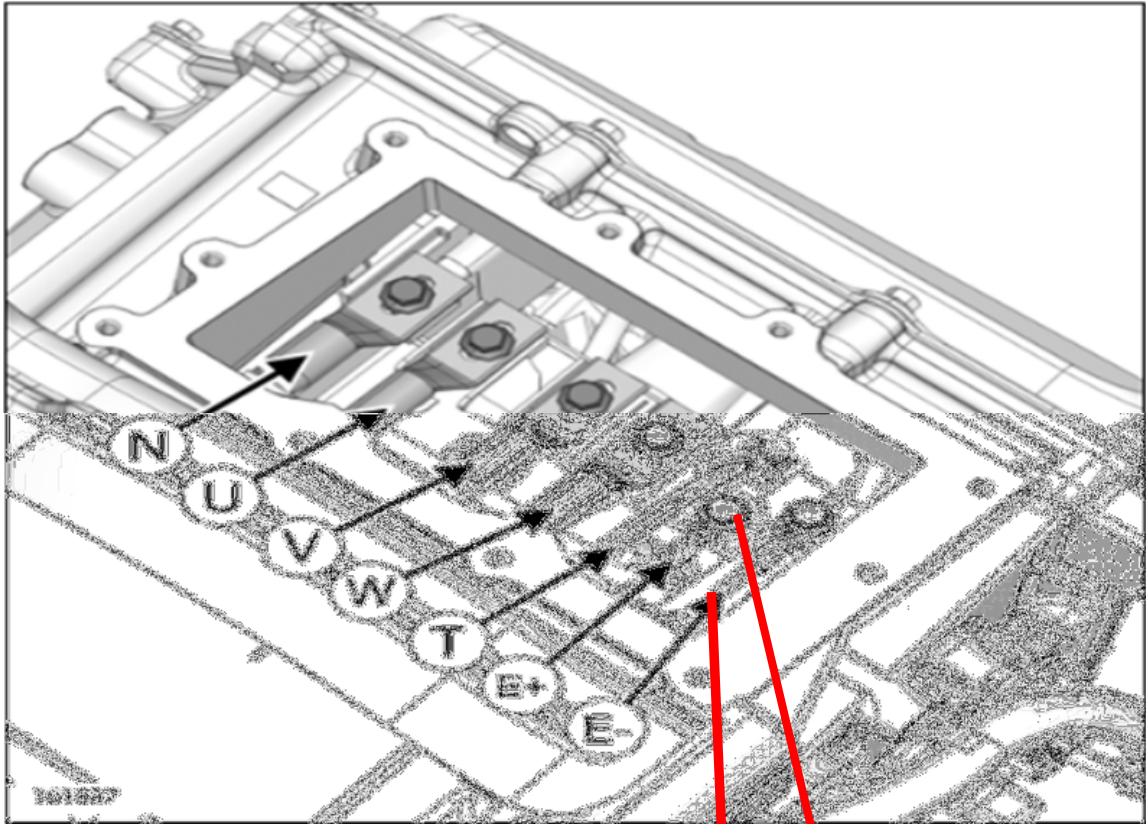
## Measurement location of the excitation circuit

**Excitation Circuit Resistance should be approx.  
(4.5 Ohms (left / Black Clip, E-) / 25 ohms (right / Red Clip, E+))**

1) If the measured resistance is outside the specified range, replace the electric motor.

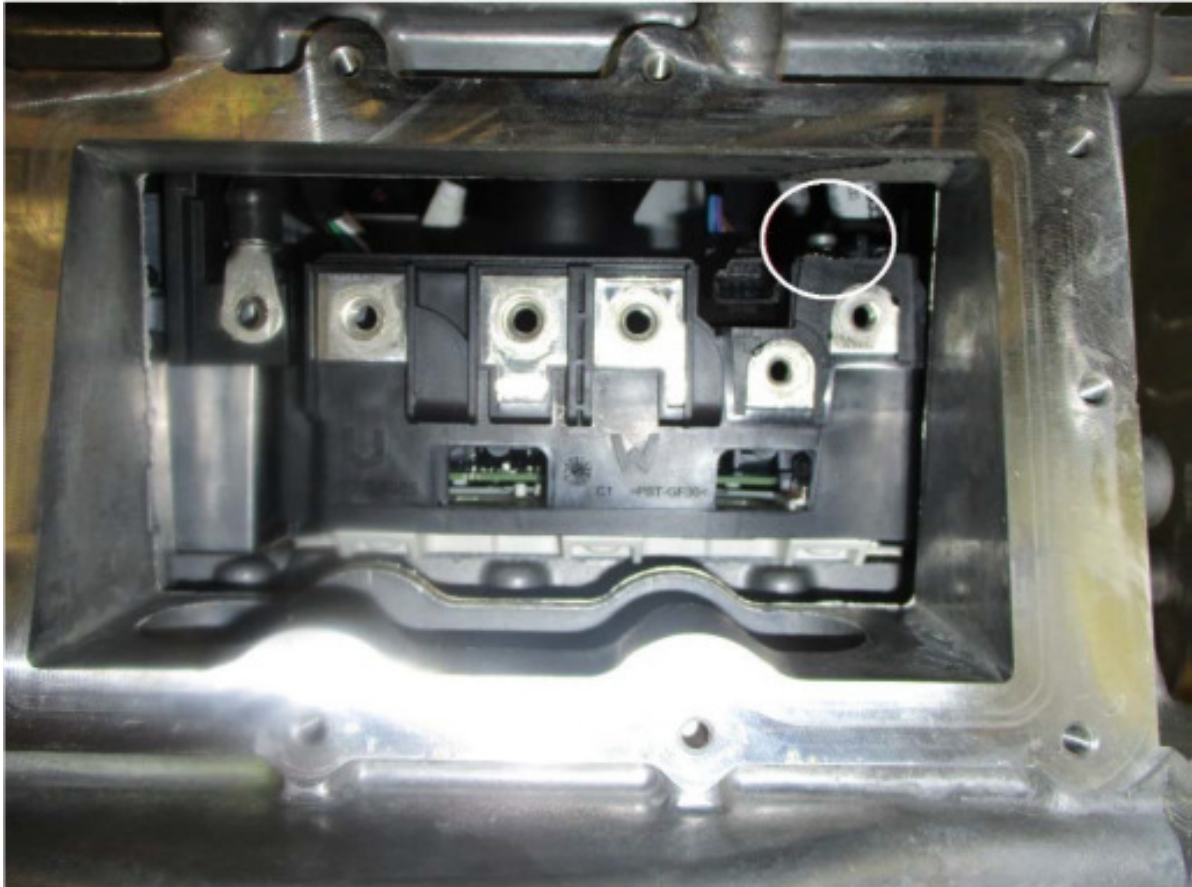
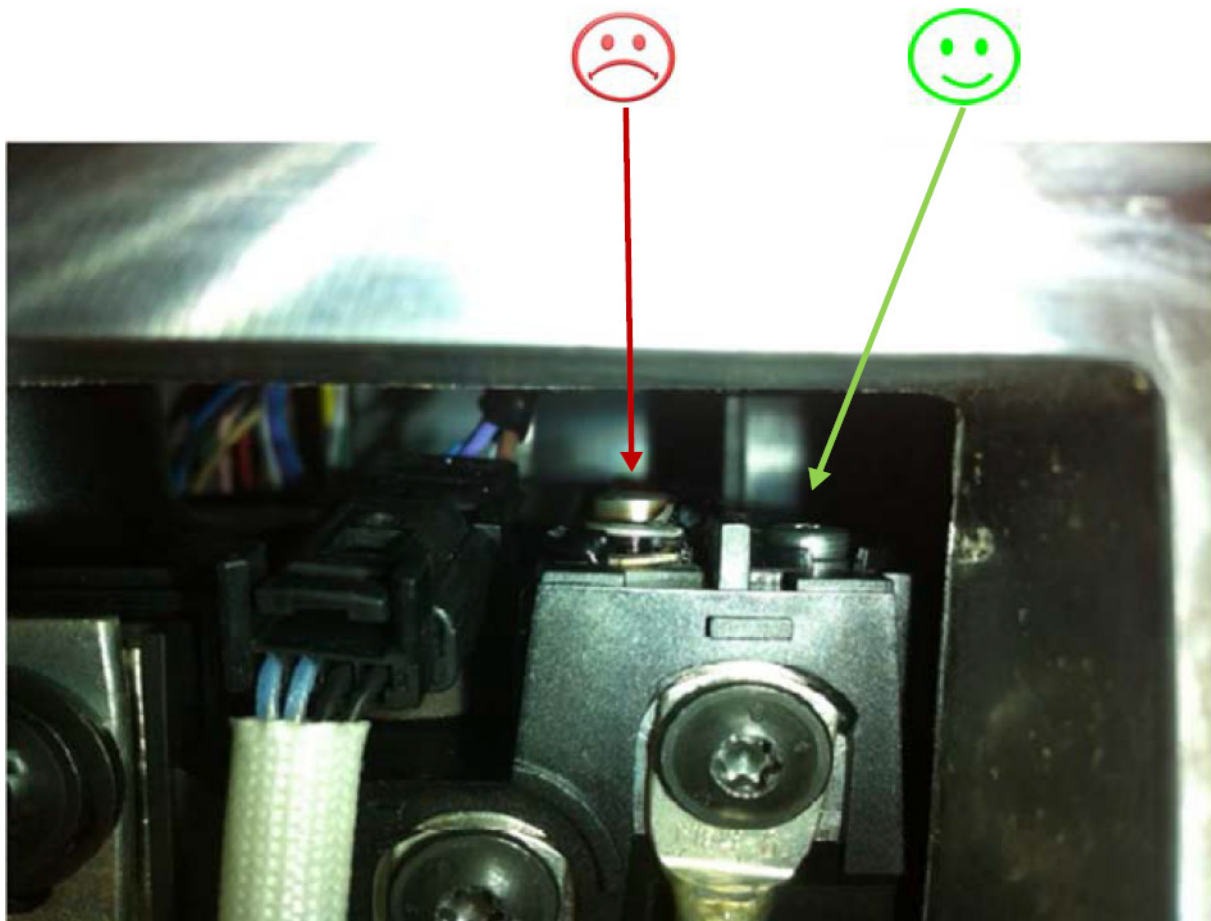
**Visual verification of the clamping of the 2 excitation terminals on the PEC internal inverter module**

2) If the measured resistance is within the specified range, visually inspect the threaded connection (picture in attachment).
