Vehicle does not start

Topic number	LI54.00-P-067822
Version	3
Function group	54.00 General
Date	08-09-2018
Validity	453 (smart electric drive)
Reason for change	Update to IC Warning Images and Excitation Test Measures
Reason for block

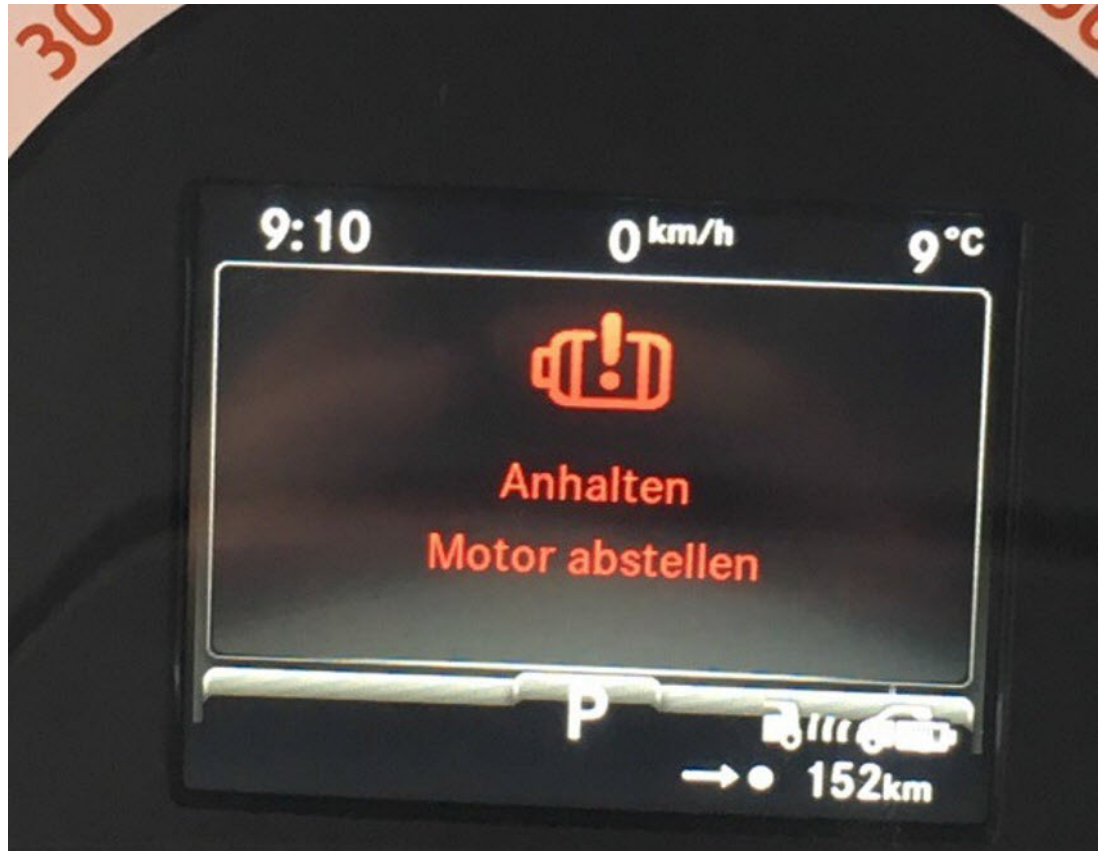
Stop Switch Off Motor.
jpg:

Red warning lamp lights up.

Stop Switch Off Motor appears.

High-voltage electrical system, engine or high-voltage battery is malfunctioning.

- ▶ Switch off the engine.
- ▶ Do not drive on.
- ▶ Consult a qualified specialist workshop.
- ▶ Do not tow away the vehicle on its own wheels.

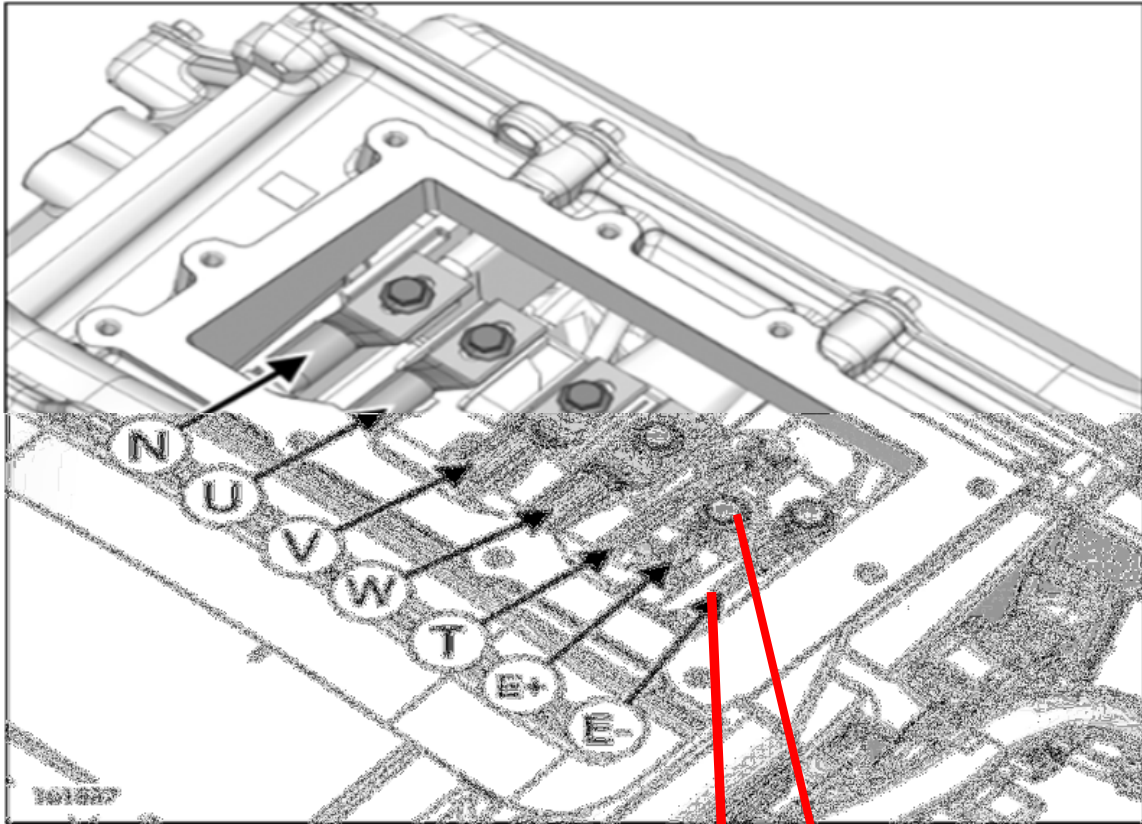
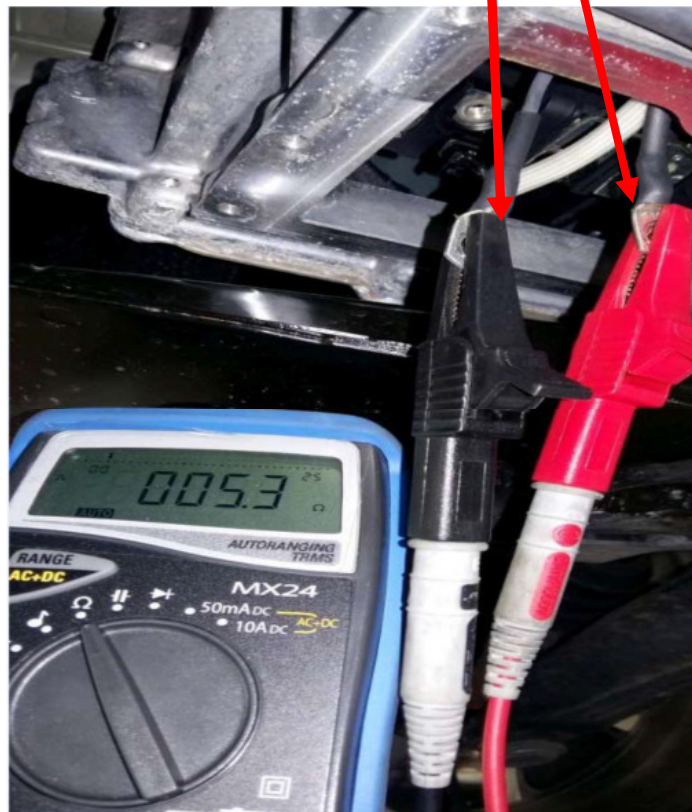
Measurement location of the excitation circuit

**Excitation Circuit Resistance should be approx.
(4.5 Ohms to 25 Ohms) between
terminals E+ (Red) and E- (Black)**

- 1) If the measured resistance is outside the specified range, replace the electric motor.
- 2) If the measured resistance is within the specified range, visually inspect the threaded connection (picture in attachment).
- 3) If no faults are found, erase the fault memory; do not replace any part, and release the vehicle to the customer.

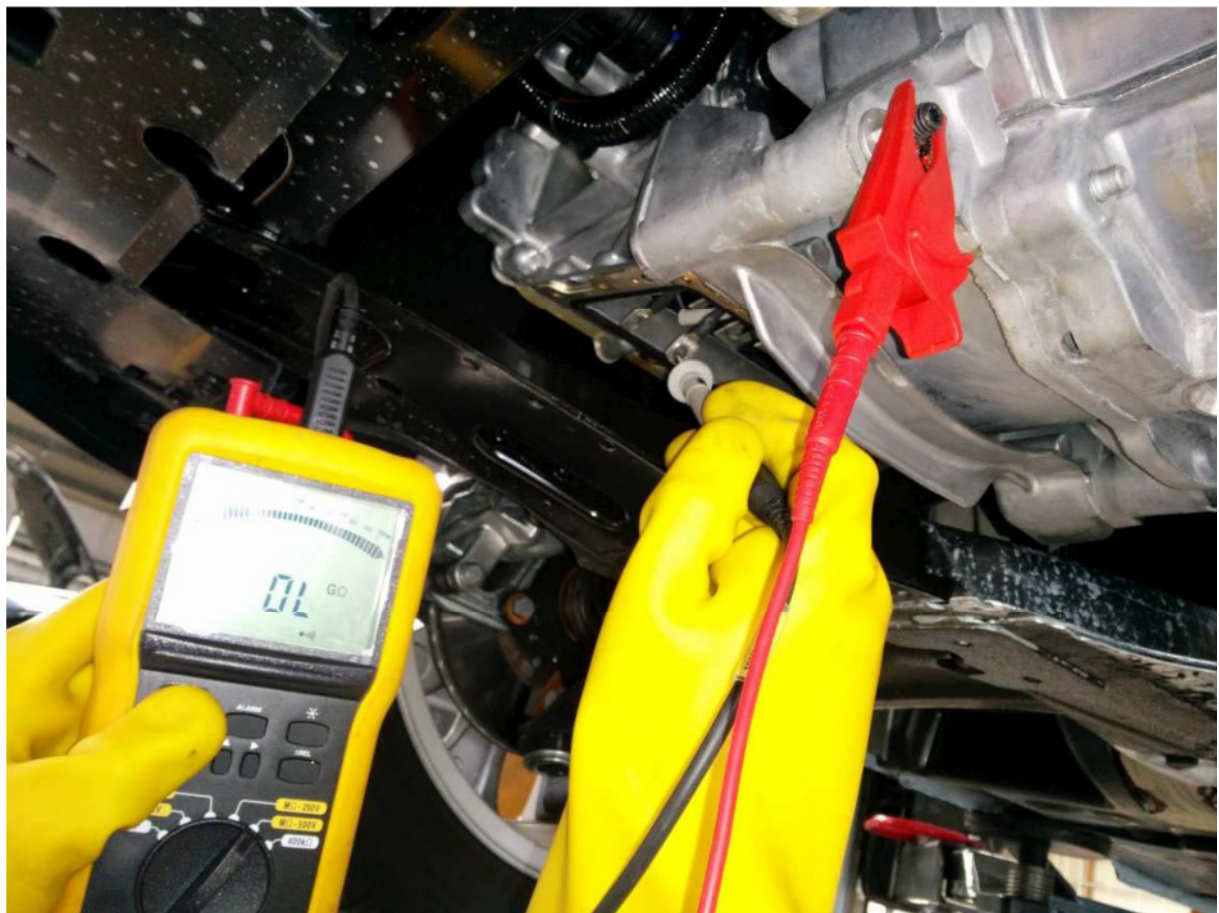
Picture below shows the test lead locations for performing an insulation test of the excitation circuit. Install the alligator clip to the ground in the motor. Set the insulation test voltage to 500 volts. Test both the E+ and E- leads shown on the previous page with your test probe. Both E+ and E- should be > 50 MOhms.
