Supplemental restraint system (SRS) lamp in instrument cluster lights up; fault code B000213 and/or B000113 is logged in the SRS control unit

Topic number	LI91.60-P-058226
Version	5
Function group	91.60 Airbag, pedestrian protection
Date	08-15-2018
Validity	Model series 176 A-Class Model series 242/246 B-Class Model series 117 CLA Production at Rastatt until end of 09/2013; production at Valmet until end of 11/2013 BR205 produced from production startup to end of 06/2014 BR166 produced from production startup to end of 2014
Reason for change	Crimping tool deleted
Reason for block

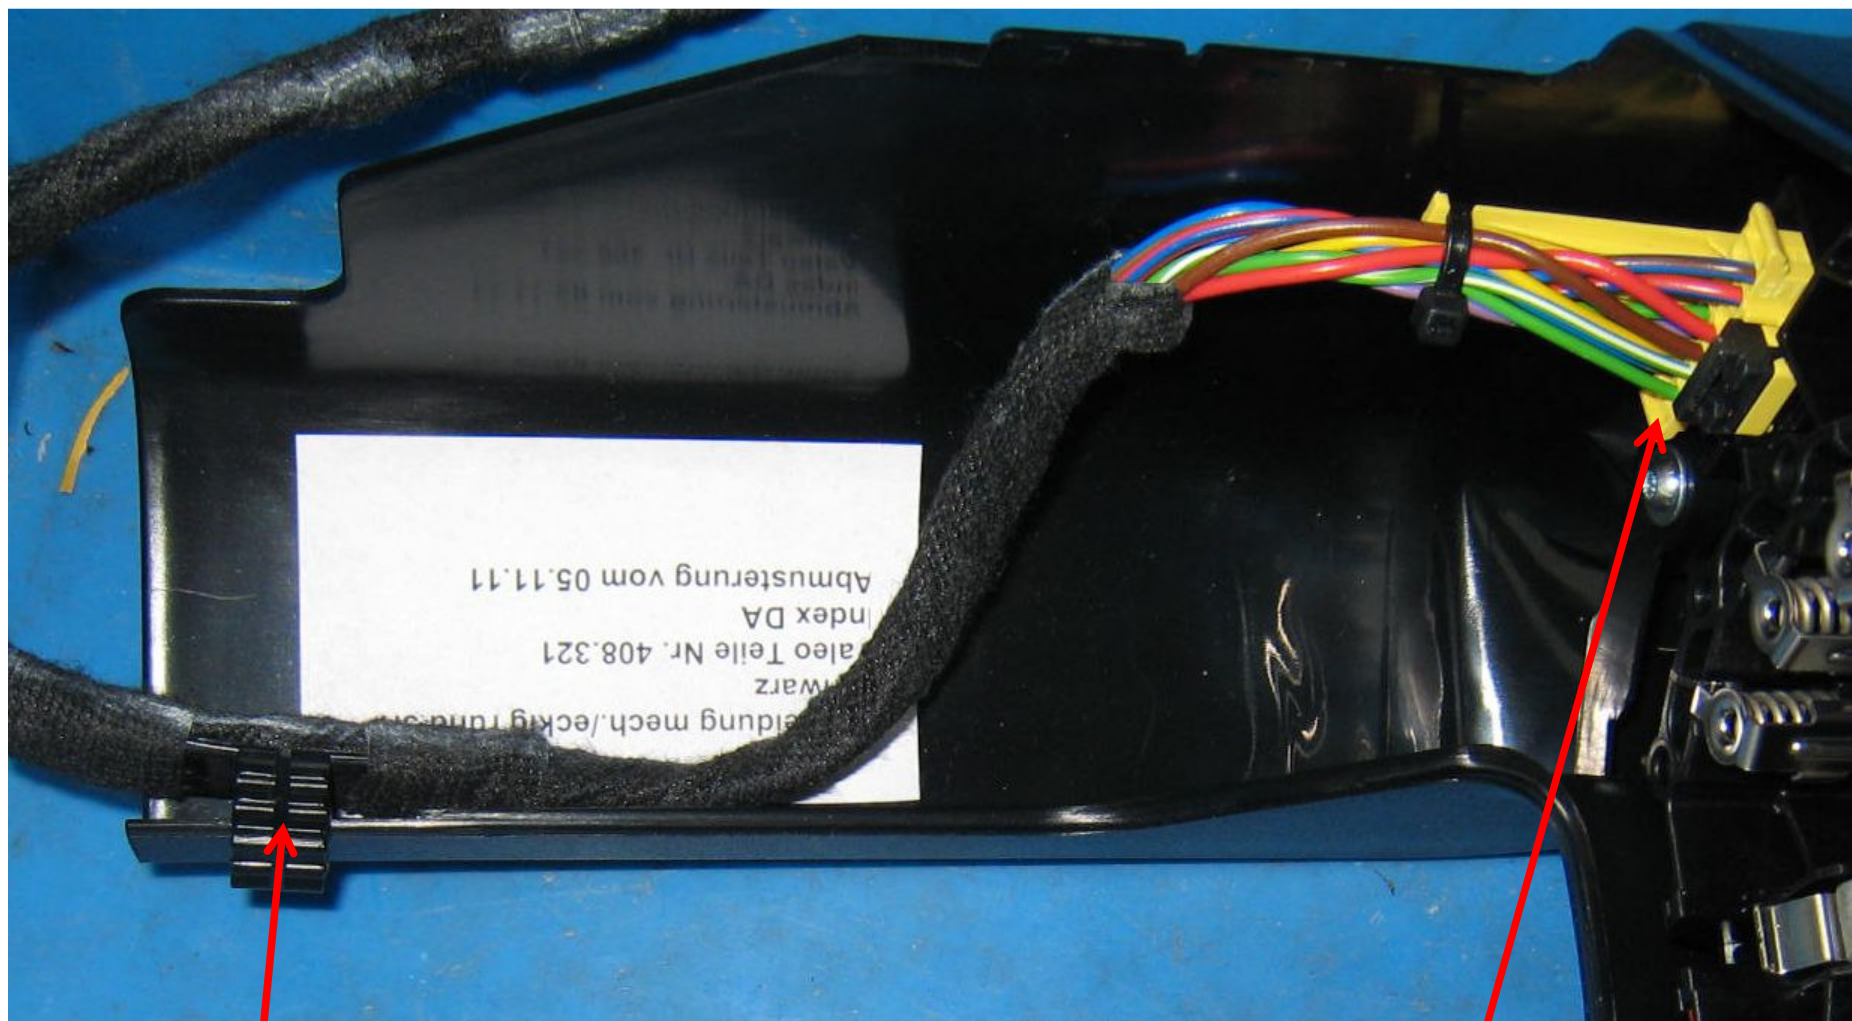
Contact between interior wiring harness and steering column tube switch module (steering column tube switch module connector no.1), see attachment 1, item "1"

2.) Check that the edge clip is correctly positioned and firmly locked (see attachment 1, item "2").

If the actual values are OK -> Replace the contacts between the interior wiring harness and the steering column tube switch module (attachment 1, item "1"):
