MBUX multimedia system: Empty pop-up after sending a POI via Send2Car

Topic number	LI82.85-P-068670
Version	1
Function group	82.85 Navigation and Communication system (CNS, ICS, COMAND, FleetBoard)
Date	08-15-2018
Validity	BR177 with MBUX code 548/549 and code 808/809
Reason for change	
Reason for block

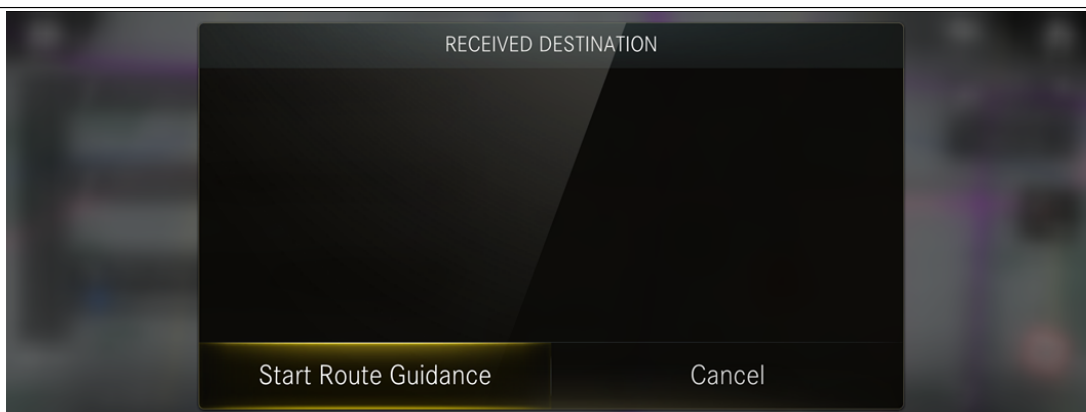
Send2Car_BT.jpg:

The MBUX multimedia system (A26/17) displays an empty pop-up after receiving POIs via the Mercedes me App. However, the route calculation can be launched normally.

The software version of the MBUX multimedia system (A26/17) E33.0, 18/09.02, or E217, 18/27.10, cannot decode the received data correctly and displays an empty pop-up.

New software is currently under development.

As an immediate measure, the data of the MBUX multimedia system (A26/17) can be reset.

To do this, select menu "Vehicle" - "System" - "Reset".

Please save the user data before resetting the MBUX multimedia system (A26/17). To do this, select "Vehicle" - "System" - "System backup" - "Export data", and after the "Reset" select "Import data".
