# Service Campaign Bulletin

Campaign No. 2018070013, August 2018

SUBJECT: **MY18 CLA-Class (117 platform)**  
**Check Seal on Left Tail Lamp, Rework if Necessary**

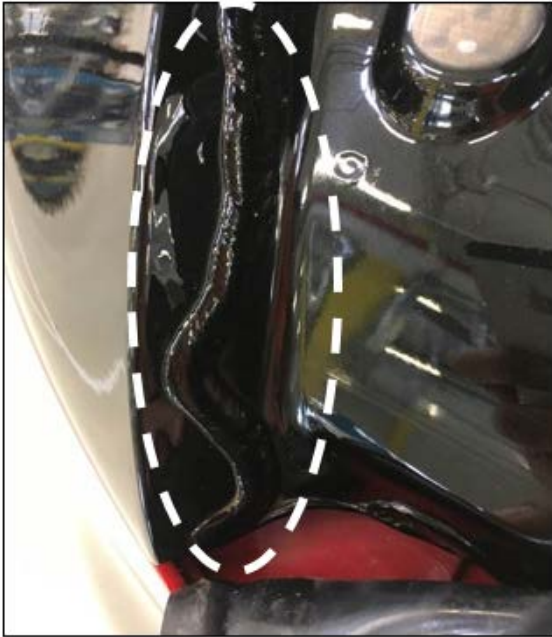
Figure 1

Daimler AG ("DAG"), the manufacturer of Mercedes-Benz vehicles, has determined that on certain MY18 CLA-Class vehicles (117 platform) the left tail lamp seal may not meet current production specifications. An authorized Mercedes-Benz dealer will check the seal and rework it if necessary for the affected vehicles.

1. Check seam seal at left tail lamp (**figure 1**).
  - i** Fold forward cover (**A**) at tail lamp (**figure 2**).
    - a. If seam seal is **NOT** continuous and evenly applied: Perform work procedure.
    - b. If seam seal is **OK**: End measure.
