LTB01238NAS1

# TECHNICAL BULLETIN

'Smart key not found' Message Displayed and Poor Smart key Operation

MODEL:	MODEL YEAR:	VIN:
Discovery (LR)	2018	047448-079570
Range Rover Sport (LW)	2018	181320-813922
Range Rover (LG)	2018	380217-516166

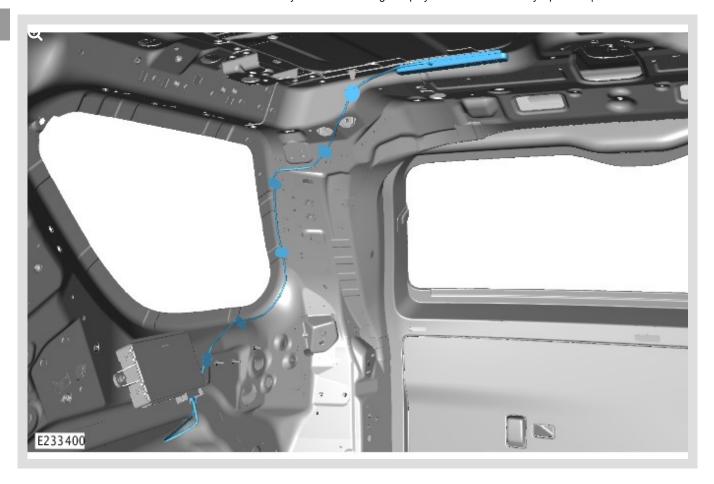
**Discovery:** Coaxial cable wiring harness route.

Route the coaxial cable as shown in the Service Information section above and secure in place with adhesive pads to make sure the cable will remain in its position.

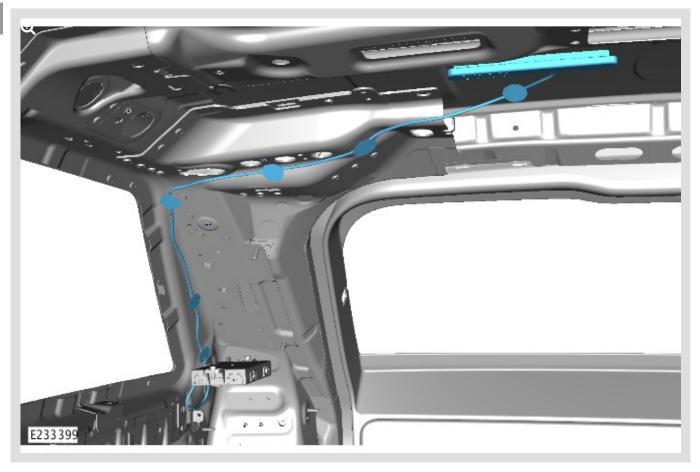
Range Rover Sport: Coaxial cable wiring harness route.

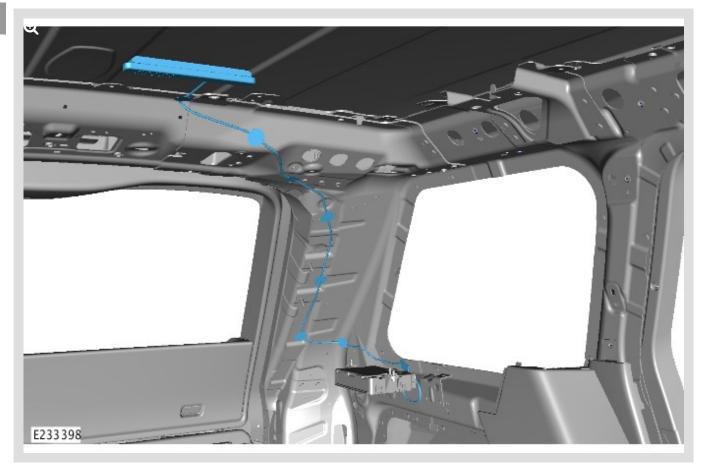
Range Rover: Coaxial cable wiring harness route.

Route the coaxial cable as shown in the Service Information section above and secure in place with adhesive pads to make sure the cable will remain in its position.
