N251NAS1

TECHNICAL BULLETIN

Service Action: Manual Tailgate Water Leaks

MODEL:	MODEL YEAR:	VIN:
Range Rover Velar (LY)	2019	781897-789531

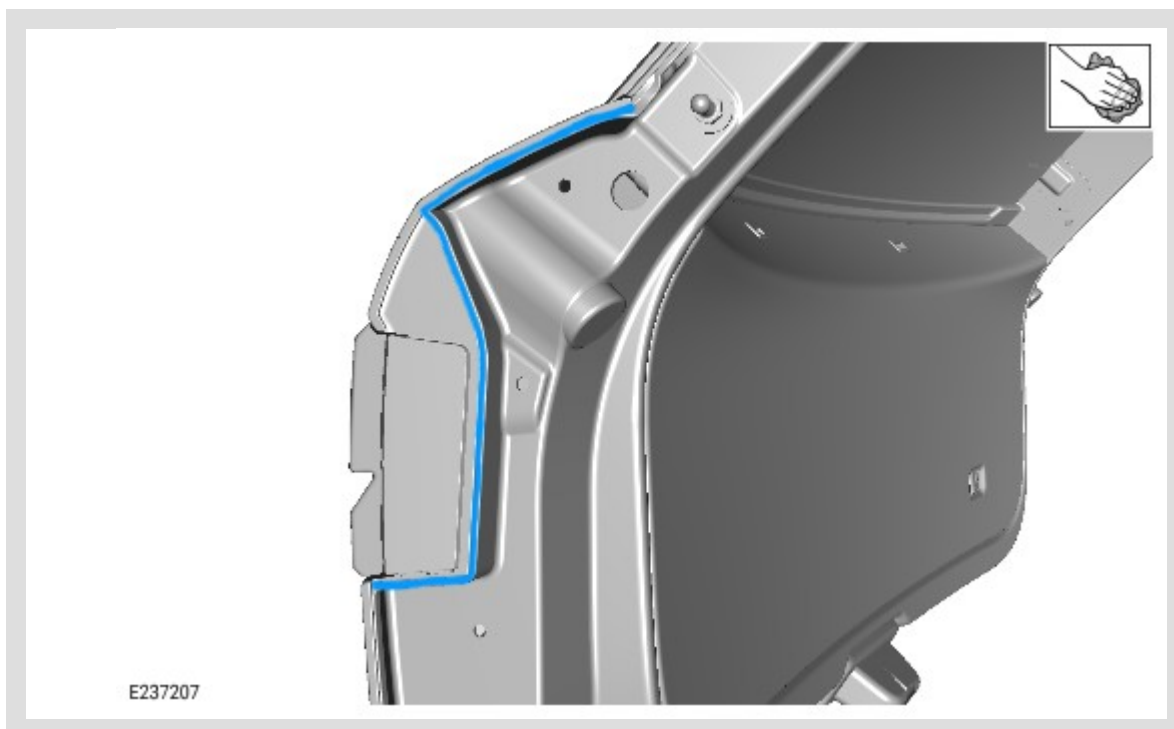
1

A potential issue has been identified on certain vehicles within the listed Affected Vehicle Range where, in the event of heavy rain or use of jet wash, water may ingress into the tailgate and leak out from the tailgate latch or passenger assist handle.

Clean the area shown.
