INSTRUCTION TO SERVICE

ITS: 58474

SECTION:	219 Engine and Transmission
WRITTEN BY:	Mike Pearson
SUBJECT:	Rework Engine Mount for Water Belt Clearance

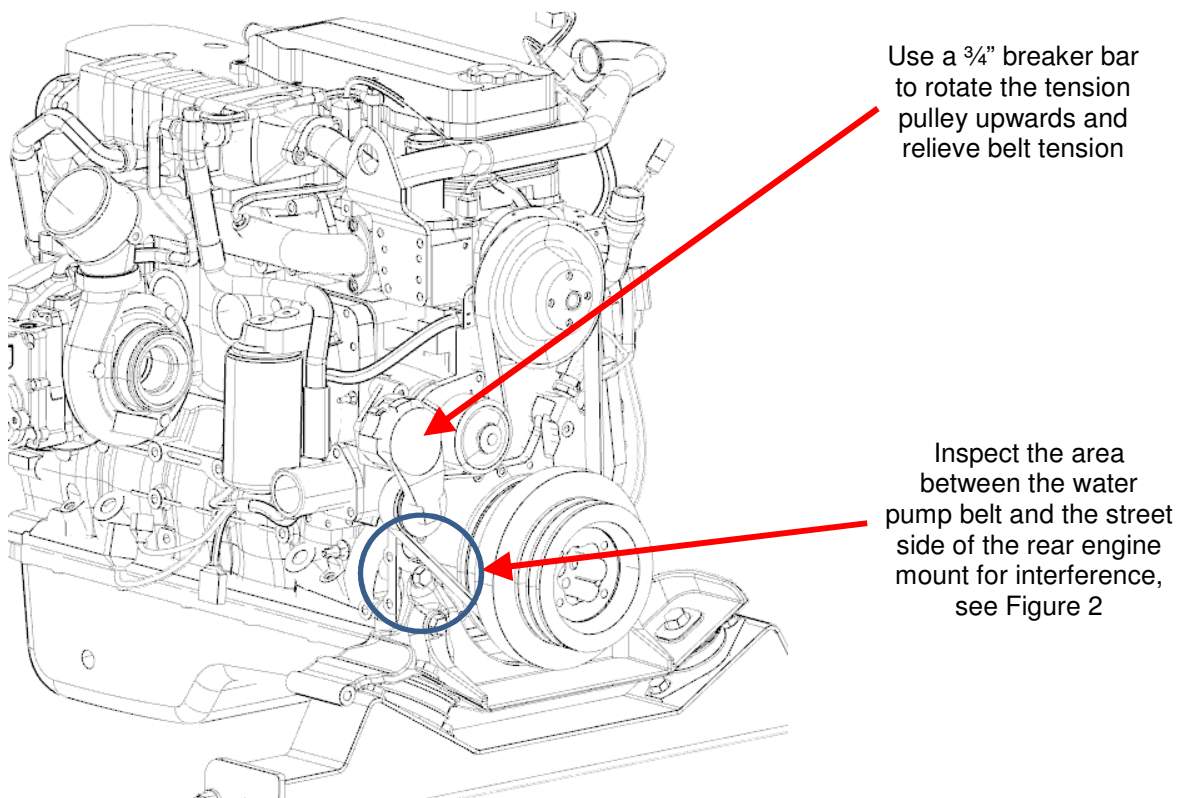
1. Turn the main battery disconnect switch to the “OFF” position.
2. Open the rear exterior engine door.
3. Open the engine belt guard.
4. If necessary, raise coach in accordance with the New Flyer Service Manual.
5. Inspect the area between the water pump belt and the street side of the rear engine mount for interference as shown Figure 1.
6. If belt contact is evident on the engine mount proceed to Step 7, if no contact is present go to Step 9.

Figure 1: Water Pump Belt Interference Location

7. Release the belt tension, remove and save the water pump belt for re-installation. See Figure 2.

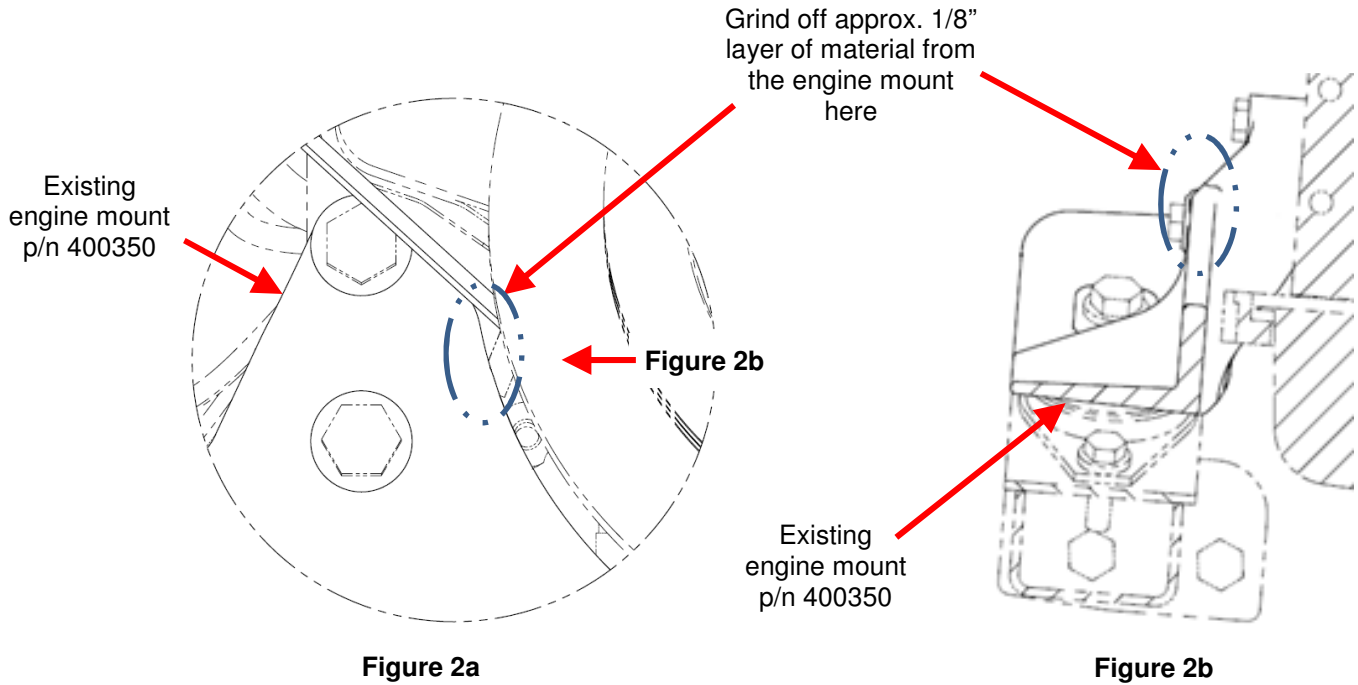
Figure 2: Water Pump Belt Interference Location

8. Grind off approx. 1/8" layer of material from the engine mount at the location of the belt interference, see Figure 2. Ensure that the finished surfaces are smooth and the corners are round. Apply a coat of zinc primer p/n 638699 to any bare metal once complete.
