| TSIB 18-01 Rev. A | | September 28, 2018 |
| TITLE: | Inspect and Reroute, as required, L9N CCV Hose | |
| APPLICABILITY: | All New Flyer L9N CNG Xcelsior Buses built prior to 18-May-2018 | |

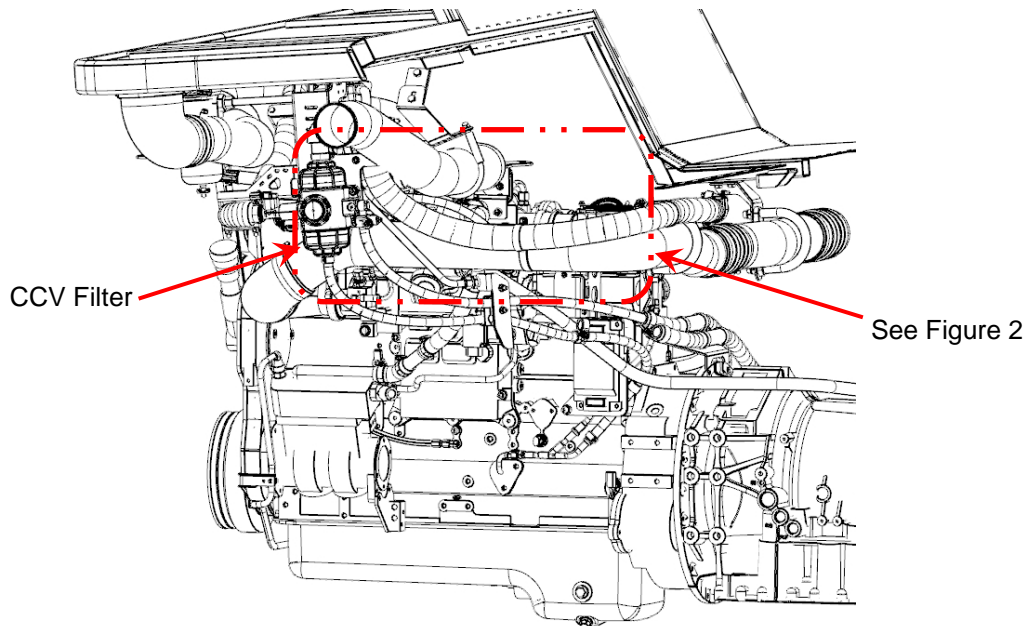
Figure 1: Crankcase Vent Filter Hose Location

New Flyer has observed some instances where the crankcase vent (CCV) filter blow-by gas outlet hose can droop from its originally installed location due to things such as maintenance of other components in the area of the hose. Cummins requires that the CCV filter blow-by gas outlet hose has a slope up from the engine to the CCV filter to prevent moisture accumulation. In four known cases drooping of the hose has allowed moisture to accumulate in the line and freeze blocking release of crankcase pressure. This pressure buildup may cause the front engine cover to bulge out and rub against the engine crankshaft pulley.

1. Inspect the routing of the crankcase vent (CCV) filter blow-by gas outlet hose, see Figure 1. Ensure the hose is sloping continuously up from engine to CCV filter without any sharp bends or dips and is routed in such a way that liquid will not accumulate. The hose may need to be adjusted by relocating the hose support p-clips. See Figures 2 and 3.
