MIL "ON" DTC P050B00 - Cold Start Ignition Timing Performance

Service Category Engine/Hybrid System

YEAR(S)	MODEL(S)	ADDITIONAL INFORMATION
2018	LS500

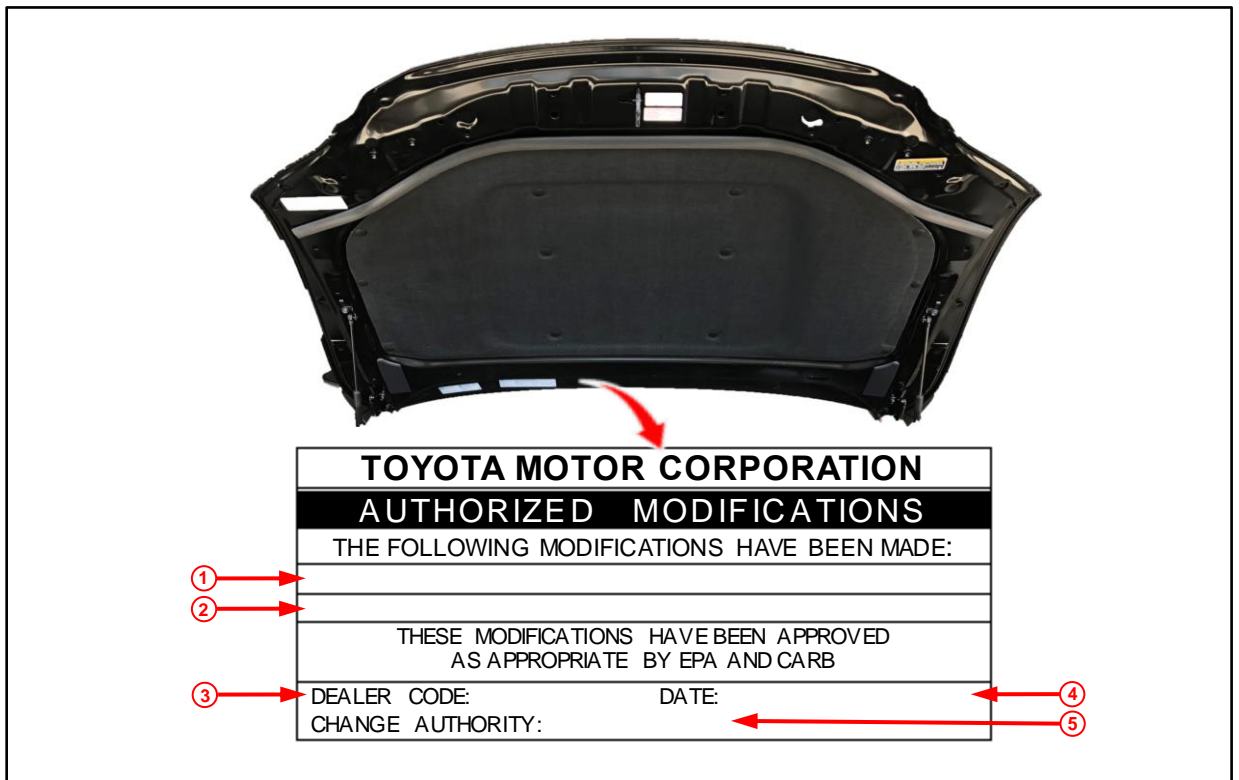
Figure 1. Location of Authorized Modifications Label for 2018 LS 500

2. Check for the Authorized Modifications Label affixed to the vehicle in the location shown below. Confirm if the ECM (PCM) calibration has been updated.
Is the calibration ID listed the latest ECM (PCM) calibration?
 - **YES** — This bulletin does NOT apply. Continue diagnosis using the applicable Repair Manual.
 - **NO** — Continue to step 3.

4. Prepare and install the Authorized Modifications Label.
 - A. Using a permanent marker, enter the following information on the label:
 - ECM (PCM) part number [*Refer to the **Parts Information** section for the **NEW PART NUMBER***]
 - Calibration ID(s) [*Refer to the **Calibration Information** section for the **NEW CALIBRATION ID***]
 - Dealer Code
 - Repair Date
 - Change Authority [***This bulletin number***]
 - B. Affix the Authorized Modifications Label to the vehicle at the location shown in Figure 1. The Authorized Modifications Label is available through the MDC, P/N 00451-00001-LBL.
5. Test drive the vehicle to confirm the DTC does NOT reset.
