Subject: BODY VIBRATION WHEN ENGINE STARTED AFTER PARKING IN EXTREMELY COLD TEMPERATURES	Bulletin No.: 01-022/18
	Last Issued: 11/09/2018

- 2017-2018 CX-5 (US spec)
- 2018 CX-5 (Mexico spec)
- 2018 Mazda6 (US spec)
- 2019 Mazda6 (Mexico spec)

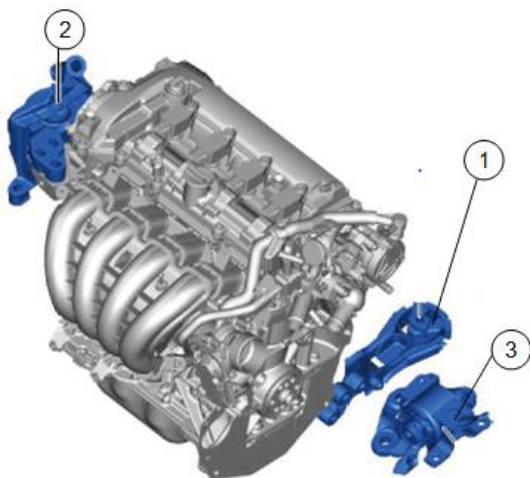
Some vehicles may exhibit an excessive body vibration/unusual noise when idling or driving after parking in extremely cold temperatures (-25°C/-13°F).

This may be caused by the No.1 engine mount rubber hardening under extremely cold temperatures due to inappropriate characteristic of the engine mount rubber.

(Figure shown is SKYACTIV-G 2.0 and SKYACTIV-G 2.5 engine for CX-5 2WD)

1	No.1 engine mount
2	No.3 engine mount
3	No.4 engine mount

To eliminate this concern, the material of the No.1 engine mount rubber has been changed to increase the damping force under extremely cold temperatures.
Customers having this concern should have their vehicle repaired using the following repair procedure.

- If yes, replace the No.1 engine mount with a modified one according to the instructions on MGSS (ENGINE MOUNT DISASSEMBLY/ASSEMBLY).
 - CX-5 (ENGINE MOUNT DISASSEMBLY/ASSEMBLY [SKYACTIV-G 2.5 (WITH CYLINDER DEACTIVATION)])
 - CX-5 (ENGINE MOUNT DISASSEMBLY/ASSEMBLY [SKYACTIV-G 2.5 (WITHOUT CYLINDER DEACTIVATION)])
 - **NOTE:** It is not necessary to remove the transfer unit or bracket "B" on CX-5 AWD models. Use a prybar to apply slight pressure toward the rear of the vehicle to align the bolt holes in the mounting bracket "A" .
 - Mazda6 (ENGINE MOUNT DISASSEMBLY/ASSEMBLY [SKYACTIV-G 2.5T])
 - Mazda6 (ENGINE MOUNT DISASSEMBLY/ASSEMBLY [SKYACTIV-G 2.5 (WITH CYLINDER DEACTIVATION)])
 - Mazda6 (ENGINE MOUNT DISASSEMBLY/ASSEMBLY [SKYACTIV-G 2.5 (WITHOUT CYLINDER DEACTIVATION)])
- If not, this TSB does not apply.
