Subject: FLOOR UNDER COVER FALLS OFF AFTER DRIVING ON SNOW AND ICE	Bulletin No.: 09-039/18
	Last Issued: 11/01/2018

2017-2018 CX-5

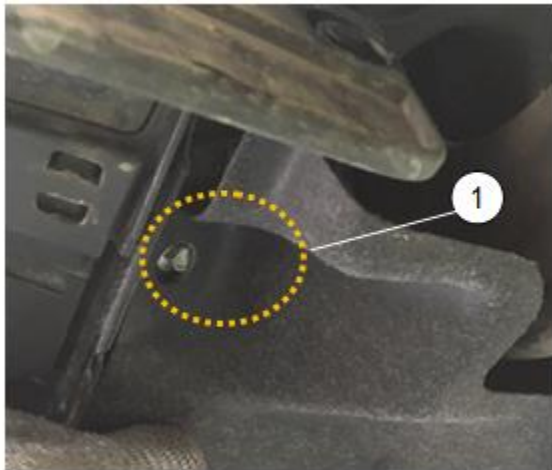
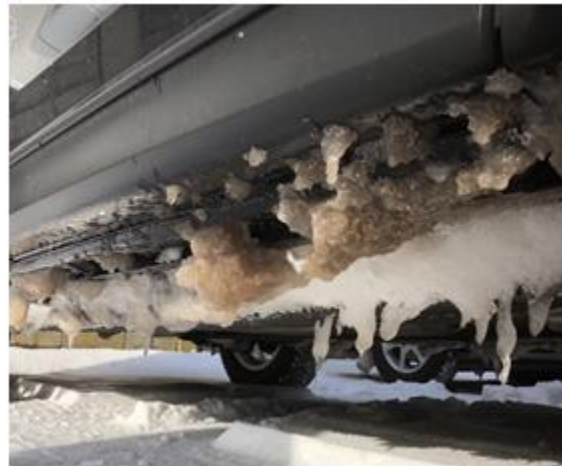
Some customers may notice the floor under cover No.2 falling off at the bolt (1) location after driving through snow and/or ice. This may be caused by snow and/or ice accumulation under cover No. 2 (as shown below).

This concern is caused because the bolt hole is too large for the bolt to hold the under cover when snow and/or ice accumulates under the body. To eliminate this concern, the bolt hole diameter has been reduced.
