Technical Service Bulletin

Subject: FLOCK FINISHING ON DOOR SASH MOLDING PEELS OFF WHEN OPENING FROZEN DOOR	Bulletin No.: 09-040/18
	Last Issued: 11/09/2018

2017-2019 CX-5 2018-2019 CX-5 (Mexico spec.)

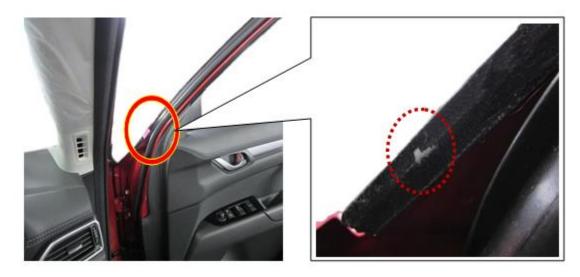
Some customers may notice the flock finishing on the door sash molding is peeled off (as shown below) when opening the frozen door. This concern may be caused by insufficient durability due to an improper production process of the door sash moldings. To eliminate this concern, the production process of the door sash moldings has been changed.

2. Replace the affected door sash molding(s) with modified part(s) according to the instructions on MGSS online:
