Technical Service Bulletin

WATER ENTRY INSIDE FRONT COMBINATION LIGHT

Bulletin No.: 09-041/18

2016-2019 CX-3 vehicles with VINs lower than JM1DK*****412730 (produced before June 4, 2018)

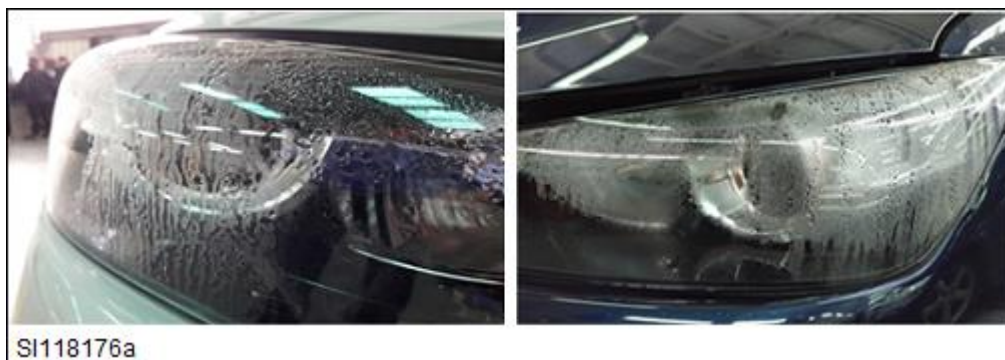
Some customers may notice water entry into the front combination lights (as shown below). This is due to poor sealing where rain or other water can enter inside the light. To eliminate this concern, the shape of the front combination light has been changed to improve sealing ability.

- If water entry is found (as shown in the illustrations above), proceed to the next step.

2. Replace the affected front combination light unit(s) with modified part(s) according to instructions on

MGSS online (FRONT COMBINATION LIGHT REMOVAL/INSTALLATION).
