Technical Service Bulletin

Subject: FRONT BUMPER CRACKED NEAR THE FRONT FENDER/FRONT COMBINATION LIGHT	Bulletin No.: 09-042/18
	Last Issued: 11/30/2018

2016-2019 CX-9 vehicles with VINs lower than JM3TC*****306028 (produced before September 17, 2018)

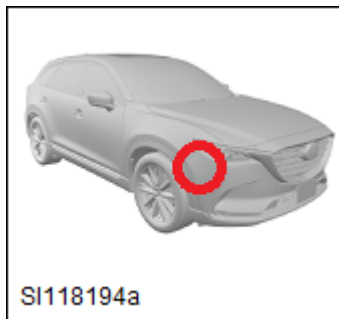
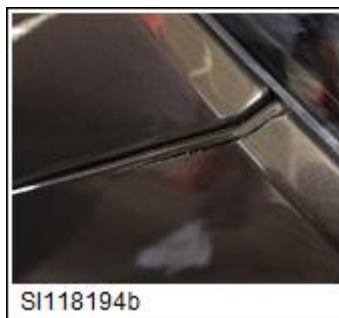
Some customers may notice cracks (as shown below) at one or both ends of the front bumper near the front fender / front combination light. This may be caused when driving over bumps. The bumper fascia may receive higher than expected forces, depending on driving manner and road conditions. To eliminate this concern, the internal shape and material of the front bumper fascia has been modified.

1. Verify the customer concern.
2. Replace the front bumper cover with a modified part according to the instructions on MGSS online:

NOTE: Be sure to disconnect the connectors to the fog lights / parking sensors and remove the wiring harness clips before removing the front bumper.
