MODEL: Karma Revero

TITLE: Downstream O2 Sensor Inspection

PURPOSE: To ensure correct routing of secondary oxygen sensor wiring

TB-18-12-05

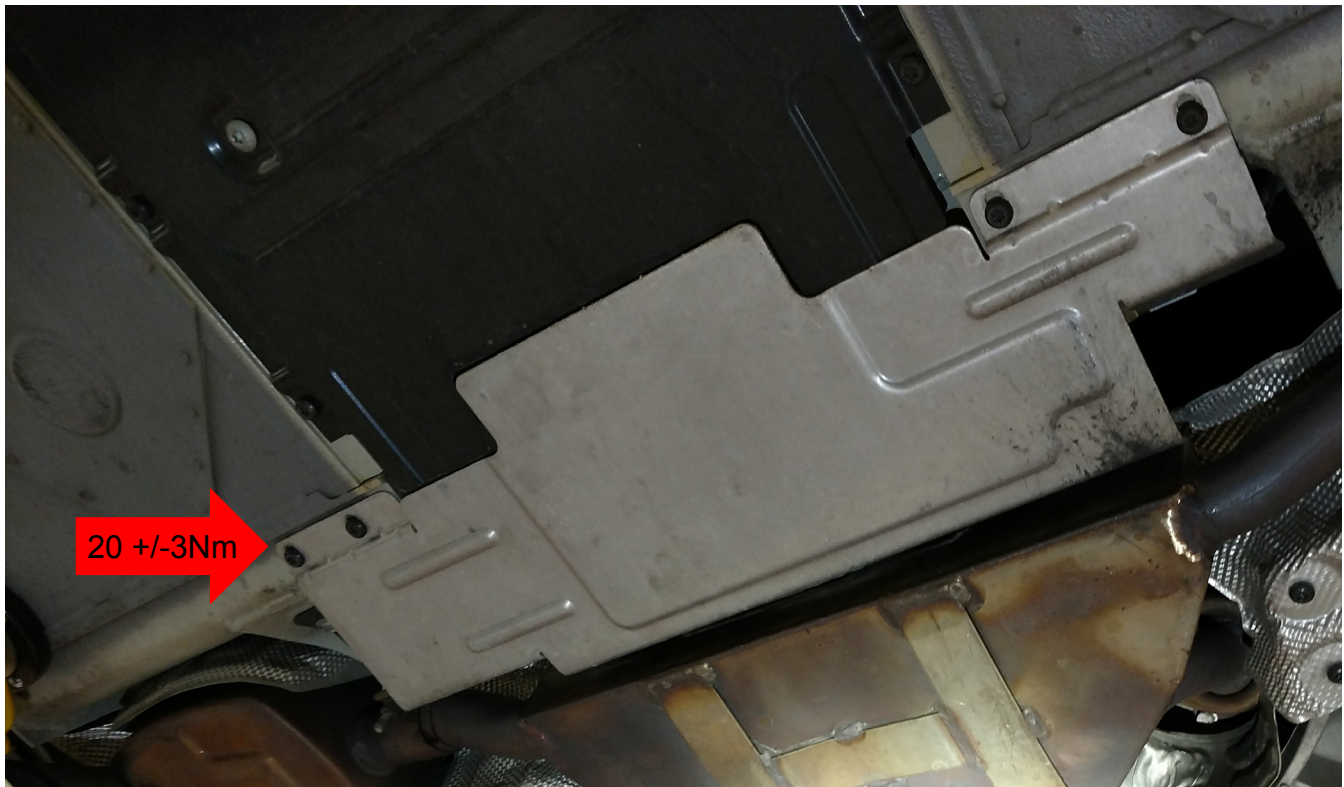
fig. 1a

Remove the Shield-HV Battery,Front (fig 1a) for best viewing for the inspection. remove the four (4) torx head bolts. Reassembly torque is 20Nm (+/- 3).

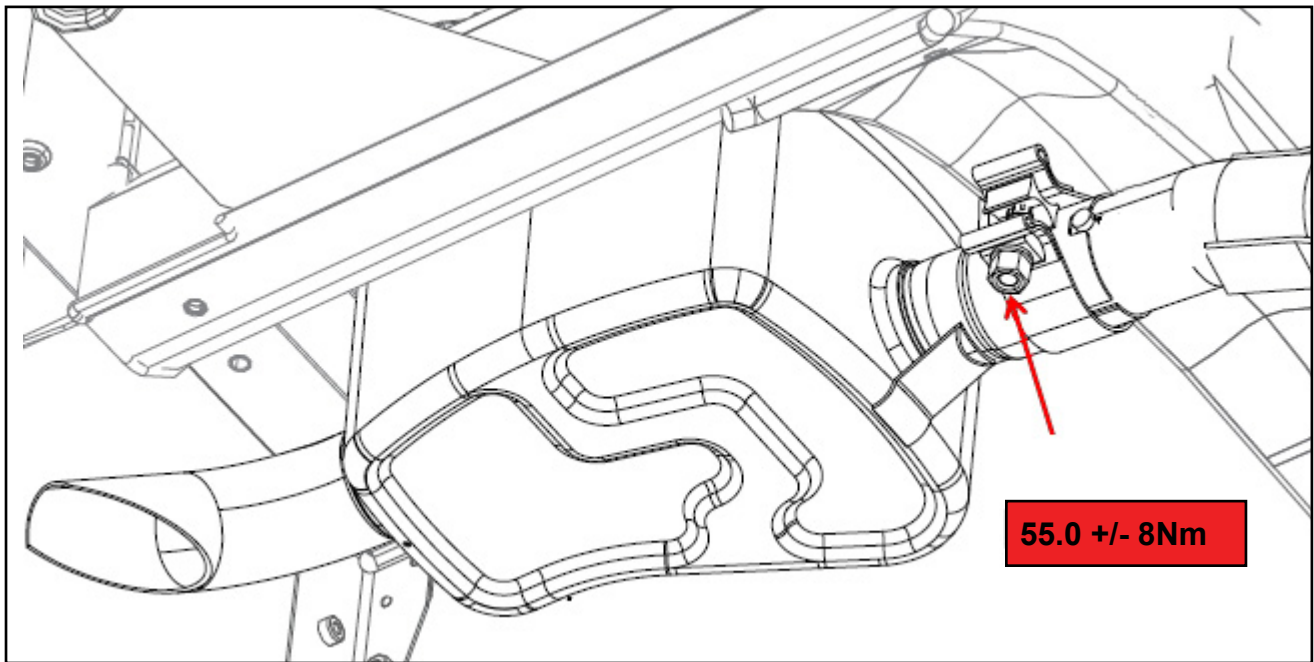
fig. 1b

Remove the center muffler at this time as well for best access. Exhaust clamp torque is 55.0 +/- 8Nm (fig. 1b) following page and the center muffler to catalyst studs is 17 +/- 2Nm (fig. 1c) on the following page as well.

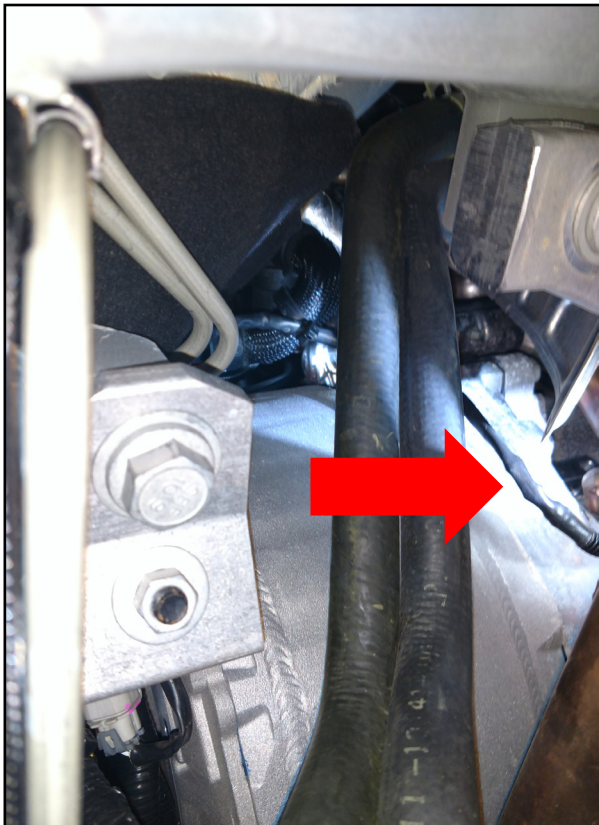
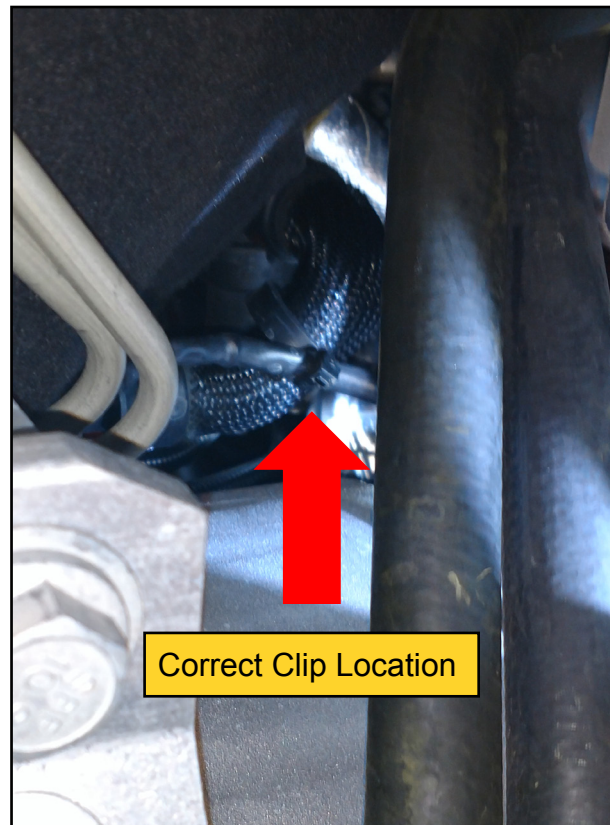
With the shield removed the catalyst monitor O2 sensor (downstream sensor) should be readily visible (fig. 2a). The sensor wire should be as shown, by following the wire up a clip around the braided hose should be visible. This is the correct location (fig 2a, 2b). If the retainer is not found here, un-clip it and relocate as necessary.

NOTE: This downstream sensor wire should in not contact the muffler or exhaust system.

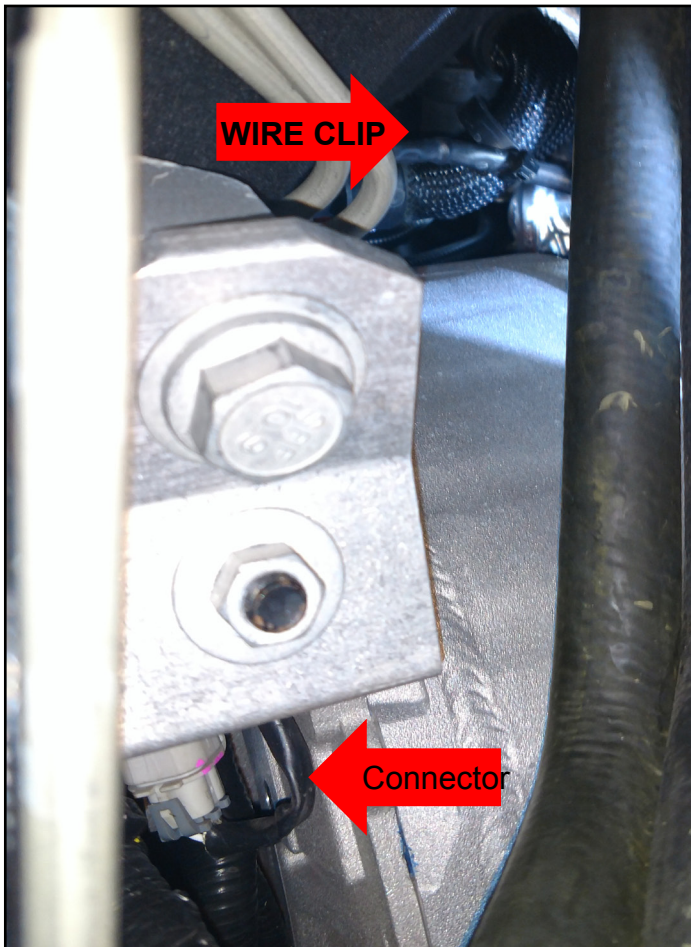
fig.3a

Inspect the connector. Follow the wire from the clip f down along the generator, the connector is accessible here (fig 3a). There is a tension clip to the generator mount fastening the connector, this can be popped off for inspection (fig 3b).

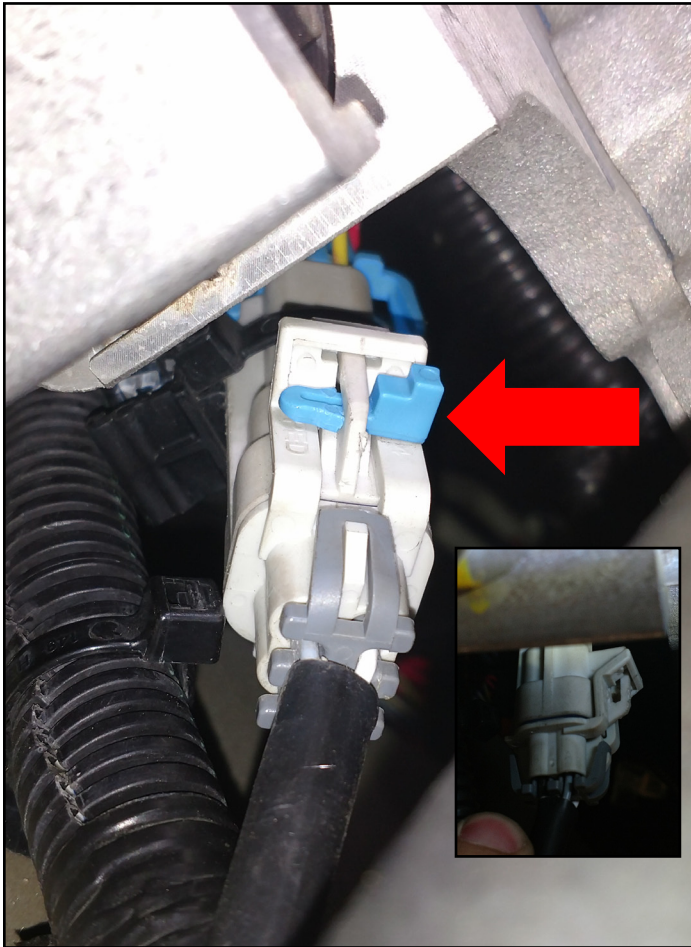
fig.4a

To undo the device connector, there is a blue locking tab, this can be pushed out, and saved for reassembly (fig.4a) and inset.

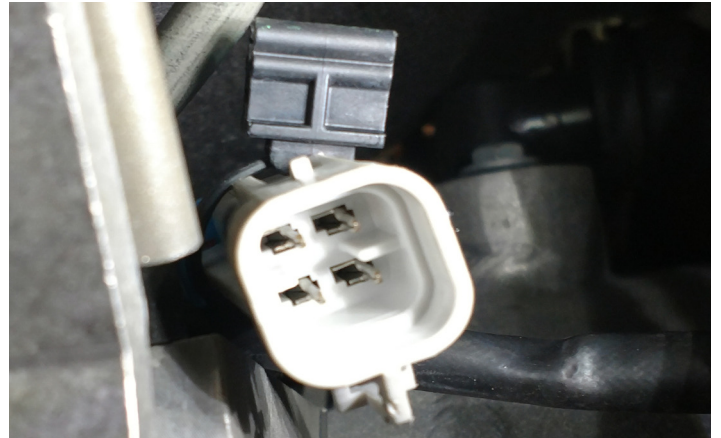
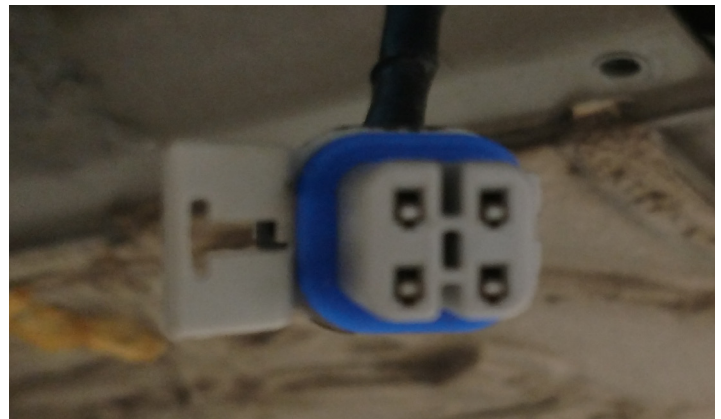
The connector and terminals should be found clean (fig 4b, 4c). Reassemble when the inspection is complete with no damage or corrosion found.

Should any corrosion be found, replace the Oxygen sensor, and splice a new connector end on to the harness.

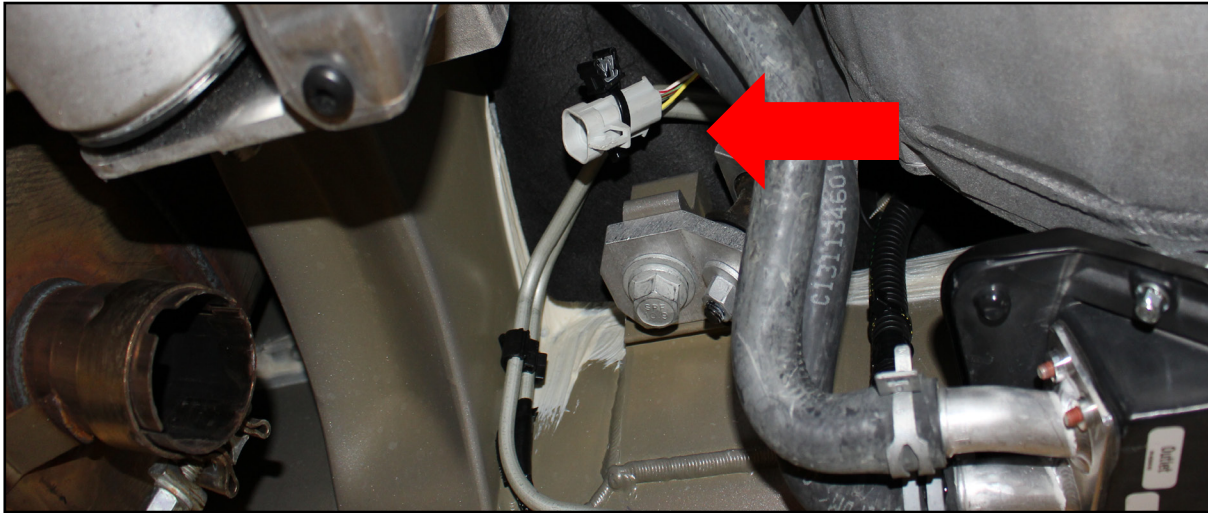
fig.6a

The splice-in repair part has matching wire colors, to connect like to like. The harness connector is visible here. (fig 6a).
