## **IMPORTANT TECHNICAL SERVICE BULLETIN - IMMEDIATE ACTION REQUIRED**

## IMPORTANT TECHNICAL SERVICE BULLETIN - IMMEDIATE ACTION REQUIRED

Technical Service Bulletin for trailers equipped with optional inverter potentially improperly installed chassis ground wire or missing chassis ground wire.

Oliver Legacy Elite and Elite II models built on or after January 1, 2014.

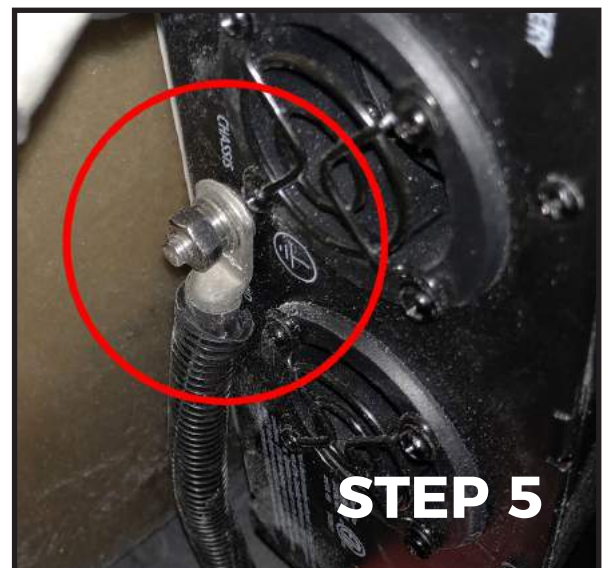
1. Go to the main circuit breaker panel located below the dinette and turn off the main 30-amp circuit breaker.
2. Unplug all 30-amp power cords from the camper, including the optional 30-amp convenience connection if installed.
3. Locate and disconnect the inverter's 4/0 positive wire followed by the inverter's 4/0 negative wire from the battery bank.
4. Locate the inverter in one of the lower street side compartments.
5. Check whether there is a ground wire connected to the chassis ground terminal on the inverter.  
**(Note: See Step 5 image)**

6. If there **IS** a ground wire connected to the chassis ground terminal on the inverter, check that the appropriately-sized ring terminal has been installed and that the ring terminal **DOES NOT** have a flat washer between it and the chassis of the inverter.
7. If the ground wire **IS** installed with the appropriately-sized ring terminal and there is **NOT** a flat washer installed between the ring terminal and chassis, the issue is not present in your travel trailer. Please fill out the included inspection reply card and mail to address below using the postage provided return envelope :
